**PHASE I CULTURAL RESOURCES INVESTIGATION
FOR THE PROPOSED HAMBURG CROSSINGS
RETAIL DEVELOPMENT, TOWN OF HAMBURG,
ERIE COUNTY, NEW YORK**

May 2007

Phase of Survey: Phase I Cultural Resources Reconnaissance Survey

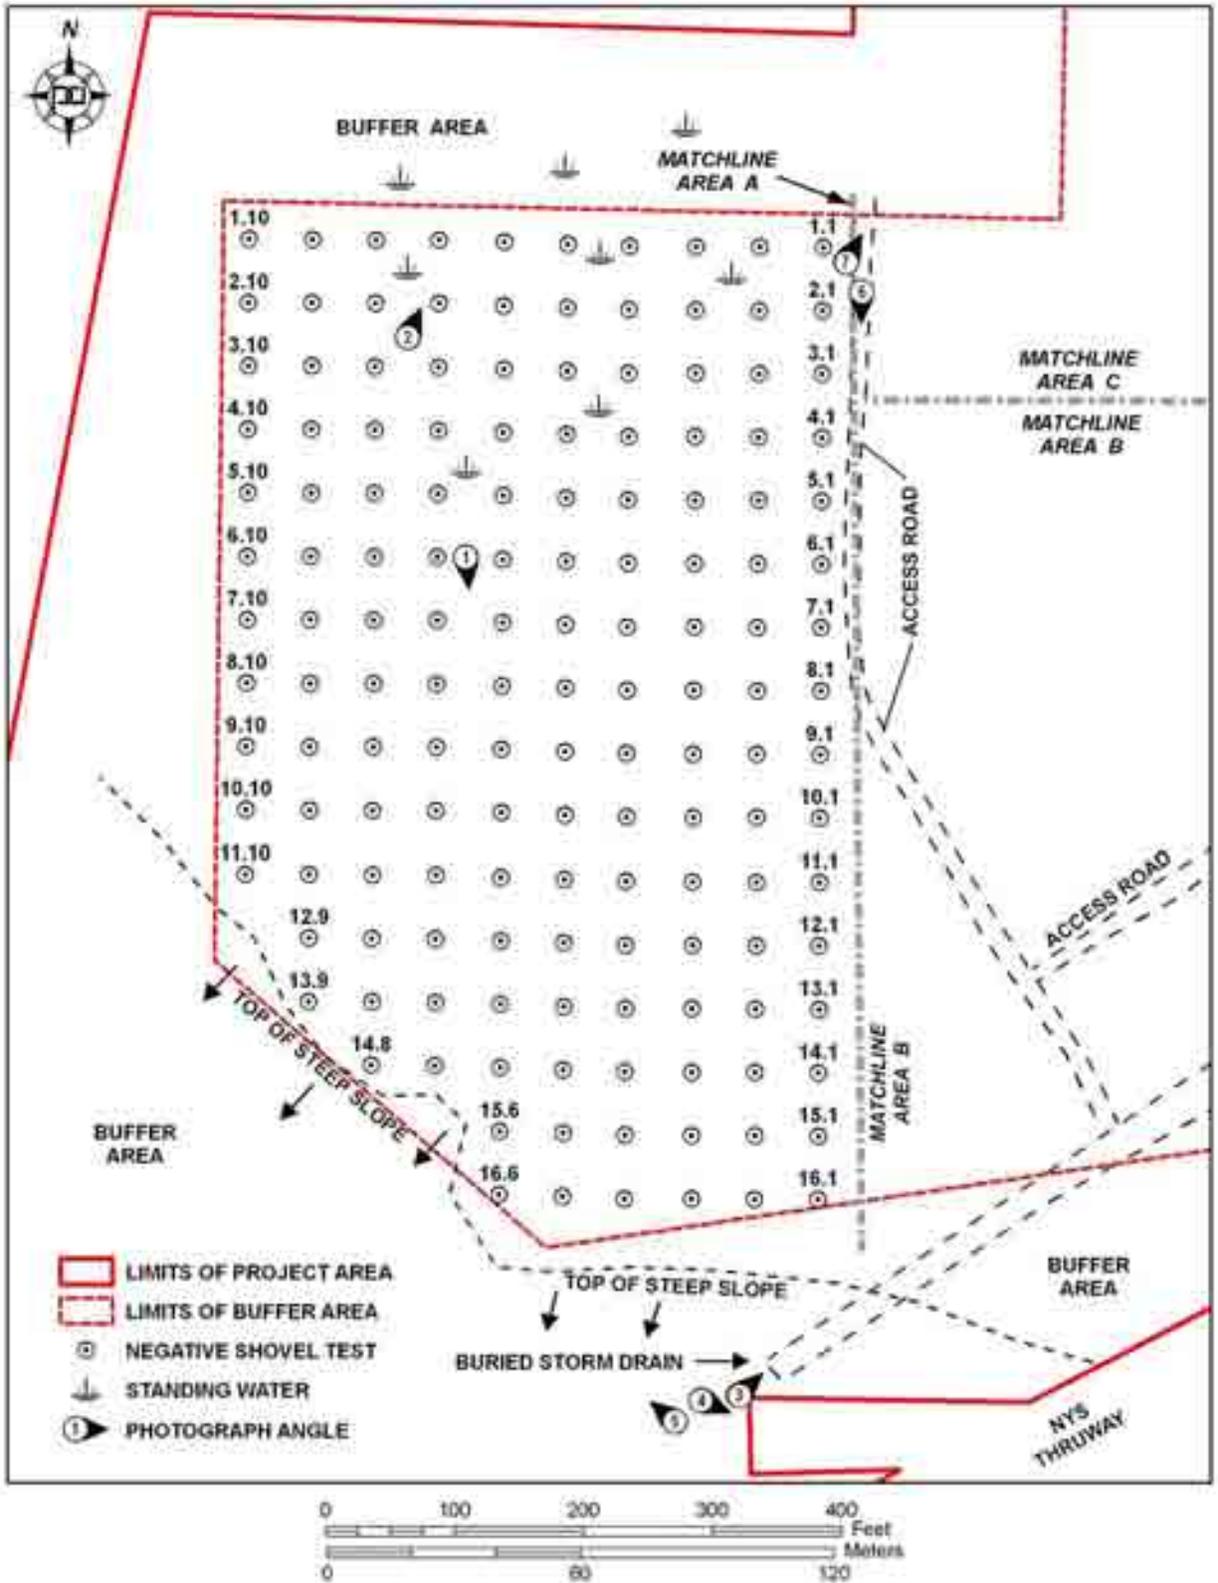
Figure 9. Study Area A: locations of shovel tests, disturbances, and photograph angles.

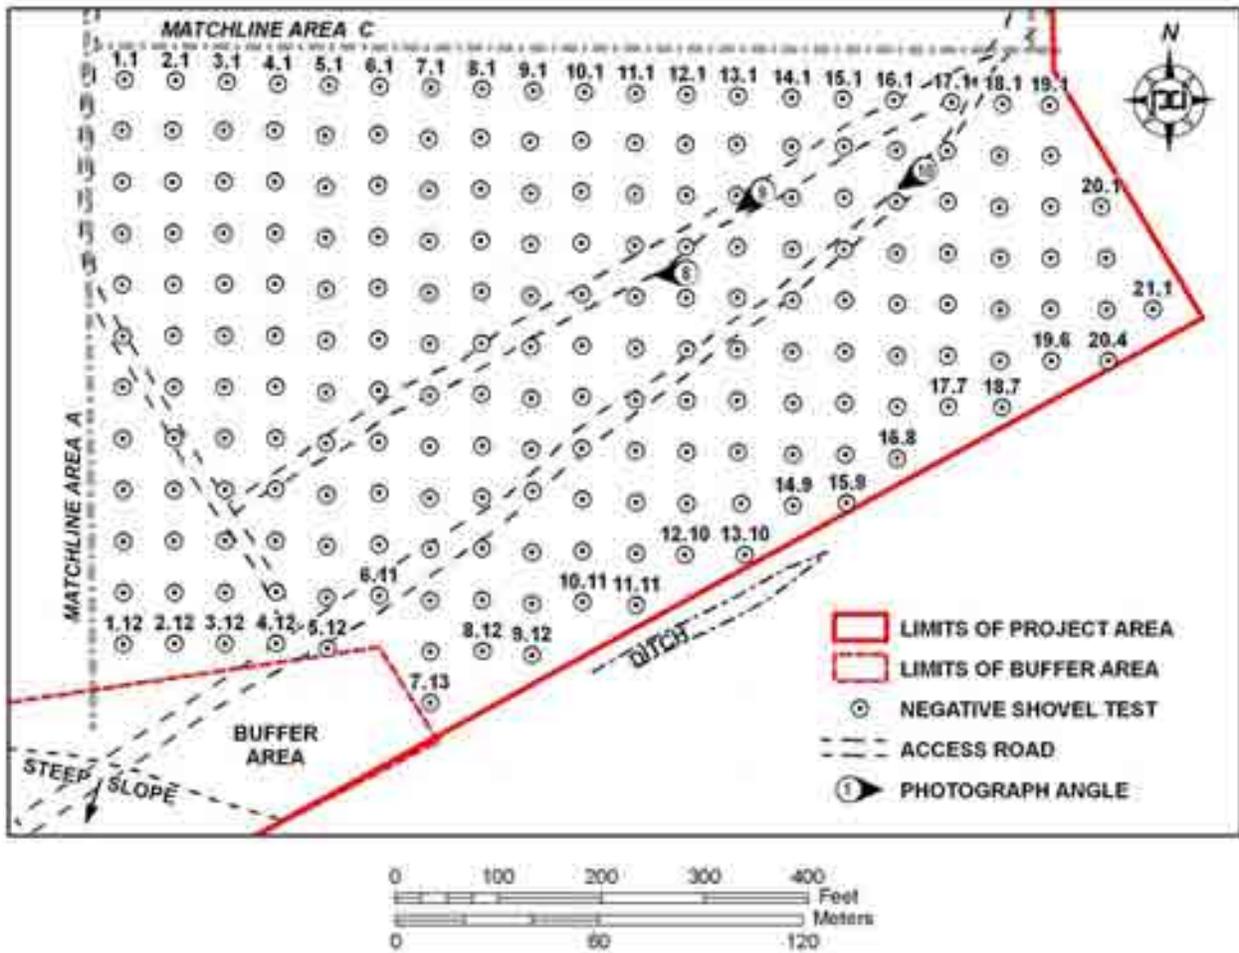
Stratum 1 typically consisted of dark grayish brown silty loam, reaching an average depth of 16 cm (6.3 in), and ranging between 7 and 34 cm (2.8 and 13.4 in). Stratum 2 was a yellowish brown or mottled light brownish gray and brownish yellow clay loam or silt clay loam, reaching an average depth of 31 cm (12.2 in), and ranging between 19 and 44 cm (7.5 and 17.3 in). Water seepage occurred in 63 shovel tests (see Appendix B). No artifacts or buried features were found in the shovel tests of Study Area B.

Figure 10. Study Area B: locations of shovel tests, disturbances and photograph angles.

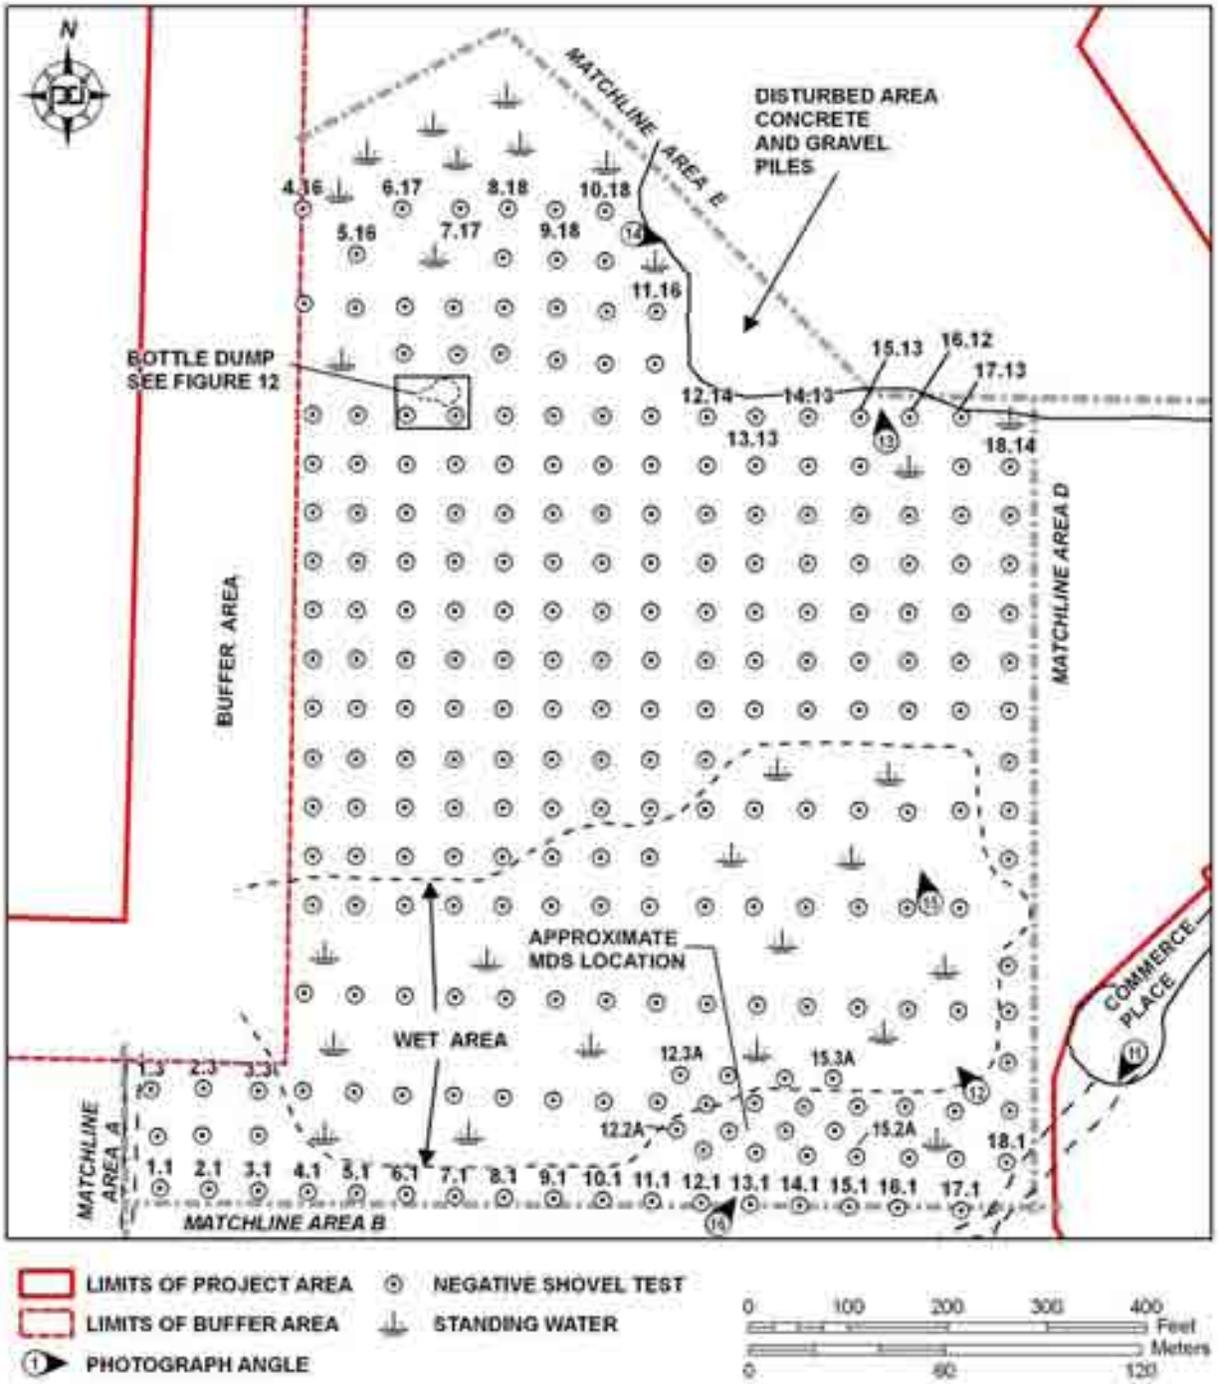
In the north portion of Study Area C, a small mid-twentieth century dump consisting of approximately 30 bottles and bottle fragments was found during the walkover reconnaissance, located approximately 20 ft (6.1 m) northeast of STP C6.14 (see Figure 11). A representative sample totaling 13 objects was collected, including a Vitalis bottle dated 1937; a glass condiment jar and an amber glass both exhibiting a Hazel-Atlas Glass Company mark used between 1920 and 1964; one glass pickle jar; one Musterole mustard plaster jar made of white milk glass with an embossed aluminum spin-cap (date undetermined); one Murine eye solution glass jar (date undetermined); one lemon juice bottle (clear glass) marked Owens-Illinois Glass Co. and "Duraglass" dating between 1940 and 1954; three modern vitrified cup bodies, one vitrified possible plate base, one green Depression or carnival-type glass bowl fragment, and one milkglass novelty dish lid fragment in the form of a hen's head and body (Table 2). These materials typify household refuse.

Figure 11. Study Area C: locations of shovel tests, disturbances and photograph angles.

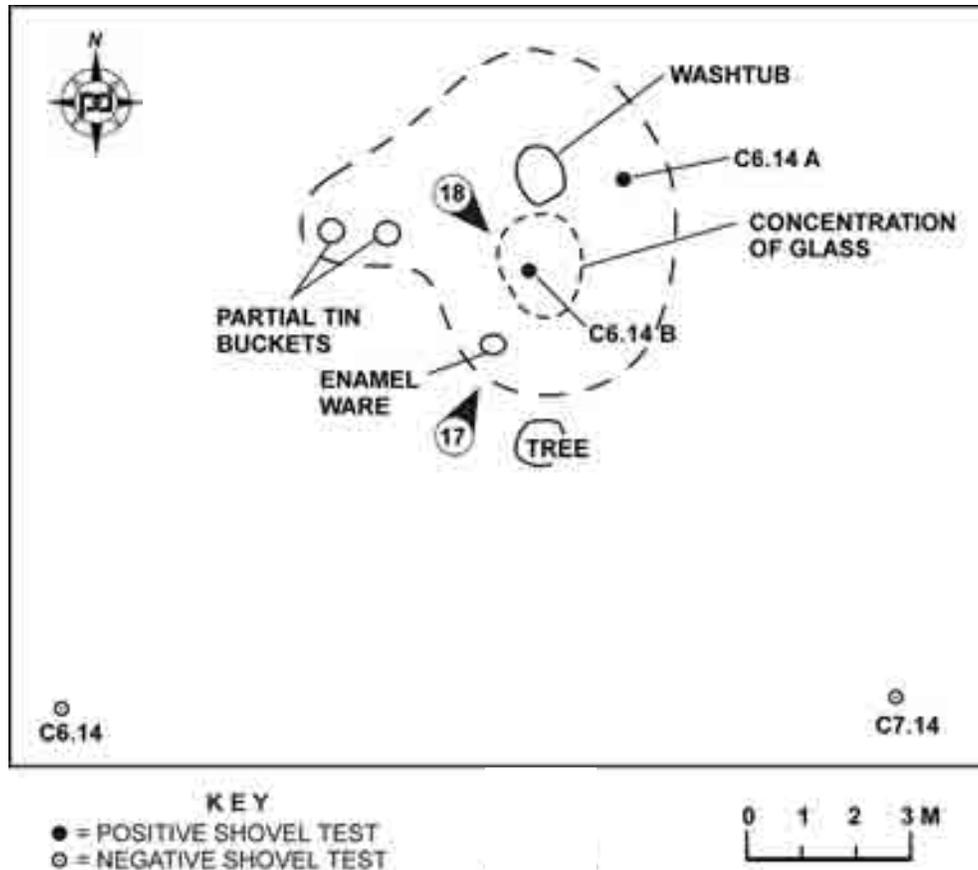
Two shovel tests were dug to determine the depth of the deposit and if it is stratified (Figure 12). STP C6.14A was placed within the east portion of the bottle dump (see Appendix A: Photograph 17). A low concentration of broken bottle glass was found to a depth of 15 cm (5.9 in) in Stratum 1. No large or diagnostic fragments were found in the shovel test, therefore no materials were collected. STP C6.14B was placed centrally in the dump where a concentration of bottles was found obscured by leaves (see Appendix A: Photograph 18). Broken bottle glass was found in moderate density within the shovel test to a depth of approximately 15 cm (5.9 in) in Stratum 1. Potentially diagnostic materials were collected, including a complete half-pint liquor bottle with a post-1938 Anchor-Hocking Glass Co. bottle mark and a potential date of manufacture mark – "46", one milkglass teacup fragment with handle, one green Depression or carnival-type glass bowl rim fragment, and one non-diagnostic opaque glass vessel fragment with a textured wavy decorative surface (see Table 2).

Based upon field examination, the surface scatter was contemporaneous with materials found in the two shovel tests. Complete or nearly complete bottles tended to be located closer to the surface, while fragments were found below the surface in the saturated soil. There was no sign, however, of stratified deposits by age or type of bottles. Although the sample size of

Figure 12. Bottle dump within Study Area C: locations of shovel tests and photograph angles.

diagnostic bottles is too small to provide a meaningful mean-date calculation, a likely 1940s period of deposit is obtained based upon frequency of dateable bottles. No additional artifacts or buried features were found in the shovel tests of Study Area C.

The bottle dump is considered to have low research potential and limited cultural significance based upon its lack of associated context and stratigraphy. The bottle dump does not meet the eligibility criteria for listing in the State or National Registers of Historic Places. No cultural materials were found in the remaining portions of the APE. Therefore, no further cultural resource investigations are recommended.

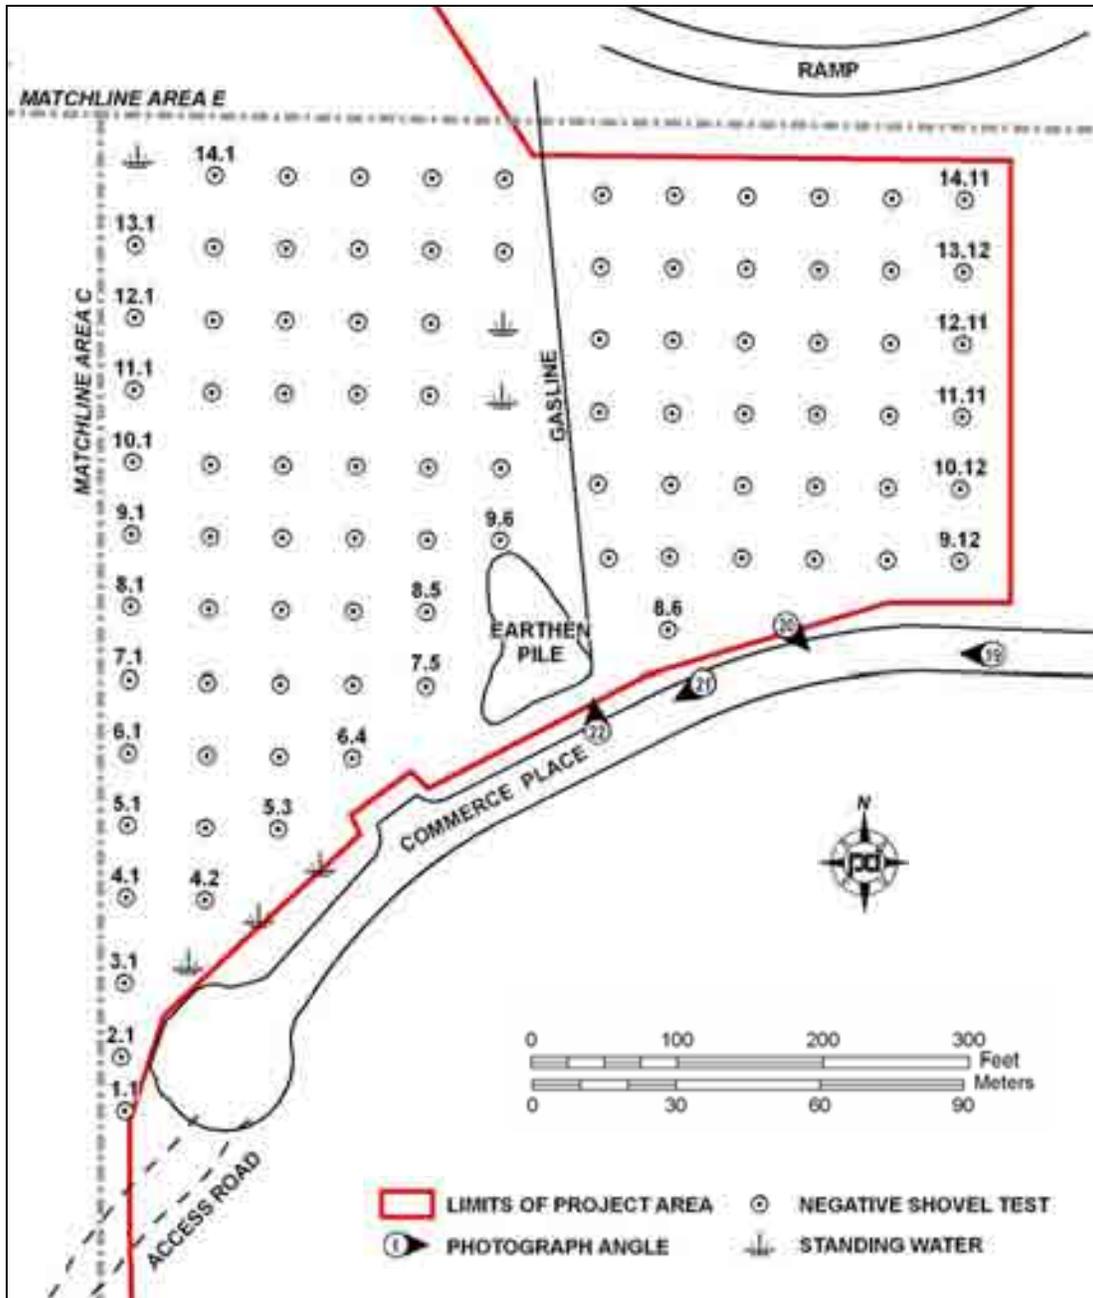
Study Area D. This study area consists of approximately five acres in the eastern part of the project area, located adjacent to the north side of Commerce Place (see Figure 8; see Appendix A: Photograph 19). Structures located adjacent to the study area include a medical care facility and a Comfort Inn, both located on the south side of Commerce Place (outside the project area) (see Appendix A: Photographs 20 and 21). Vegetation within Study Area D consisted of younger trees (beach with a few maples noted) and a significant increase in brush coverage (dogwood) compared to other areas of the project. Drainage was fair to moderate, with isolated pockets of standing water frequently observed in proximity to the west and northwest extent of the study area. Impacts include a gasoline corridor bisecting the study area from north to south (see Appendix A: Photograph 22). An earthen pile approximately 75 ft (22.9 m) in diameter is located adjacent to the south extent of the gasoline corridor (which is also shown in Photograph 22).

Figure 13. Study Area D: locations of shovel tests, disturbances and photograph angles.

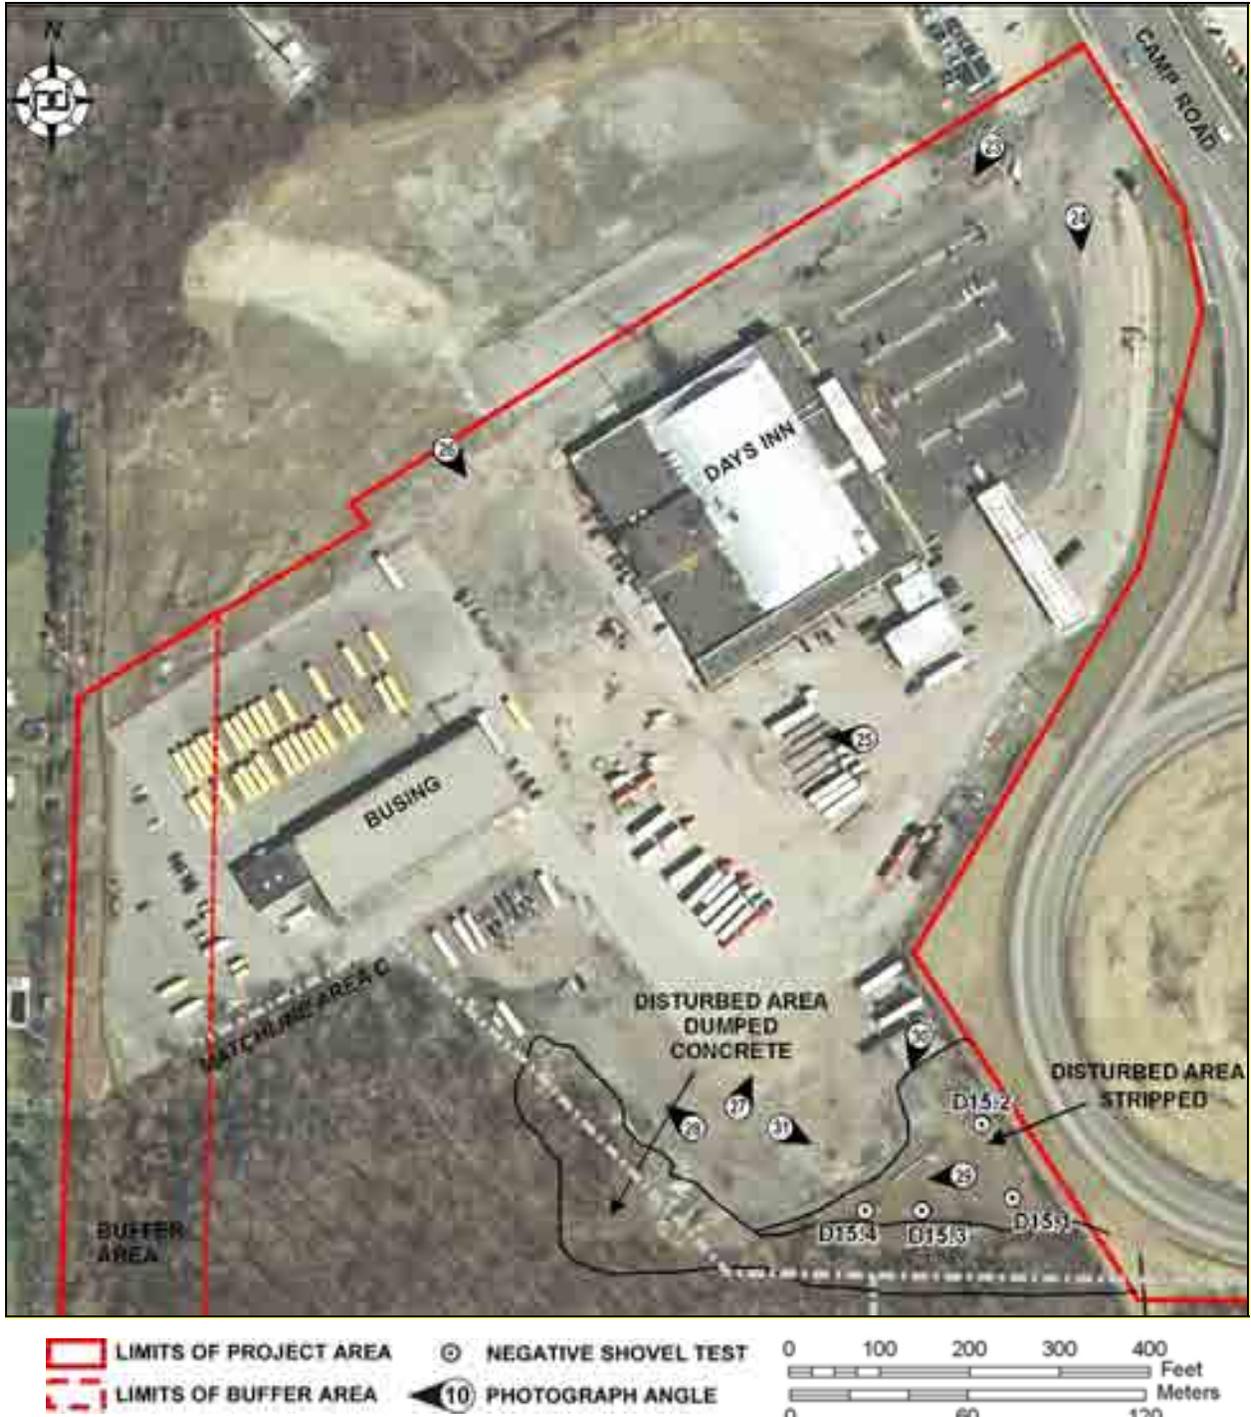
Figure 14. Study Area E: locations of disturbances and photograph angles (aerial source: NYS GIS Clearinghouse 2002).

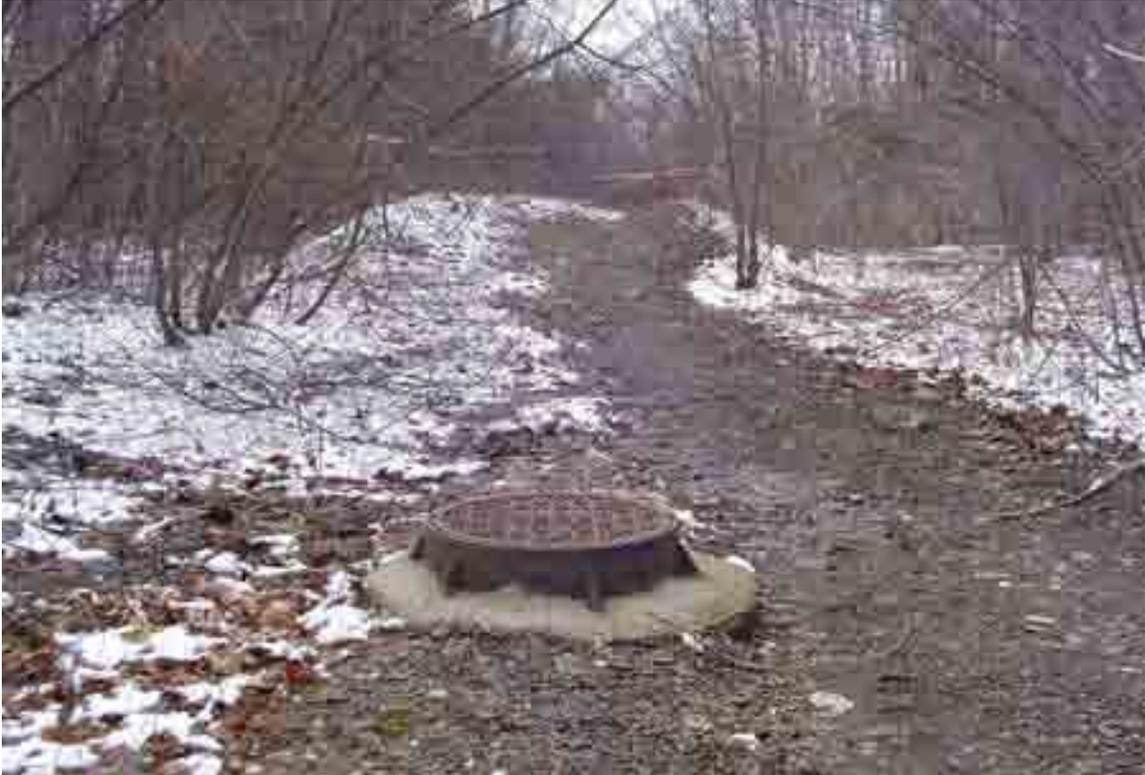
Photograph 9. Sewer cover located within graded portion of raised gravel access road, facing southwest (*PCI 2007*).

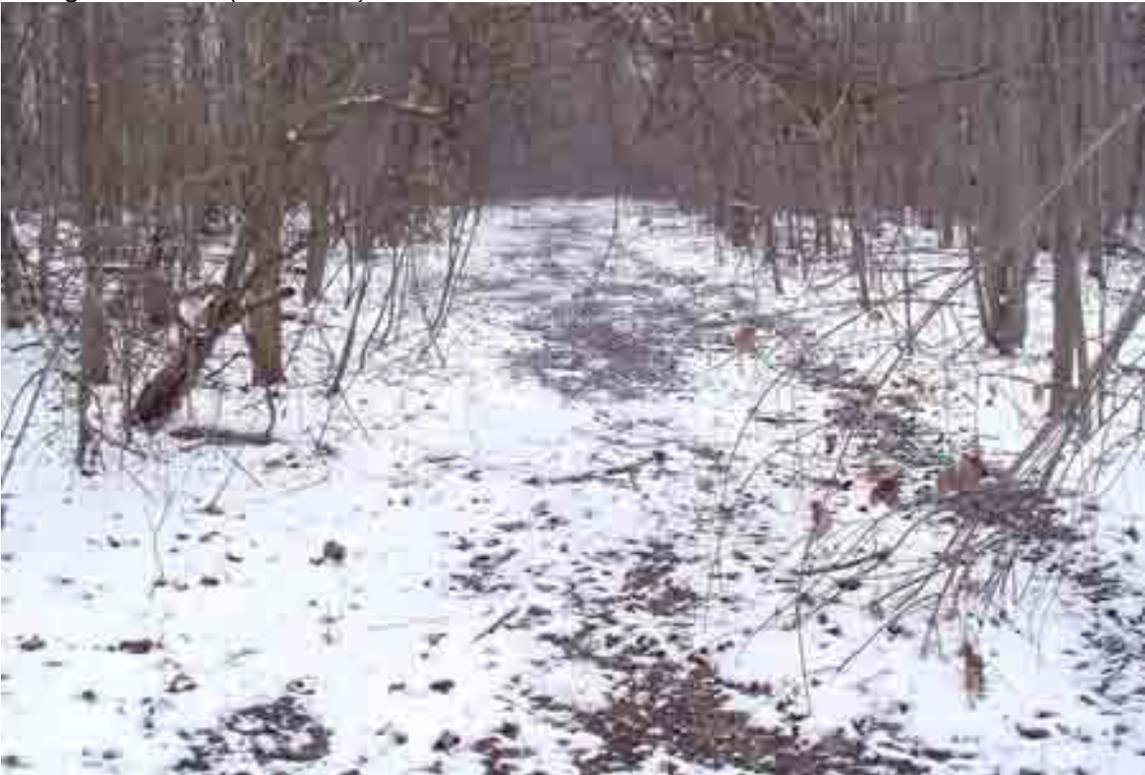
Photograph 10. Shale-covered access road within Study Area B associated with buried storm drain system, facing southwest (*PCI 2007*).

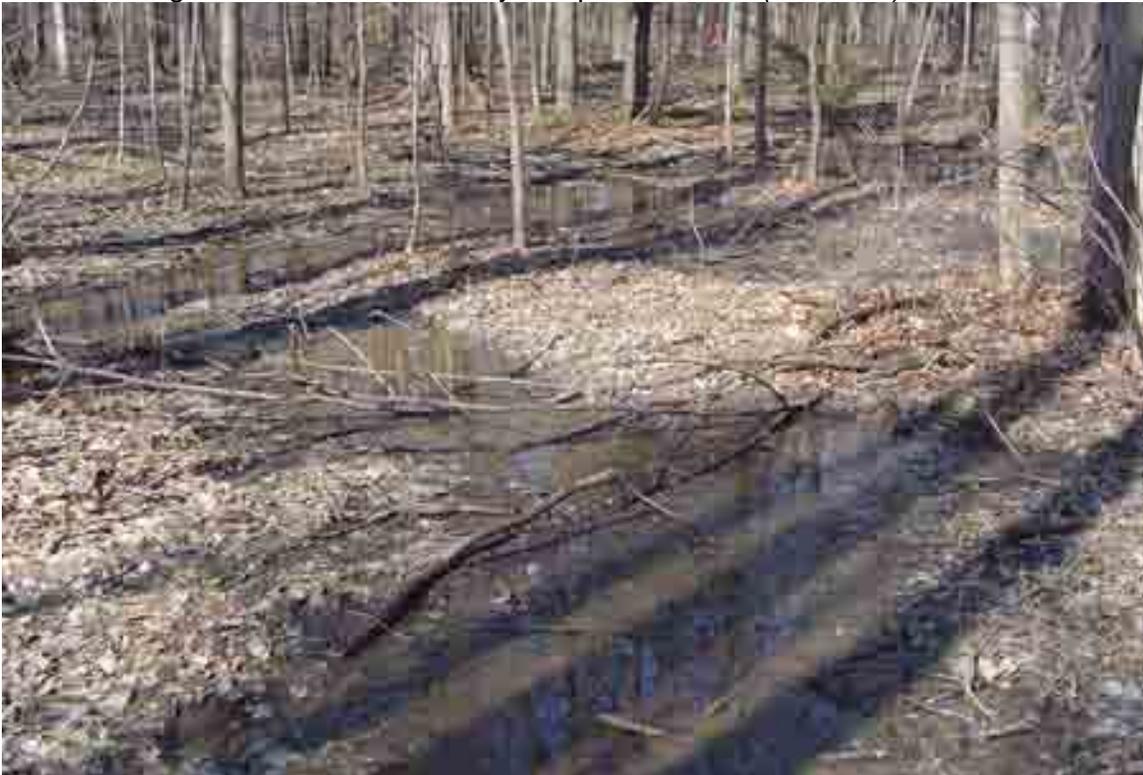
Photograph 12. Seasonally standing water frequently observed within central portion of APE, facing northwest (*PCI 2007*).

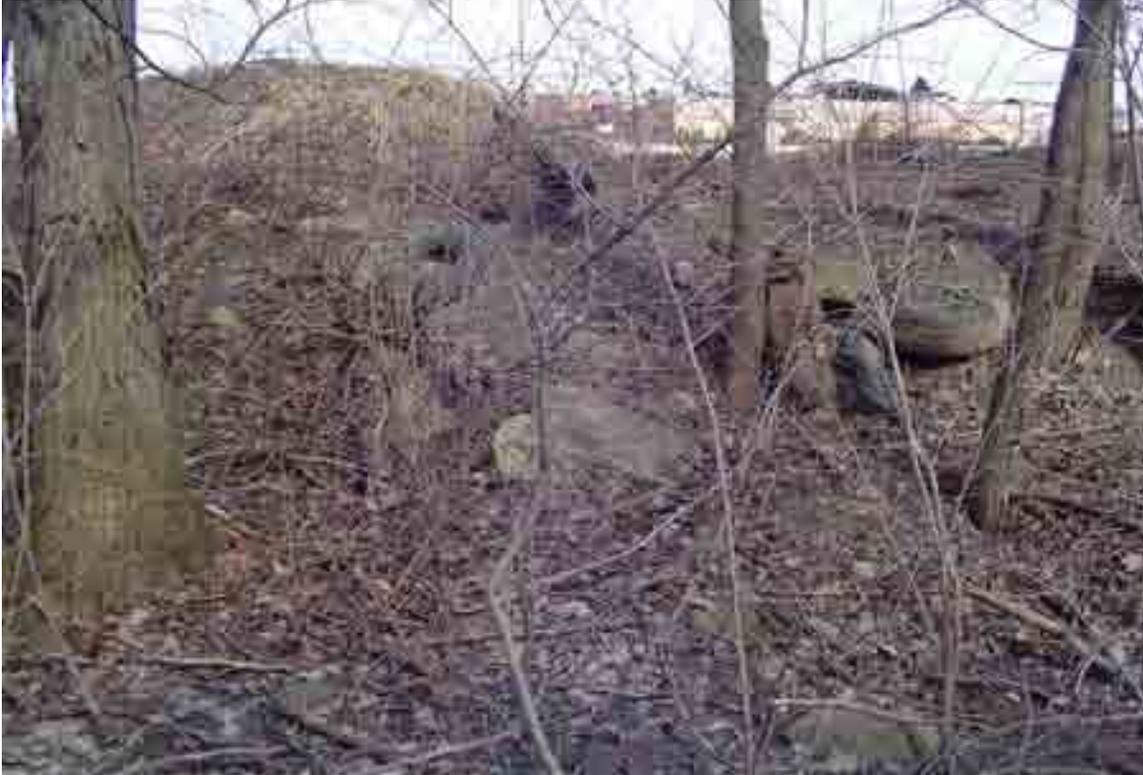
Photograph 13. Concrete and earthen piles adjacent to north extent of Study Area C, facing north. Note discarded tires and miscellaneous materials (*PCI 2007*).

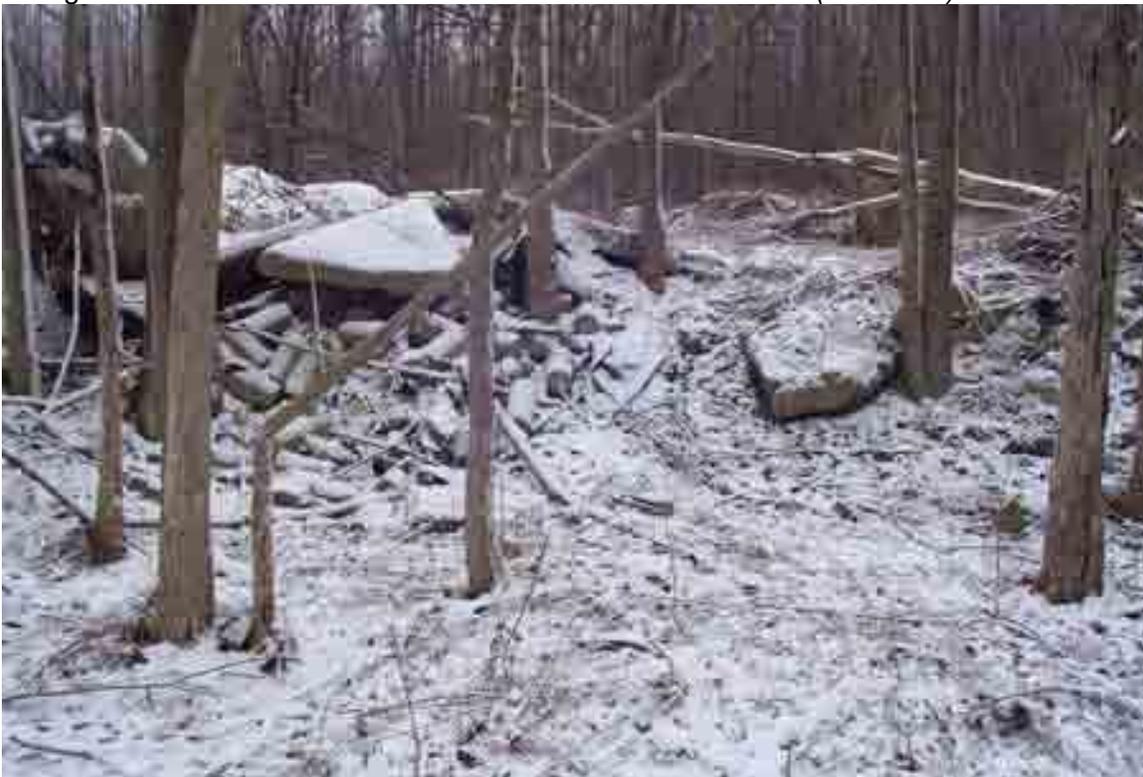
Photograph 14. Artificial elevation consisting of dumped concrete and gravel at northeast extent of Study Area C, facing east (*PCI 2007*).

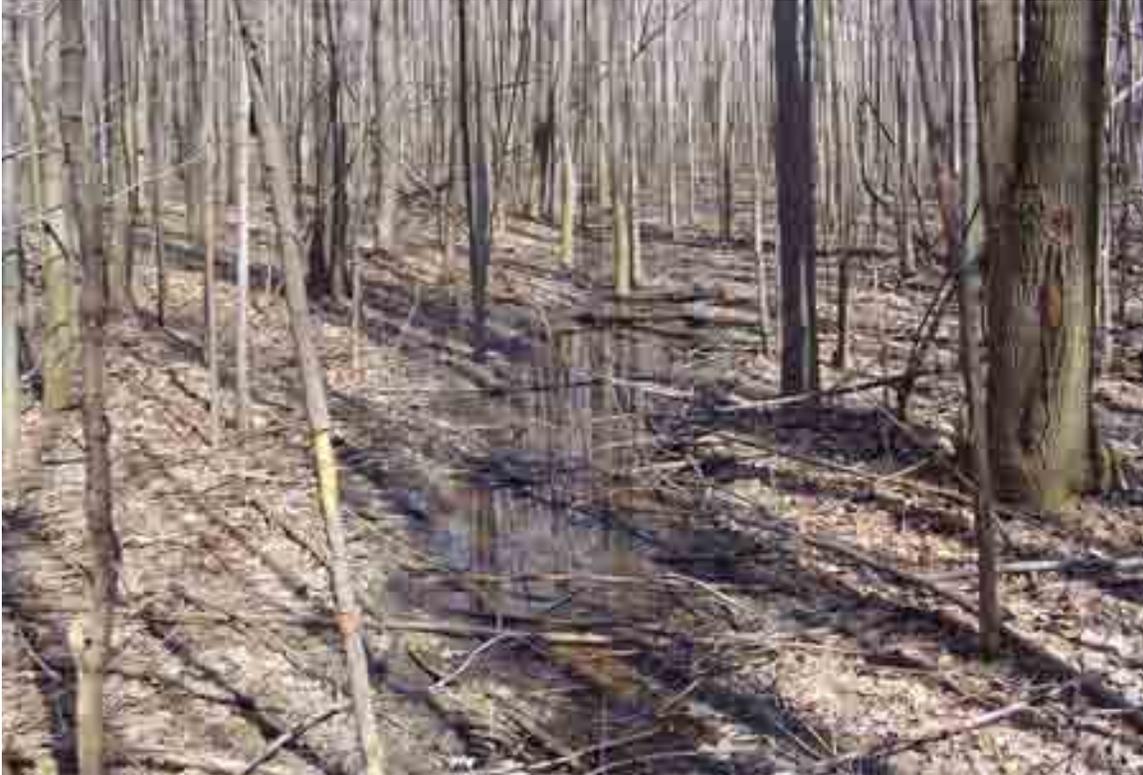
Former agricultural furrows or shallow drainage ditches generally aligned north-south and approximately spaced 30 ft (9.1 m) apart were observed over the greater central portion of the project area suggesting former agricultural land use and associated impacts due to plowing.

Photograph 15. Typical furrow or shallow drainage ditch found frequently within north portion of project area, generally aligned north-south, facing north (*PCI 2007*).

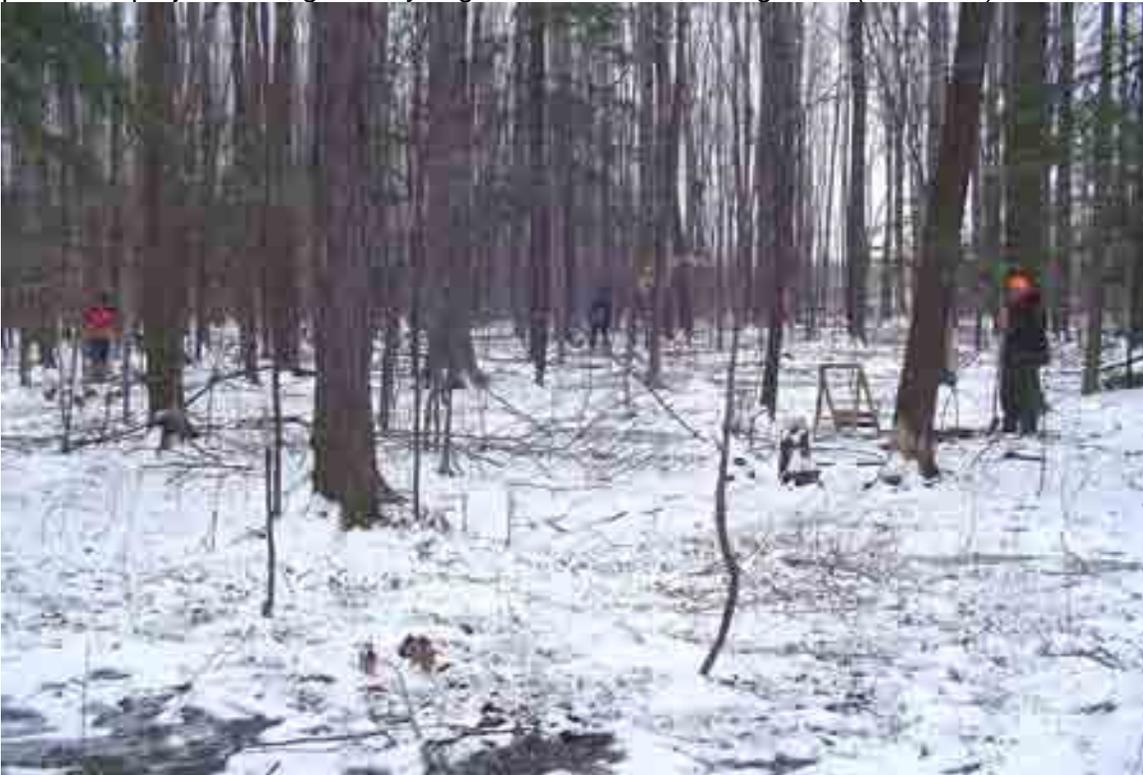
Photograph 16. Close-interval shovel tests being dug near an MDS (1880) location shown within the southeast corner of Study Area C, facing northeast (*PCI 2007*).

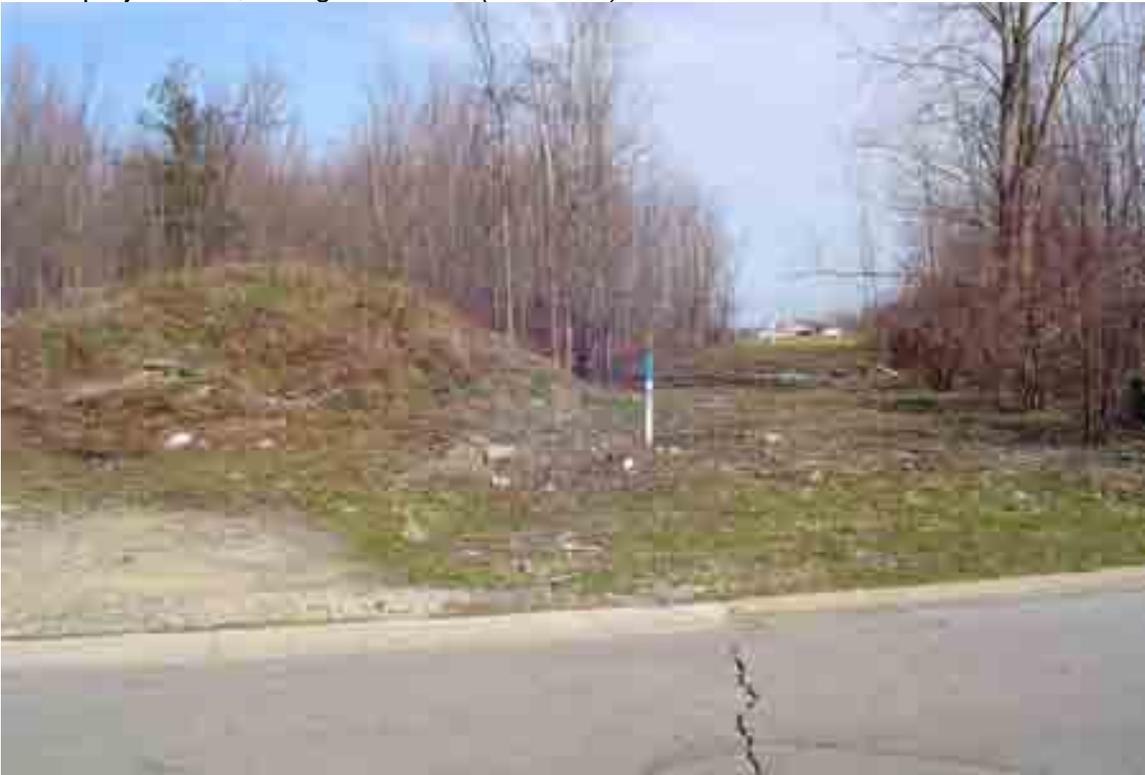
Photograph 22. Disturbance within Study Area D, including a gasline corridor and a gravel earthenpile (left), facing north (*PCI 2007*).

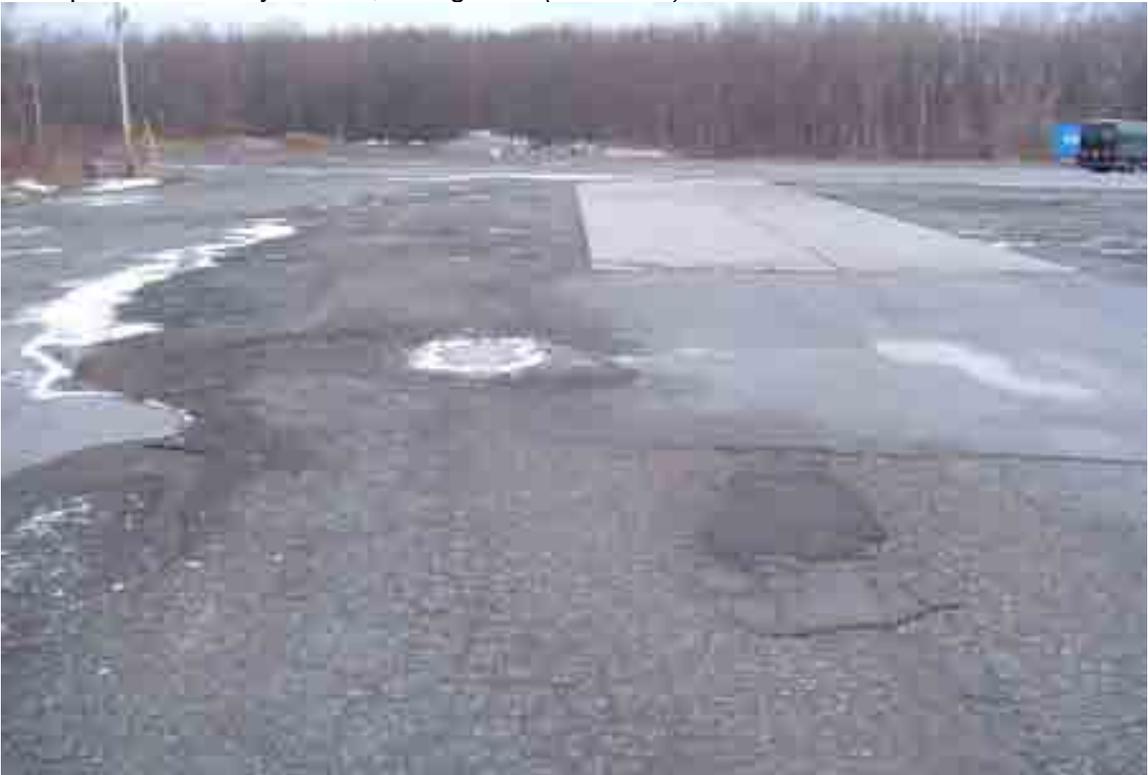
Photograph 26. View across Study Area E from north extent facing southeast. Note concrete and earthen pushpiles along tree line (*PCI 2007*).

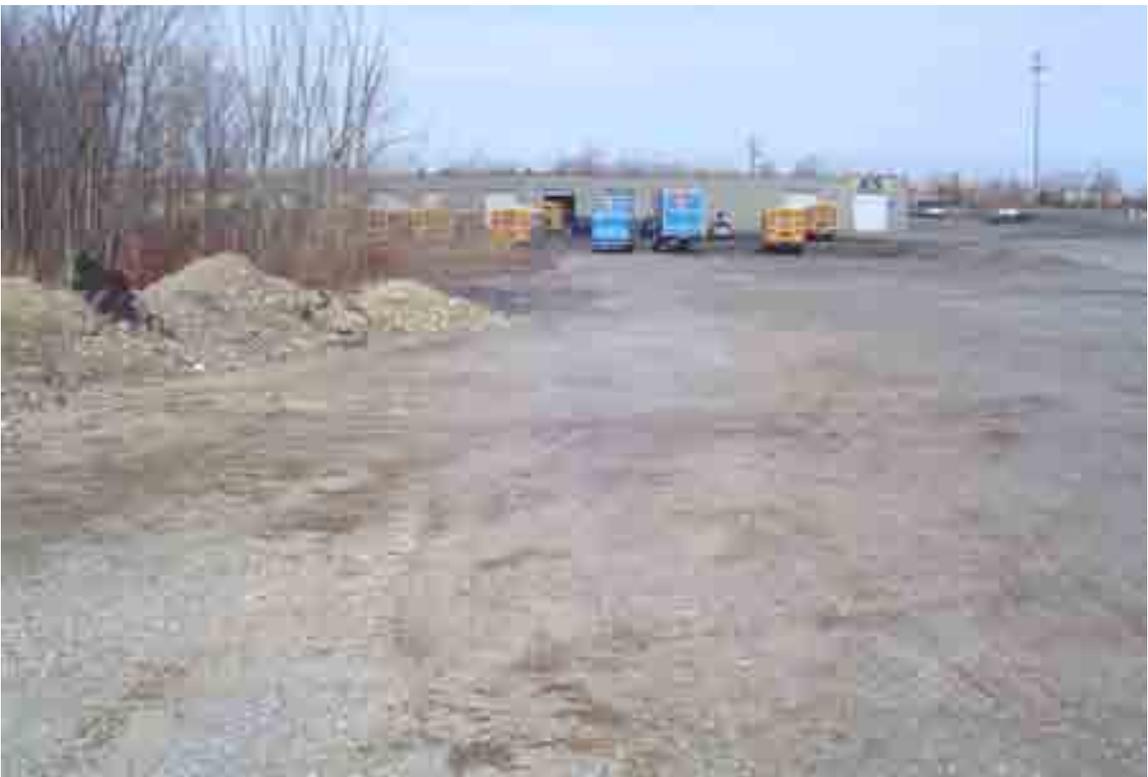
Photograph 28. South elevation of bus garage located in west portion of Study Area E, facing northwest. Gravel obscures degraded pavement located in the southwest (foreground) part of the study area (*PCI 2007*).

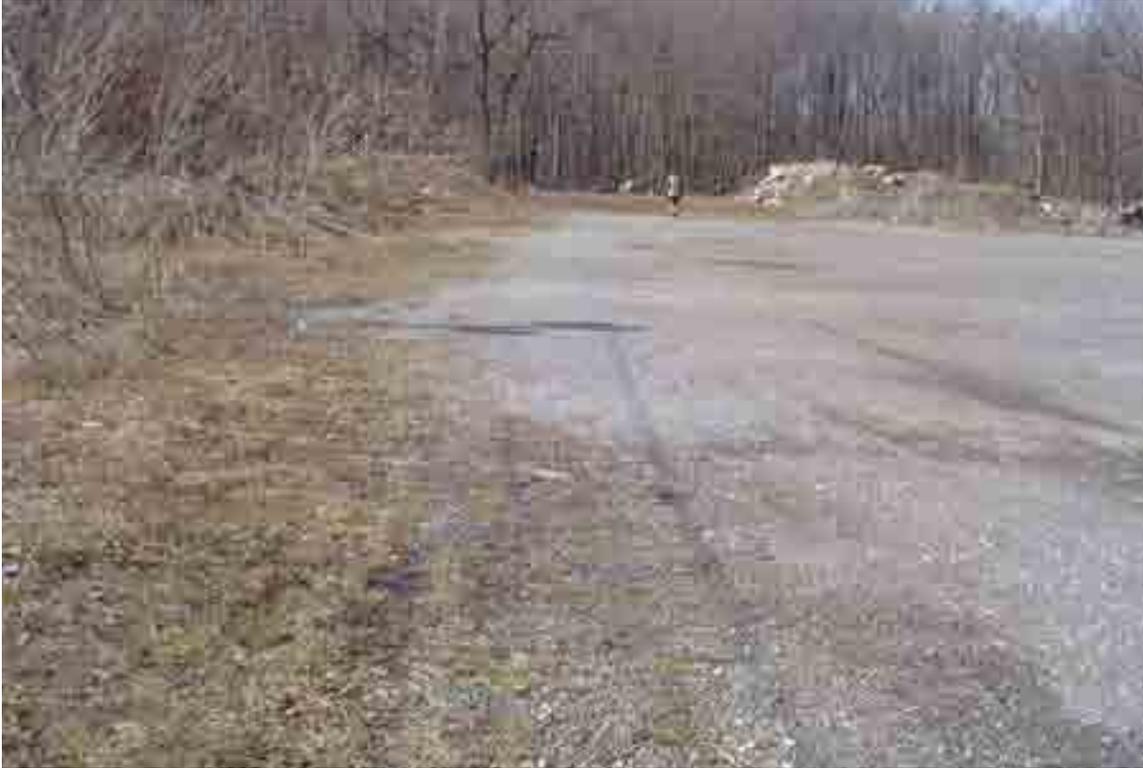
Photograph 29. Gravel obscures degraded pavement within southeast portion of Study Area E, facing west. Note extensive dumping near treeline (*PCI 2007*).

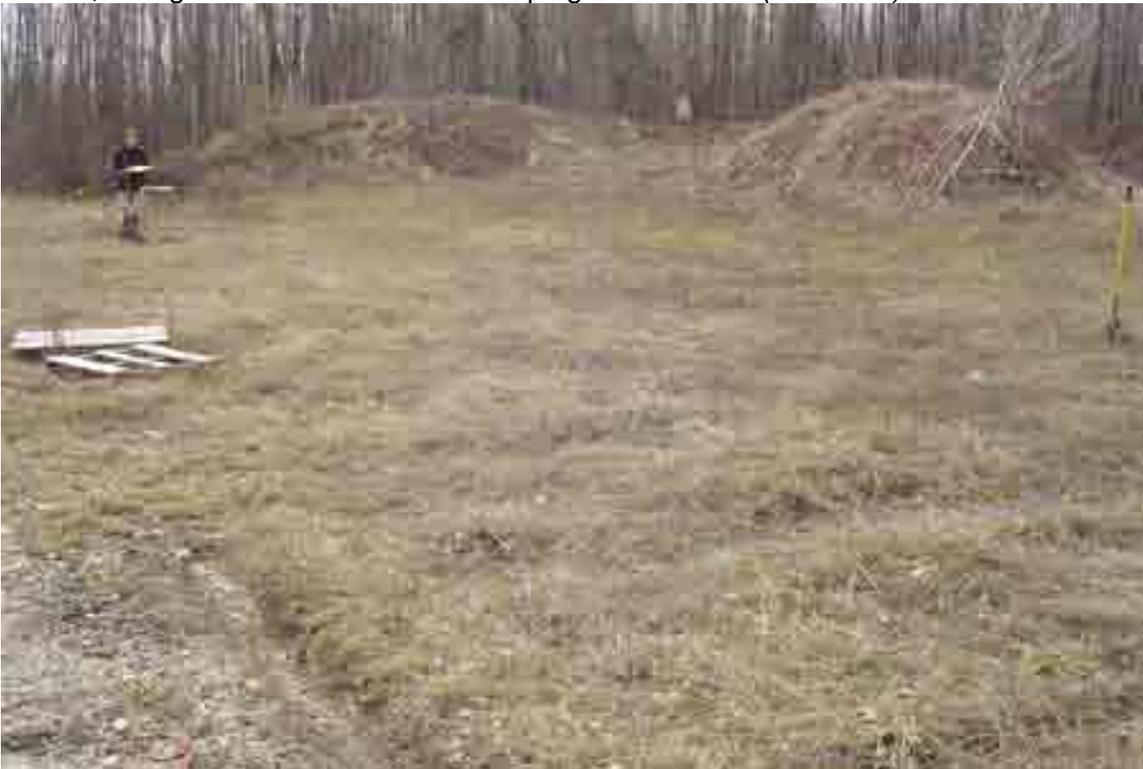
Photograph 30. Stratigraphy tested where stripped A-horizon soils were observed in southeast corner of Study Area E, facing south. Note earthen pushpiles (*PCI 2007*).

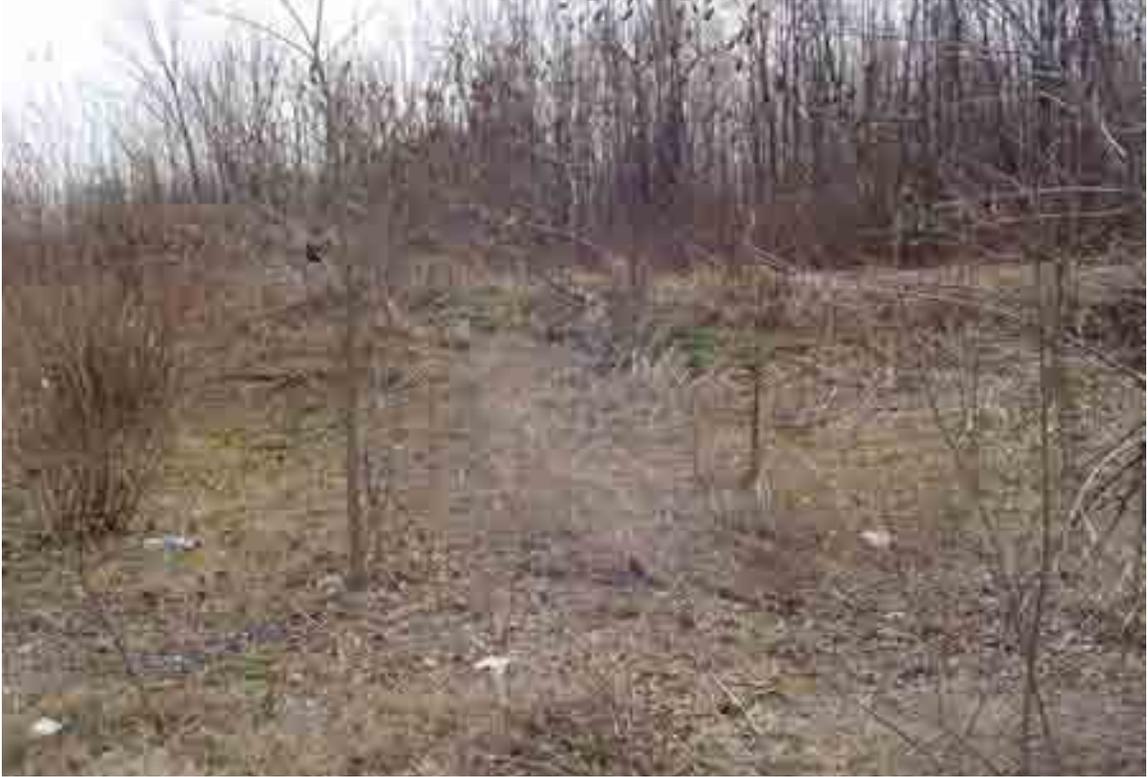
Photograph 31. Artificially elevated grassy area containing concrete, asphalt, and gravel (evident in STPs E1.3 and E1.4) at the south extent of Study Area E, facing southeast (*PCI 2007*).
