**PHASE I CULTURAL RESOURCES INVESTIGATION
FOR THE PROPOSED HAMBURG CROSSINGS
RETAIL DEVELOPMENT, TOWN OF HAMBURG,
ERIE COUNTY, NEW YORK**

May 2007

Phase of Survey: Phase I Cultural Resources Reconnaissance Survey

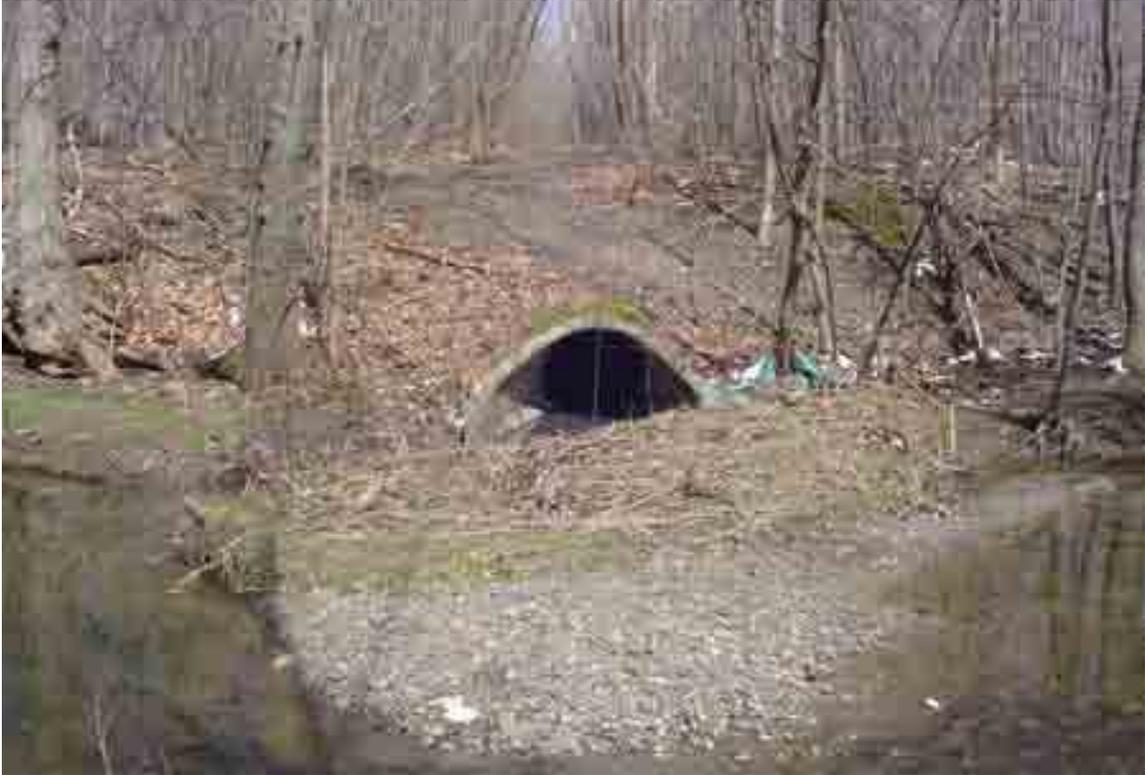
Photograph 3. Western terminus of storm drain system, located in south part of buffer zone, facing northeast. System traverses south portion of project area (*PCI 2007*).

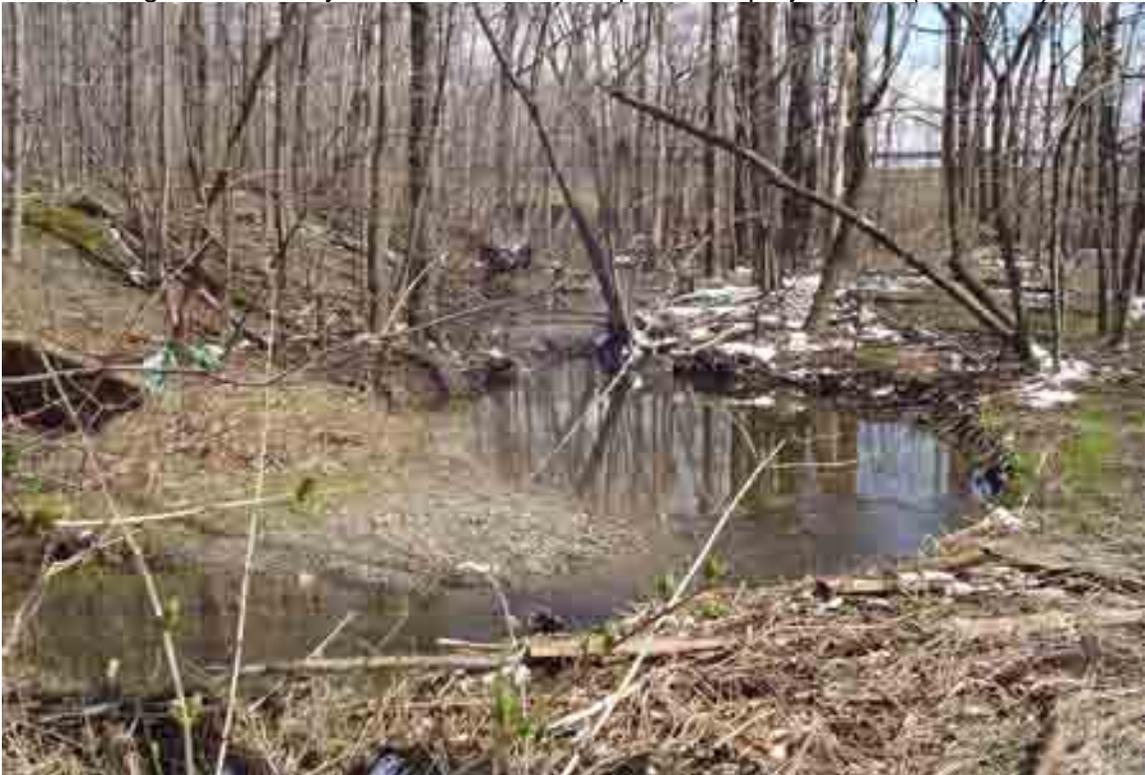
Photograph 4. Drainage from storm drain system (left) and NYS Thruway culvert (upper center – obscured by trees) within buffer zone, facing east (*PCI 2007*).
