NAME OF ACTION Proposed Sherwood Meadows Residential Project			
LOCATION OF ACTION (Include street Address, Municipality and County) 14.19 Acres of Land located on Heatherwood Drive, Town of Hamburg, Erie County			
NAME OF APPLICANT/SPONSOR DATO DEVELOPMENT, LLC c/o Sean Hopkins, Esq.		BUSINESS TELEPHONE (716) 510-4338	
ADDRESS 5500 Main Street – Suite 100			
CITY/PO Williamsville		STATE NY	ZIP CODE 14221
NAME OF OWNER (if different)		BUSINESS TELEPHONE	
ADDRESS			
CITY/PO		STATE	ZIP CODE
DESCRIPTION OF ACTION <p>The proposed project ("action") consists of the development of the Project Site as an apartment community consisting of 128 units as depicted on the Site Plan prepared by Nussbaumer &amp; Clarke, Inc. attached as Exhibit "B". The Planning Board previously approved the development of the Project Site as a 56 unit townhouse project and Phase I of the previously approved project consisting of 1 building containing 4 attached residential units, 990 feet of private roadway and related infrastructure and utility improvements were previously constructed. A copy of the Site Plan for the previously approved project is attached as Exhibit "G".</p> <p>The Project Sponsor is not propo

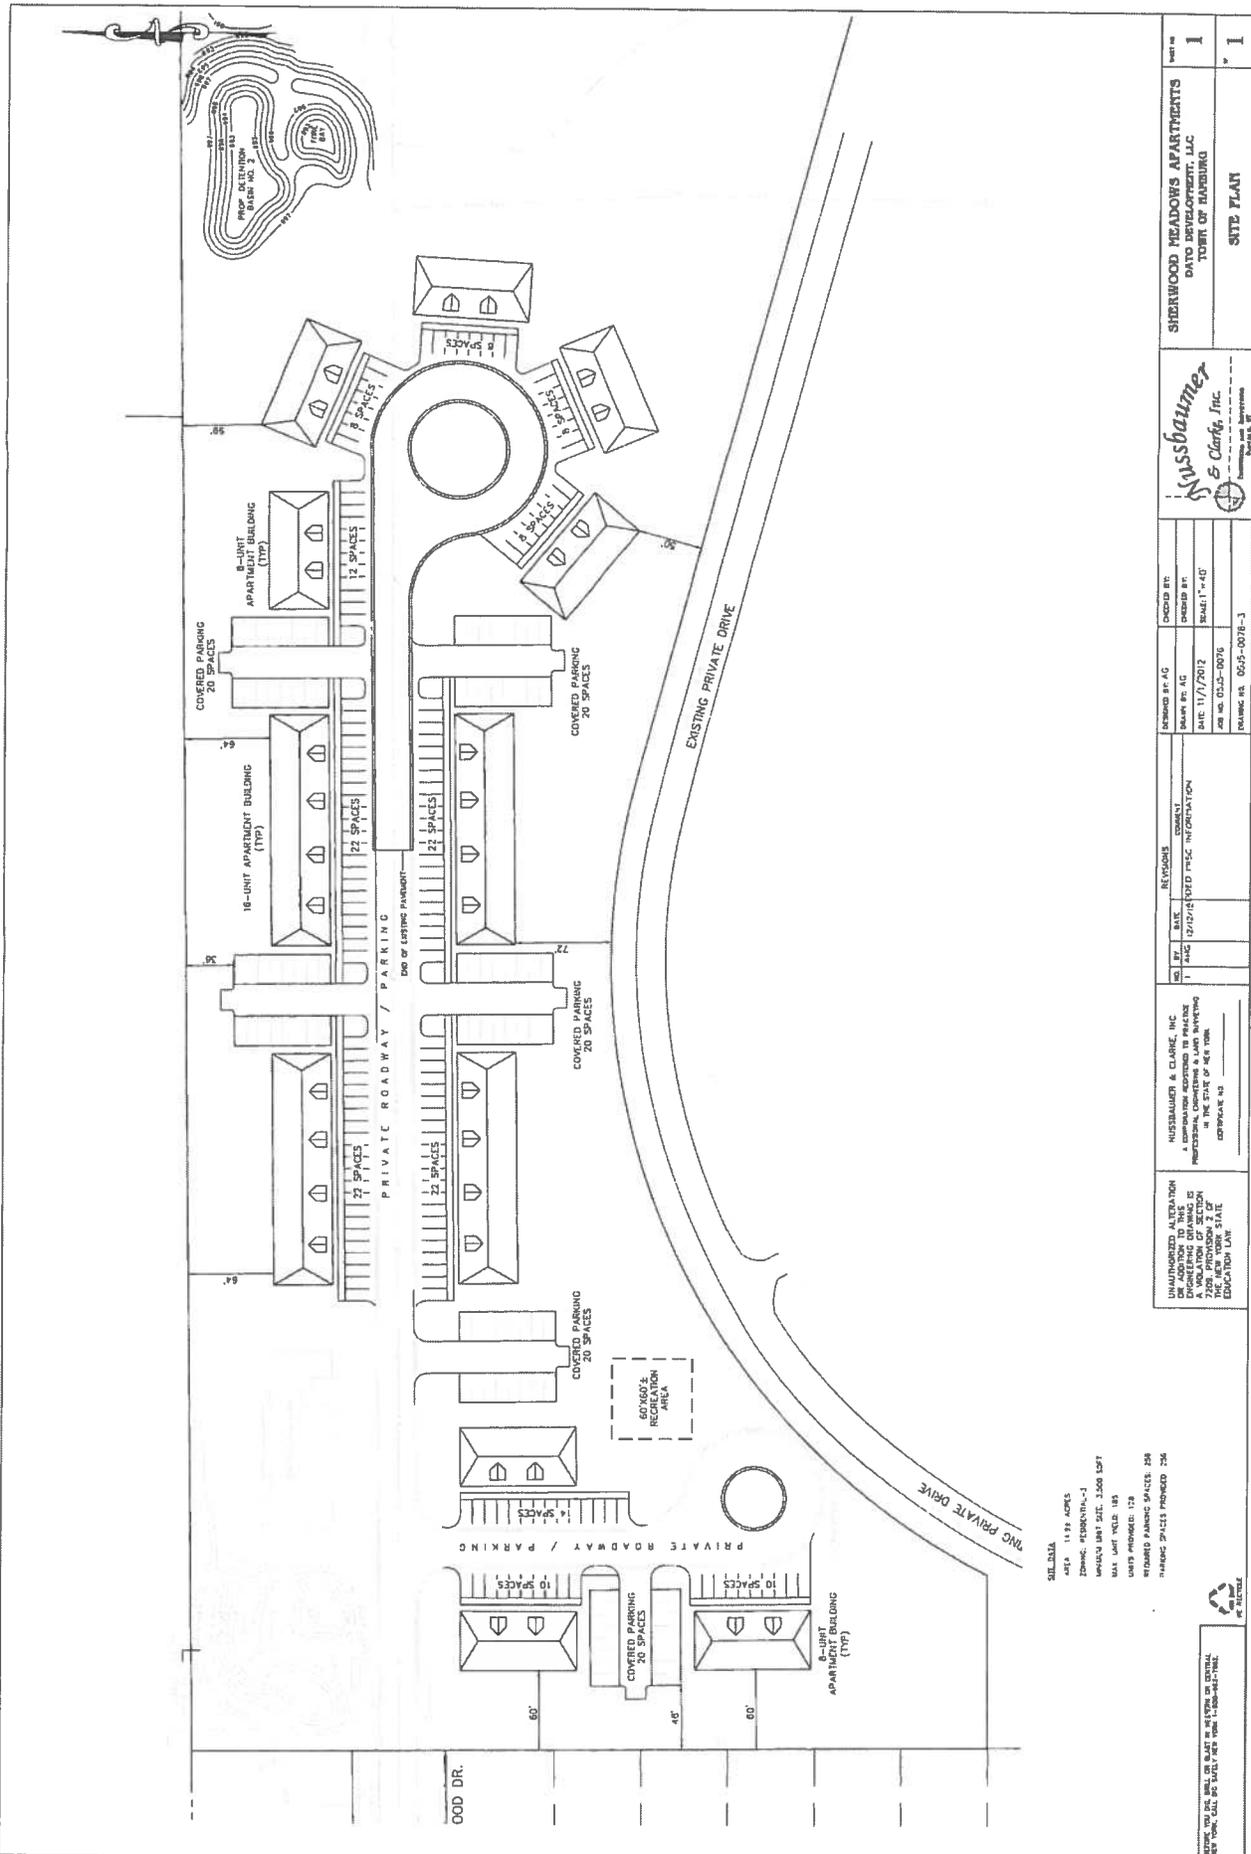
SHELDON  
 AREA 11.99 ACRES  
 ZONING: RESIDENTIAL-3  
 MAXIMUM UNIT SIZE: 2,500 SQ FT  
 MAX UNIT YIELD: 185  
 UNITS PROVIDED: 128  
 REQUIRED PARKING SPACES: 259  
 TRADING SPACES PROVIDED: 256

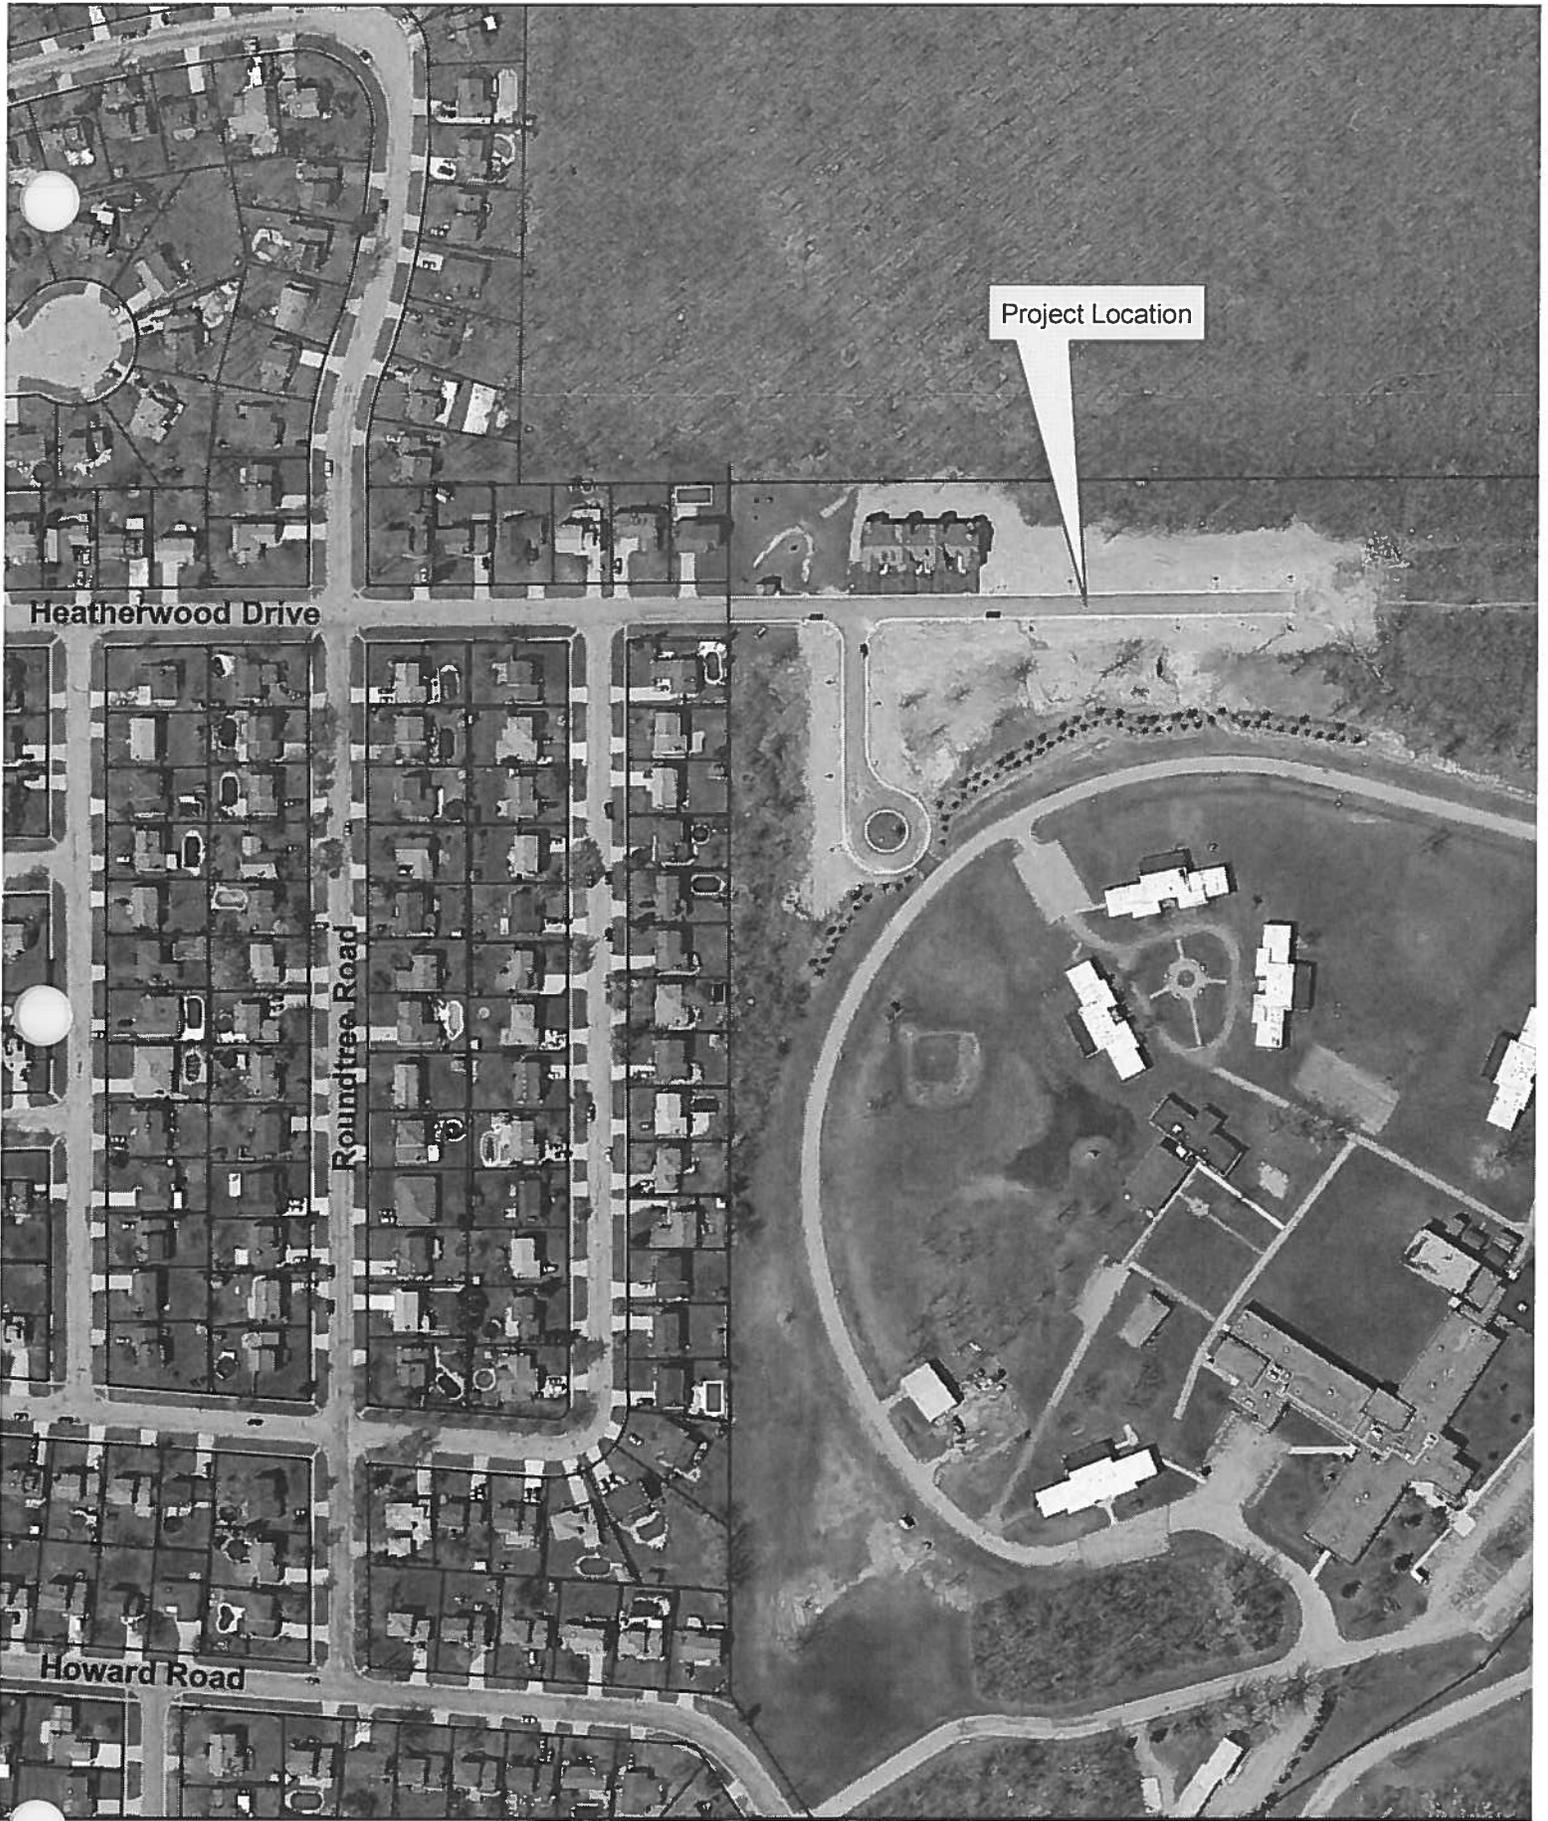
Project Location

Heatherwood Drive

Construction of the proposed Sherwood Apartments project would start in the Fall of 2013, with completion of the project expected by the end of 2018. As currently configured, the project parcel would utilize the eastern end of Heatherwood Drive to gain access to Southwestern Boulevard or Camp Road. The road extension of Heatherwood Drive is shown in the general area location map in **Figure 1**. The proposed project layout is shown in the project site plan in **Figure 2A-B**.

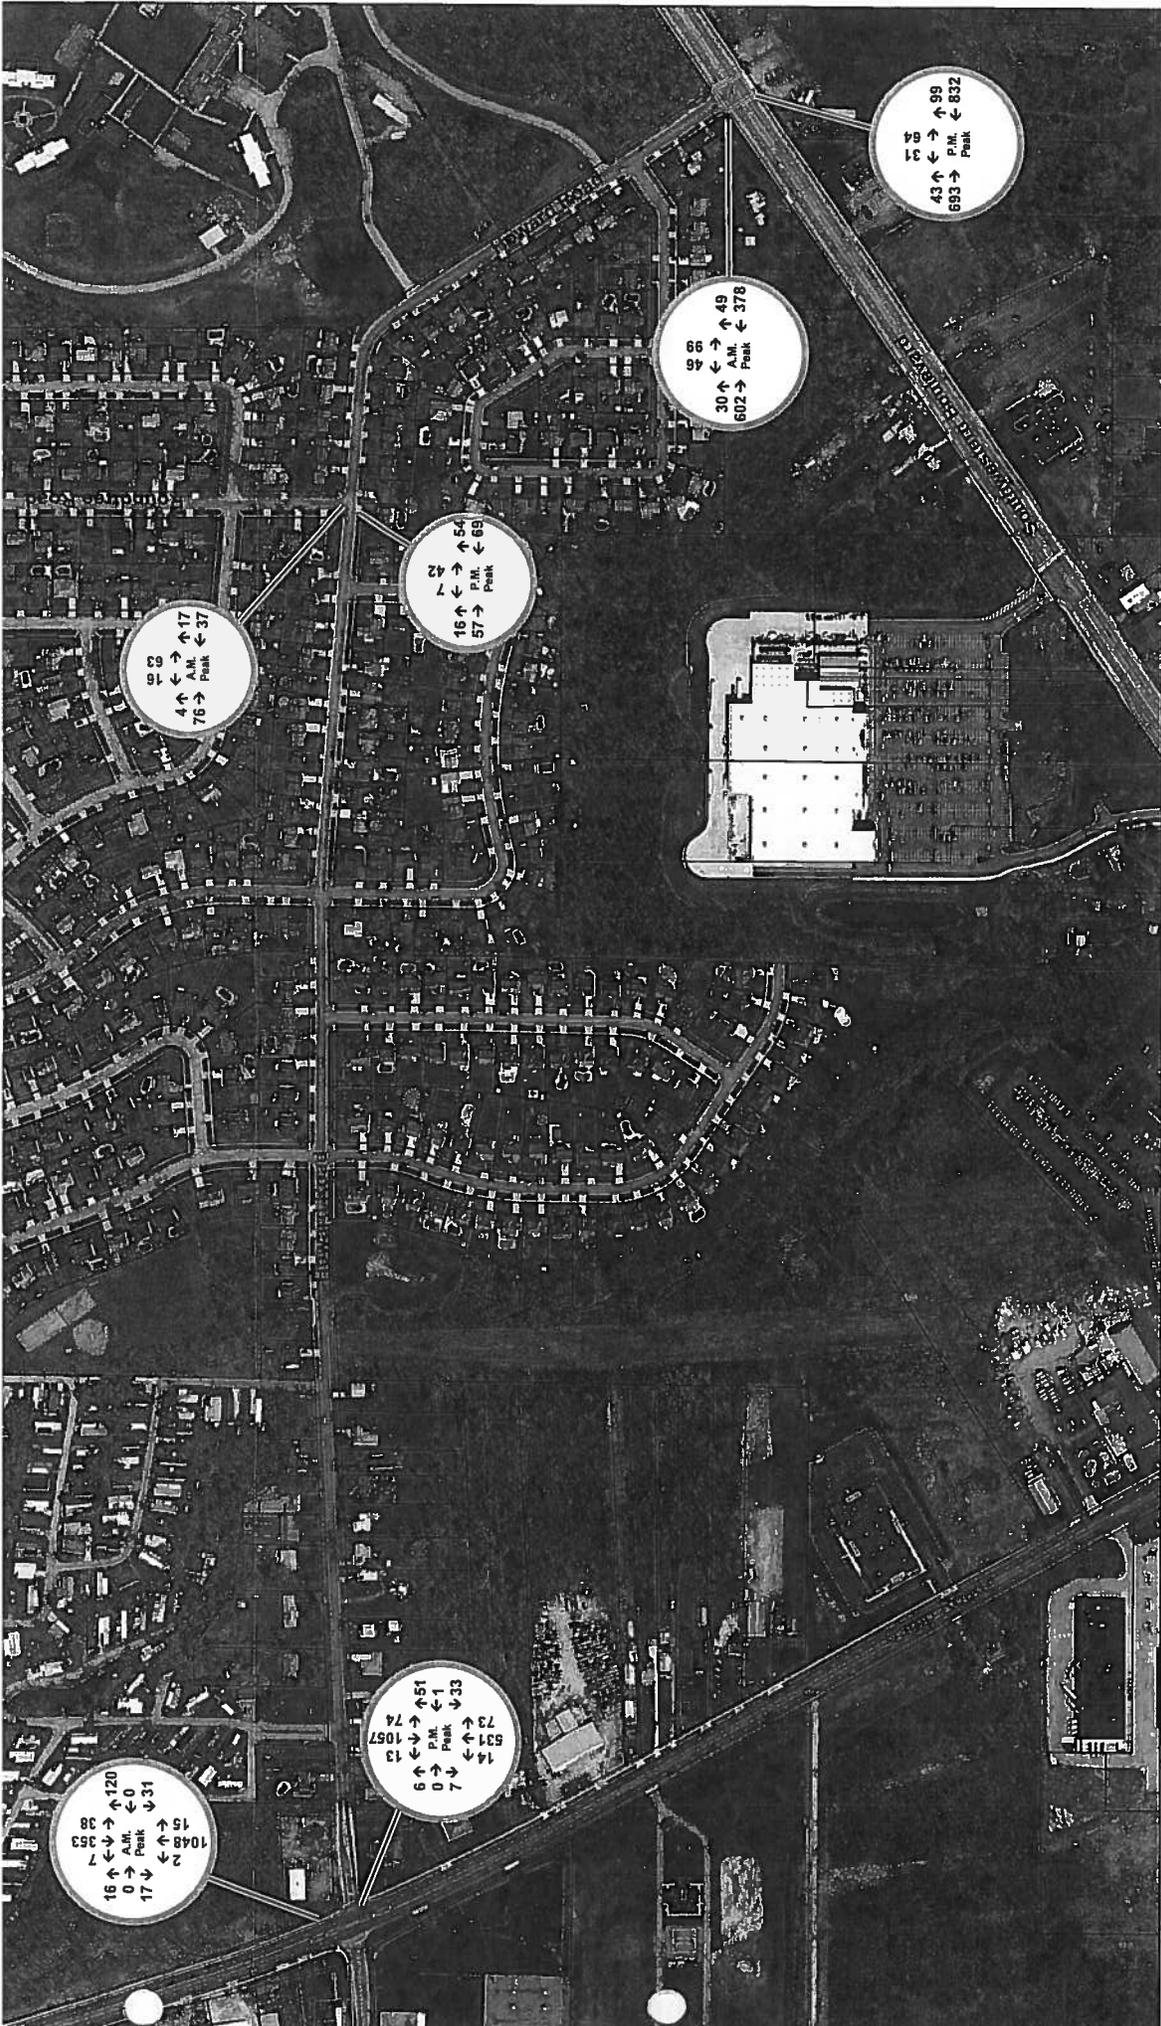
**Figure - 3**

**2013 Existing Volumes**  
**Sherwood Apartments**  
**Town of Hamburg, New York**  
 Source: NYS GIS Clearinghouse - 2011

**Figure 3** summarizes the 2013 Existing Background Traffic Volumes (weekday AM and PM Peak Hours), **Figure 4** summarizes the 2018 Background Traffic Volumes (weekday AM and PM Peak Hours) and **Figure 5** summarizes the 2018 Background with Development Traffic Volumes at the intersections within the study area. The methodology used to estimate project generated trips are further explained in **Section 4.4** of this report. The level of service analyses for all studied years and conditions are summarized in **Tables 5A-5C** of **Section 5.1** of this report. Copies of the Synchro reports for the intersection analyses are included in Appendix B.

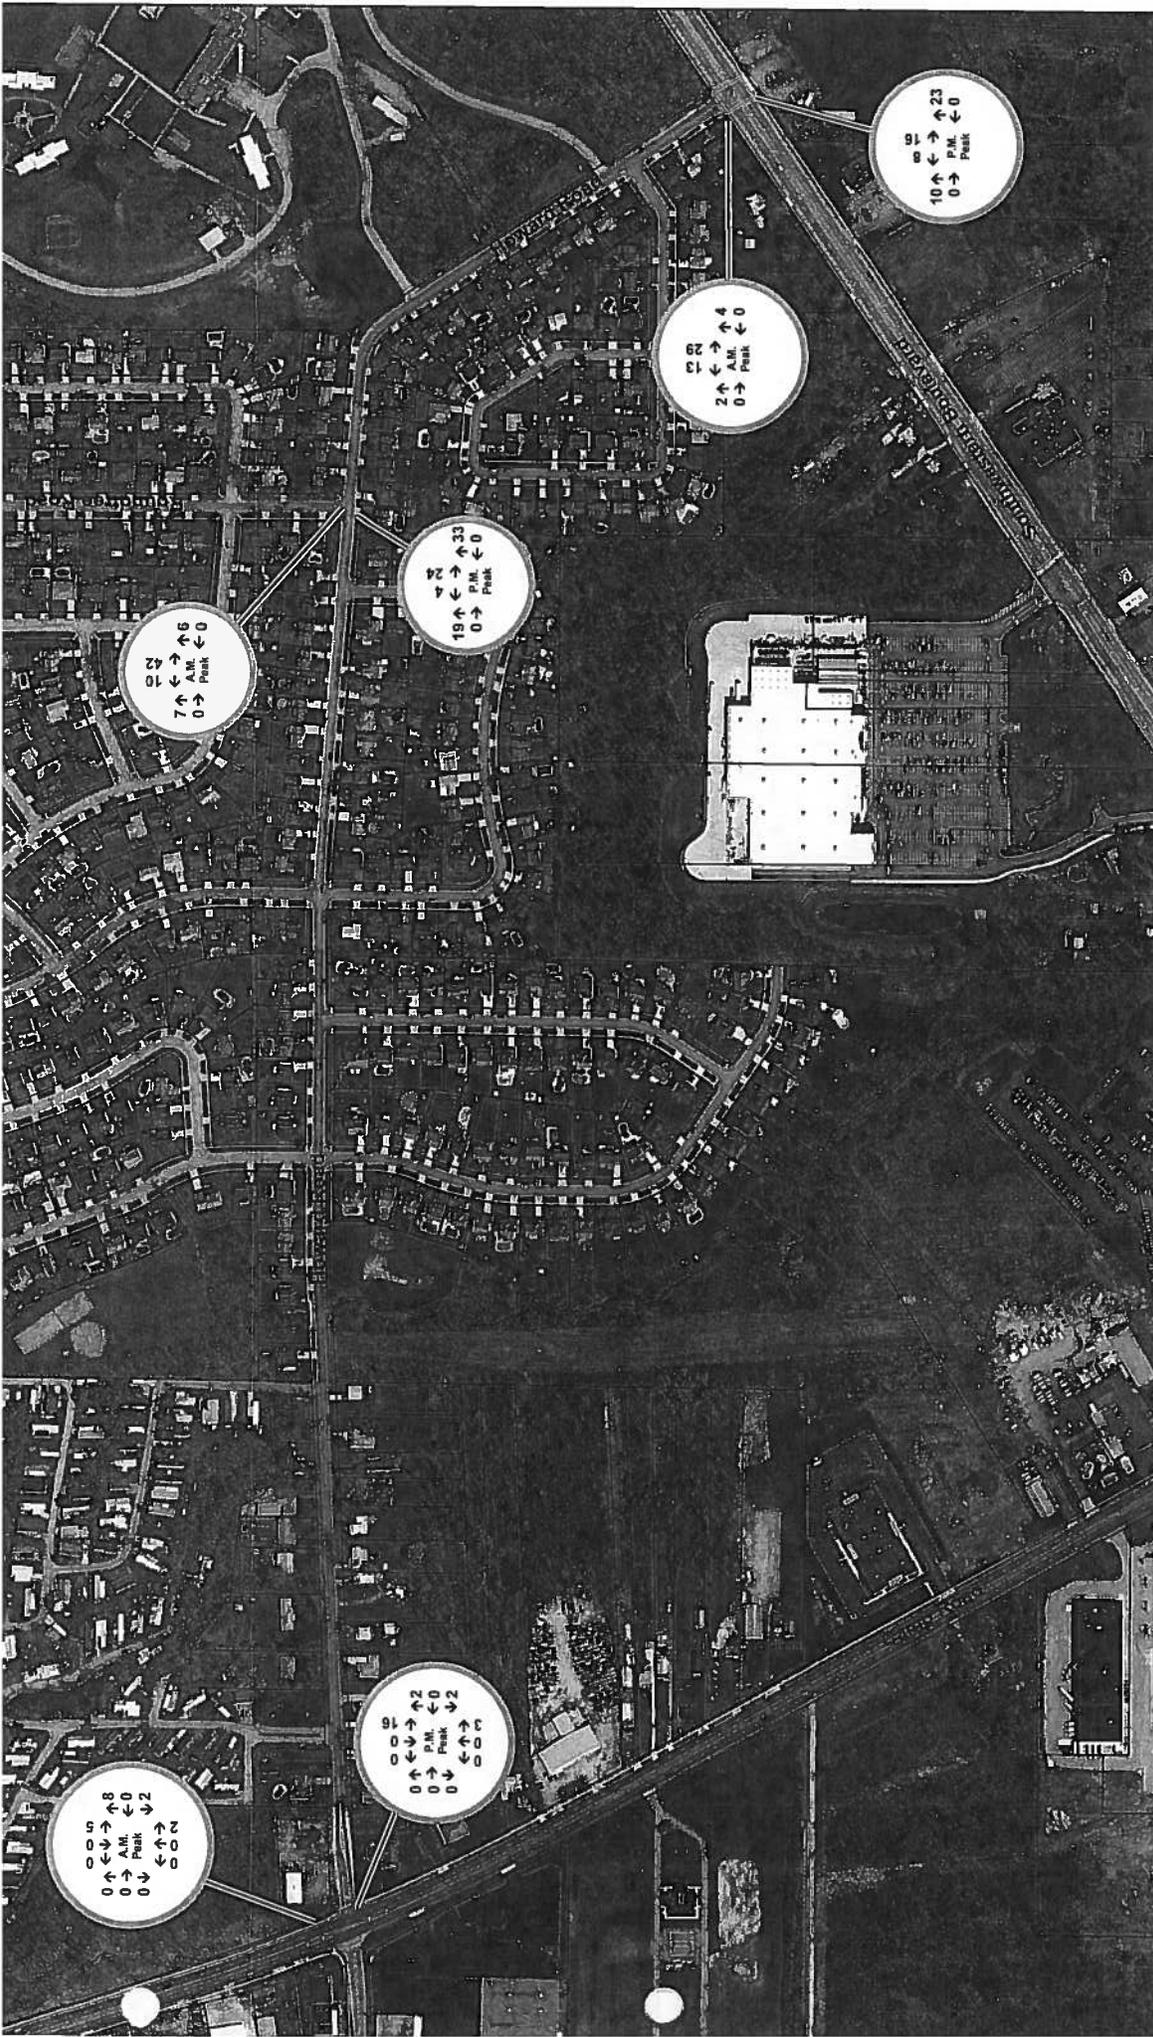
**Figure - 6**

Based on the 2013 existing background traffic volumes at the analyzed intersections, traffic trip distribution patterns were identified that would be assumed to represent trip distribution to and from the proposed Sherwood Apartments. From the observations and counts taken at these intersections, trip distribution patterns were developed to determine where the project generated trips would be assigned at the 2018 build-out year. **Figure 6** shows the project generated distribution estimated trips.

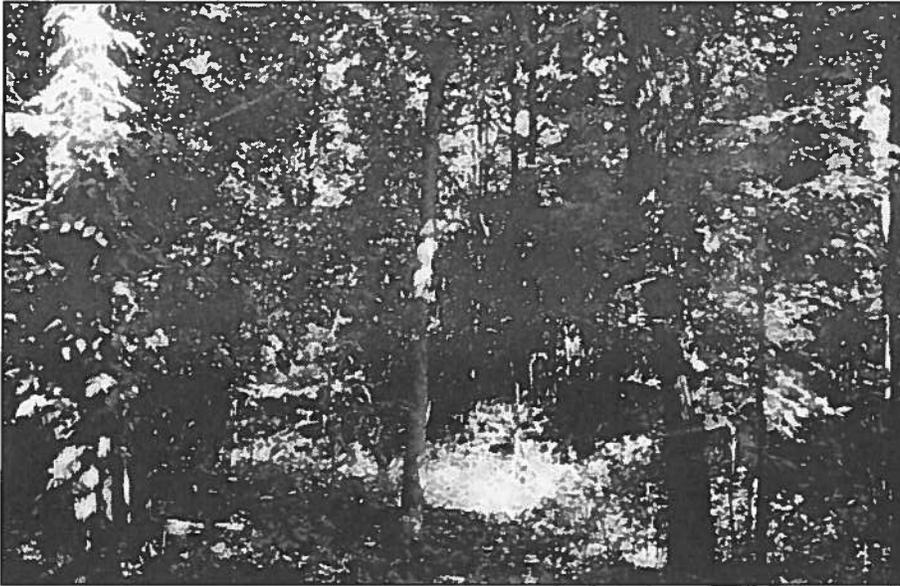
PHOTO LOCATION P1:

Viewing north in the vicinity of Wetland Area A and field data point W2W. Refer to Field Data Form W2W and W2U for information on soils, hydrology, and vegetation.

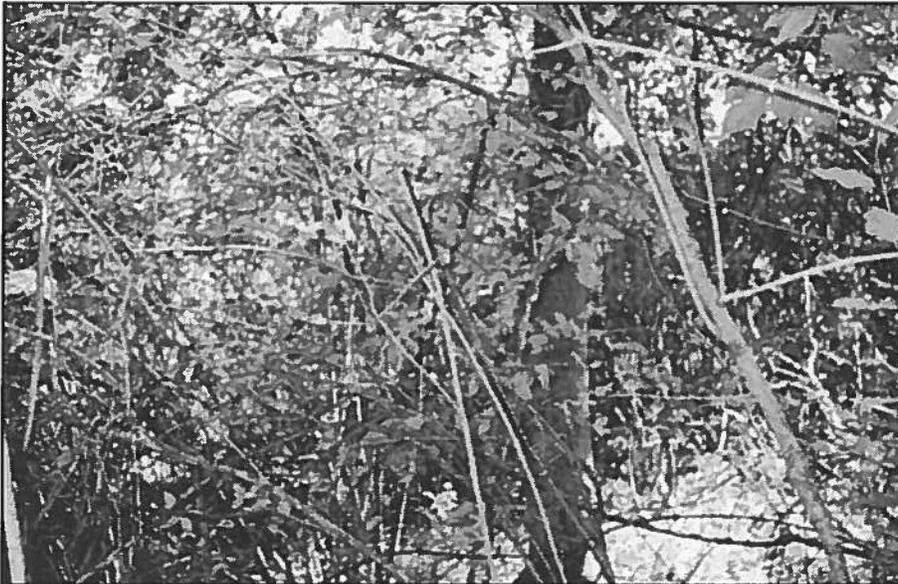
PHOTO LOCATION P2:

Viewing south from the vicinity of 1A in a shrubland upland portion of the site west of Wetland Area A. Refer to Field Data Form 1A for information on soils, hydrology, and vegetation.

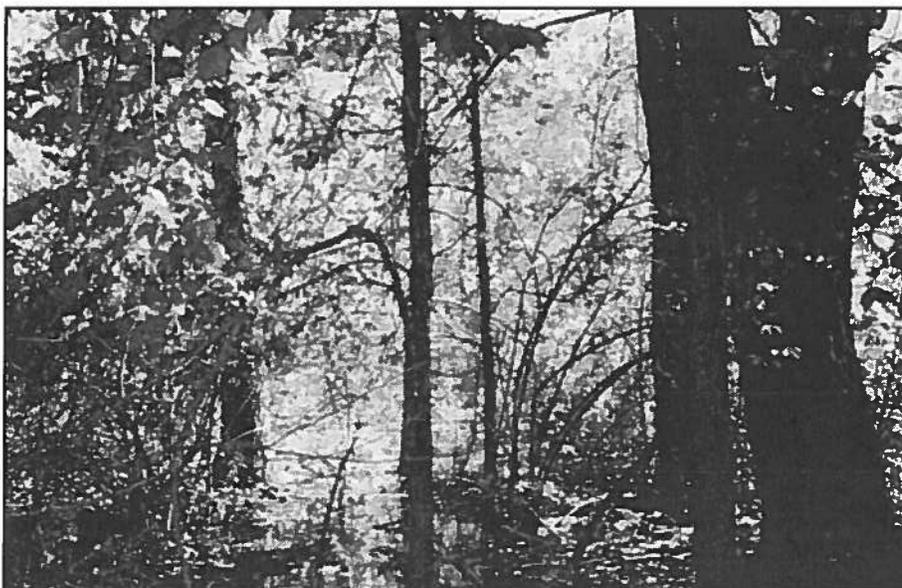
PHOTO LOCATION P3:

Viewing north in the vicinity of Wetland Area A and field data point W3W. Refer to Field Data Form W3W and W3U for information on soils, hydrology, and vegetation.

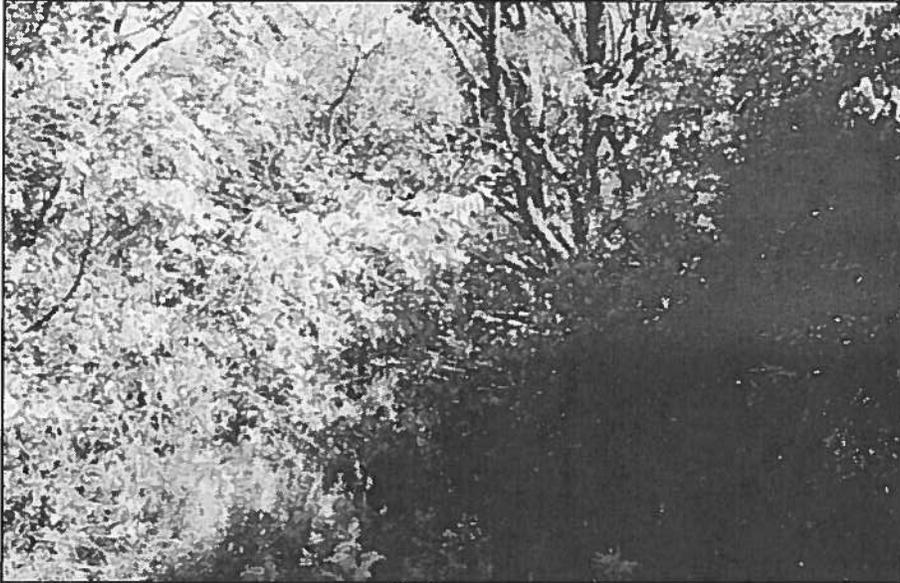
PHOTO LOCATION P4:

Viewing south from the vicinity of 2D in a shrubland upland

portion of the site west of Wetland Area A. Refer to Field Data Form 2D for information on soils, hydrology, and vegetation.

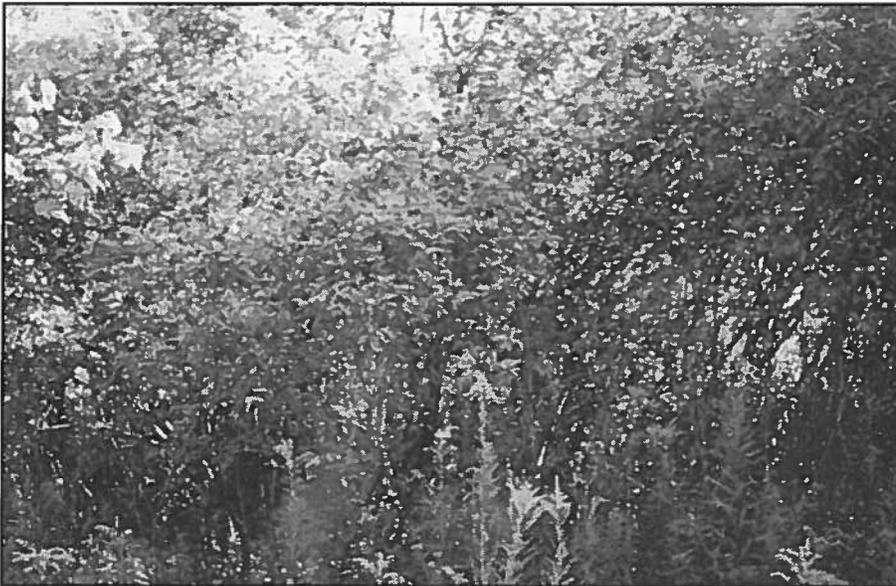
PHOTO LOCATION P5:

Viewing north in the vicinity of wetland boundary of Wetland Area A and field data point W1W. Refer to Field Data Form W1W and W1U for information on soils, hydrology, and vegetation.

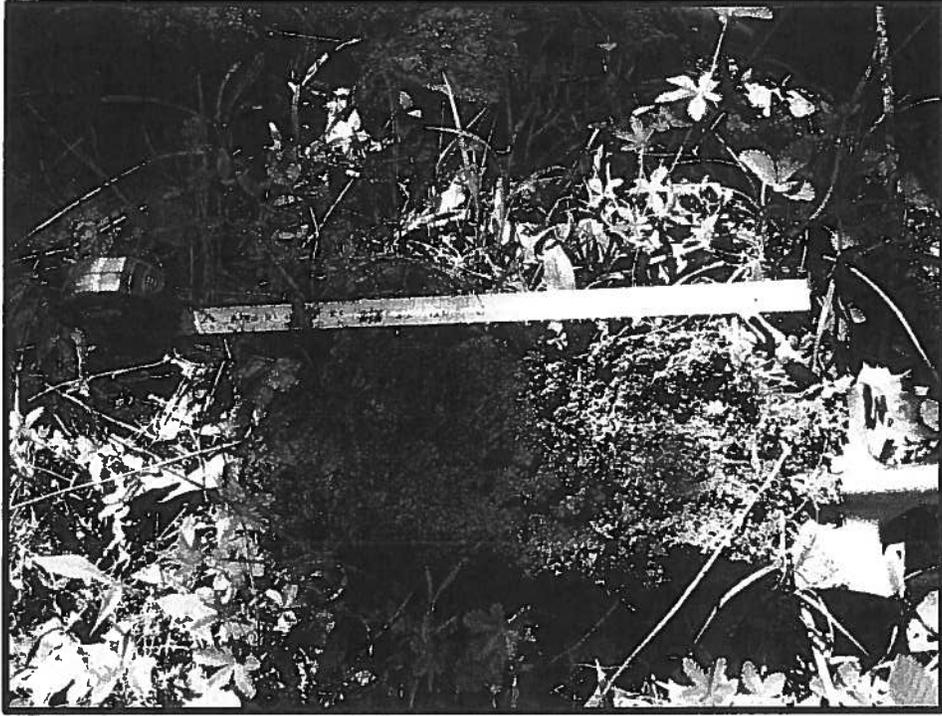
Upland soil sample taken at A2U1.

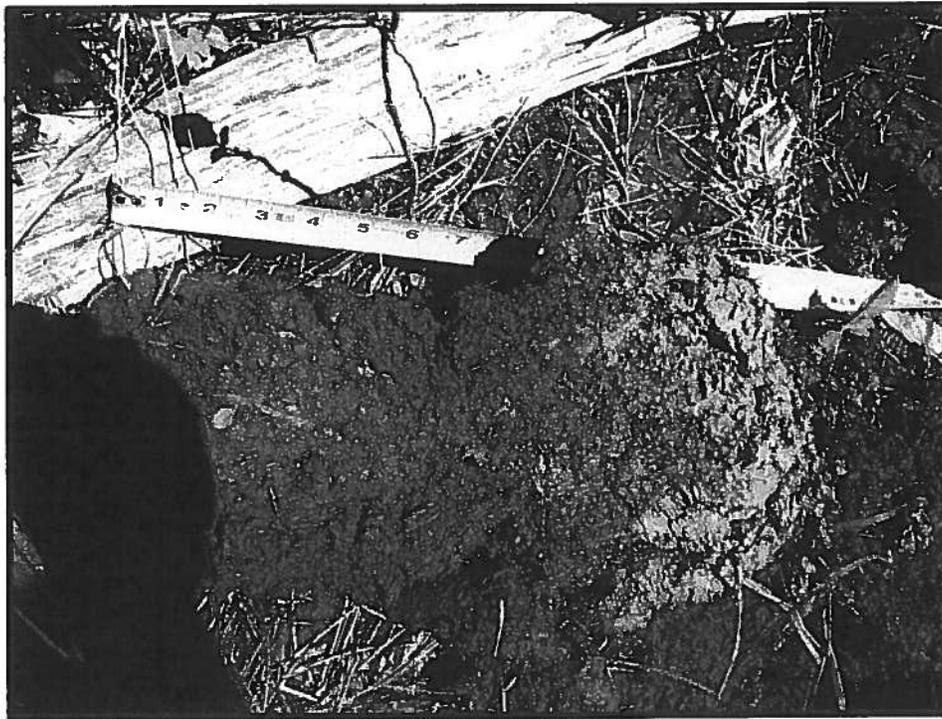
Upland soil sample from A6U4.

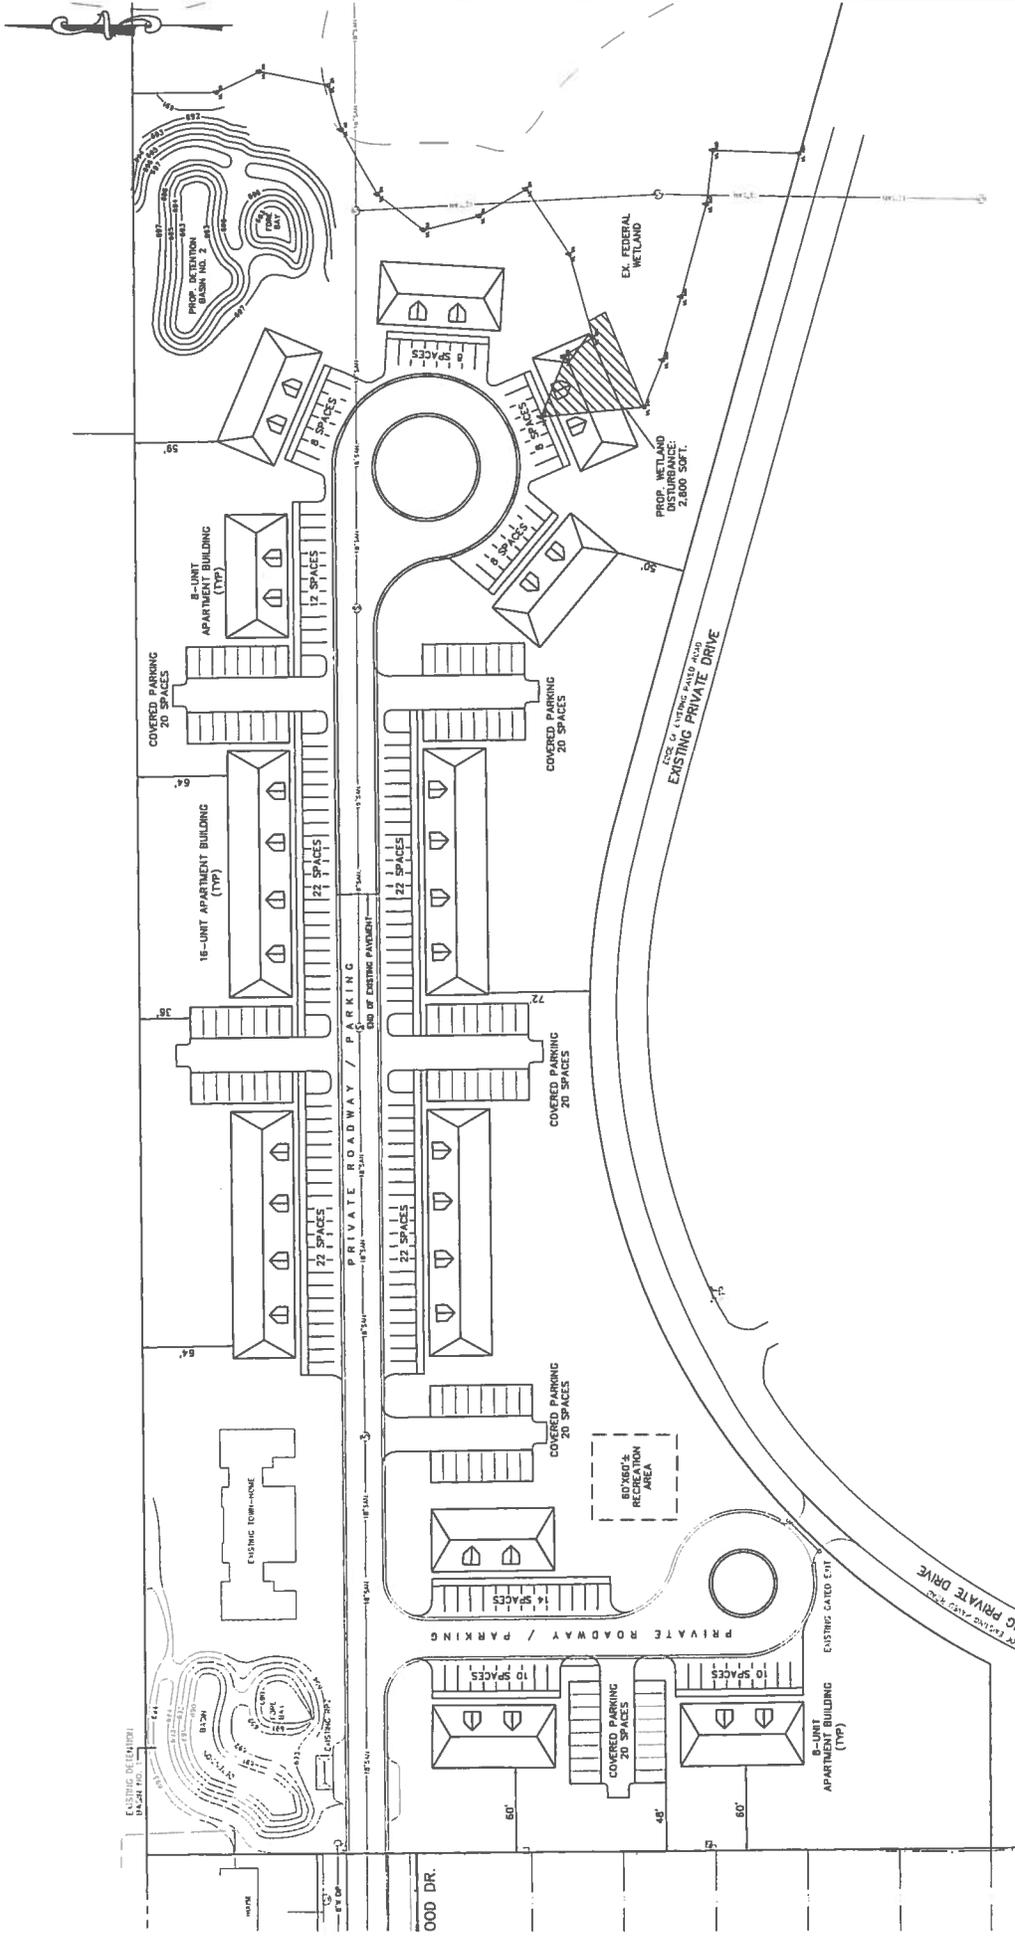
SHEET NO. 1  
 AREA: 14.89 ACRES  
 ZONING: RESIDENTIAL-3  
 MINIMUM UNIT SIZE: 3,500 SQFT  
 MAX. UNIT YIELD: 183  
 UNITS PROVIDED: 128  
 REQUIRED PARKING SPACES: 158  
 PARKING SPACES PROVIDED: 208
