DRAFT ENVIRONMENTAL IMPACT STATEMENT

"VILLAS AT BRIERWOOD AND BRIERWOOD SQUARE"  
PLANNED UNIT DEVELOPMENT

"ACTIVE ADULT LIFESTYLE COMMUNITY"

TOWN OF HAMBURG, ERIE COUNTY, NEW YORK

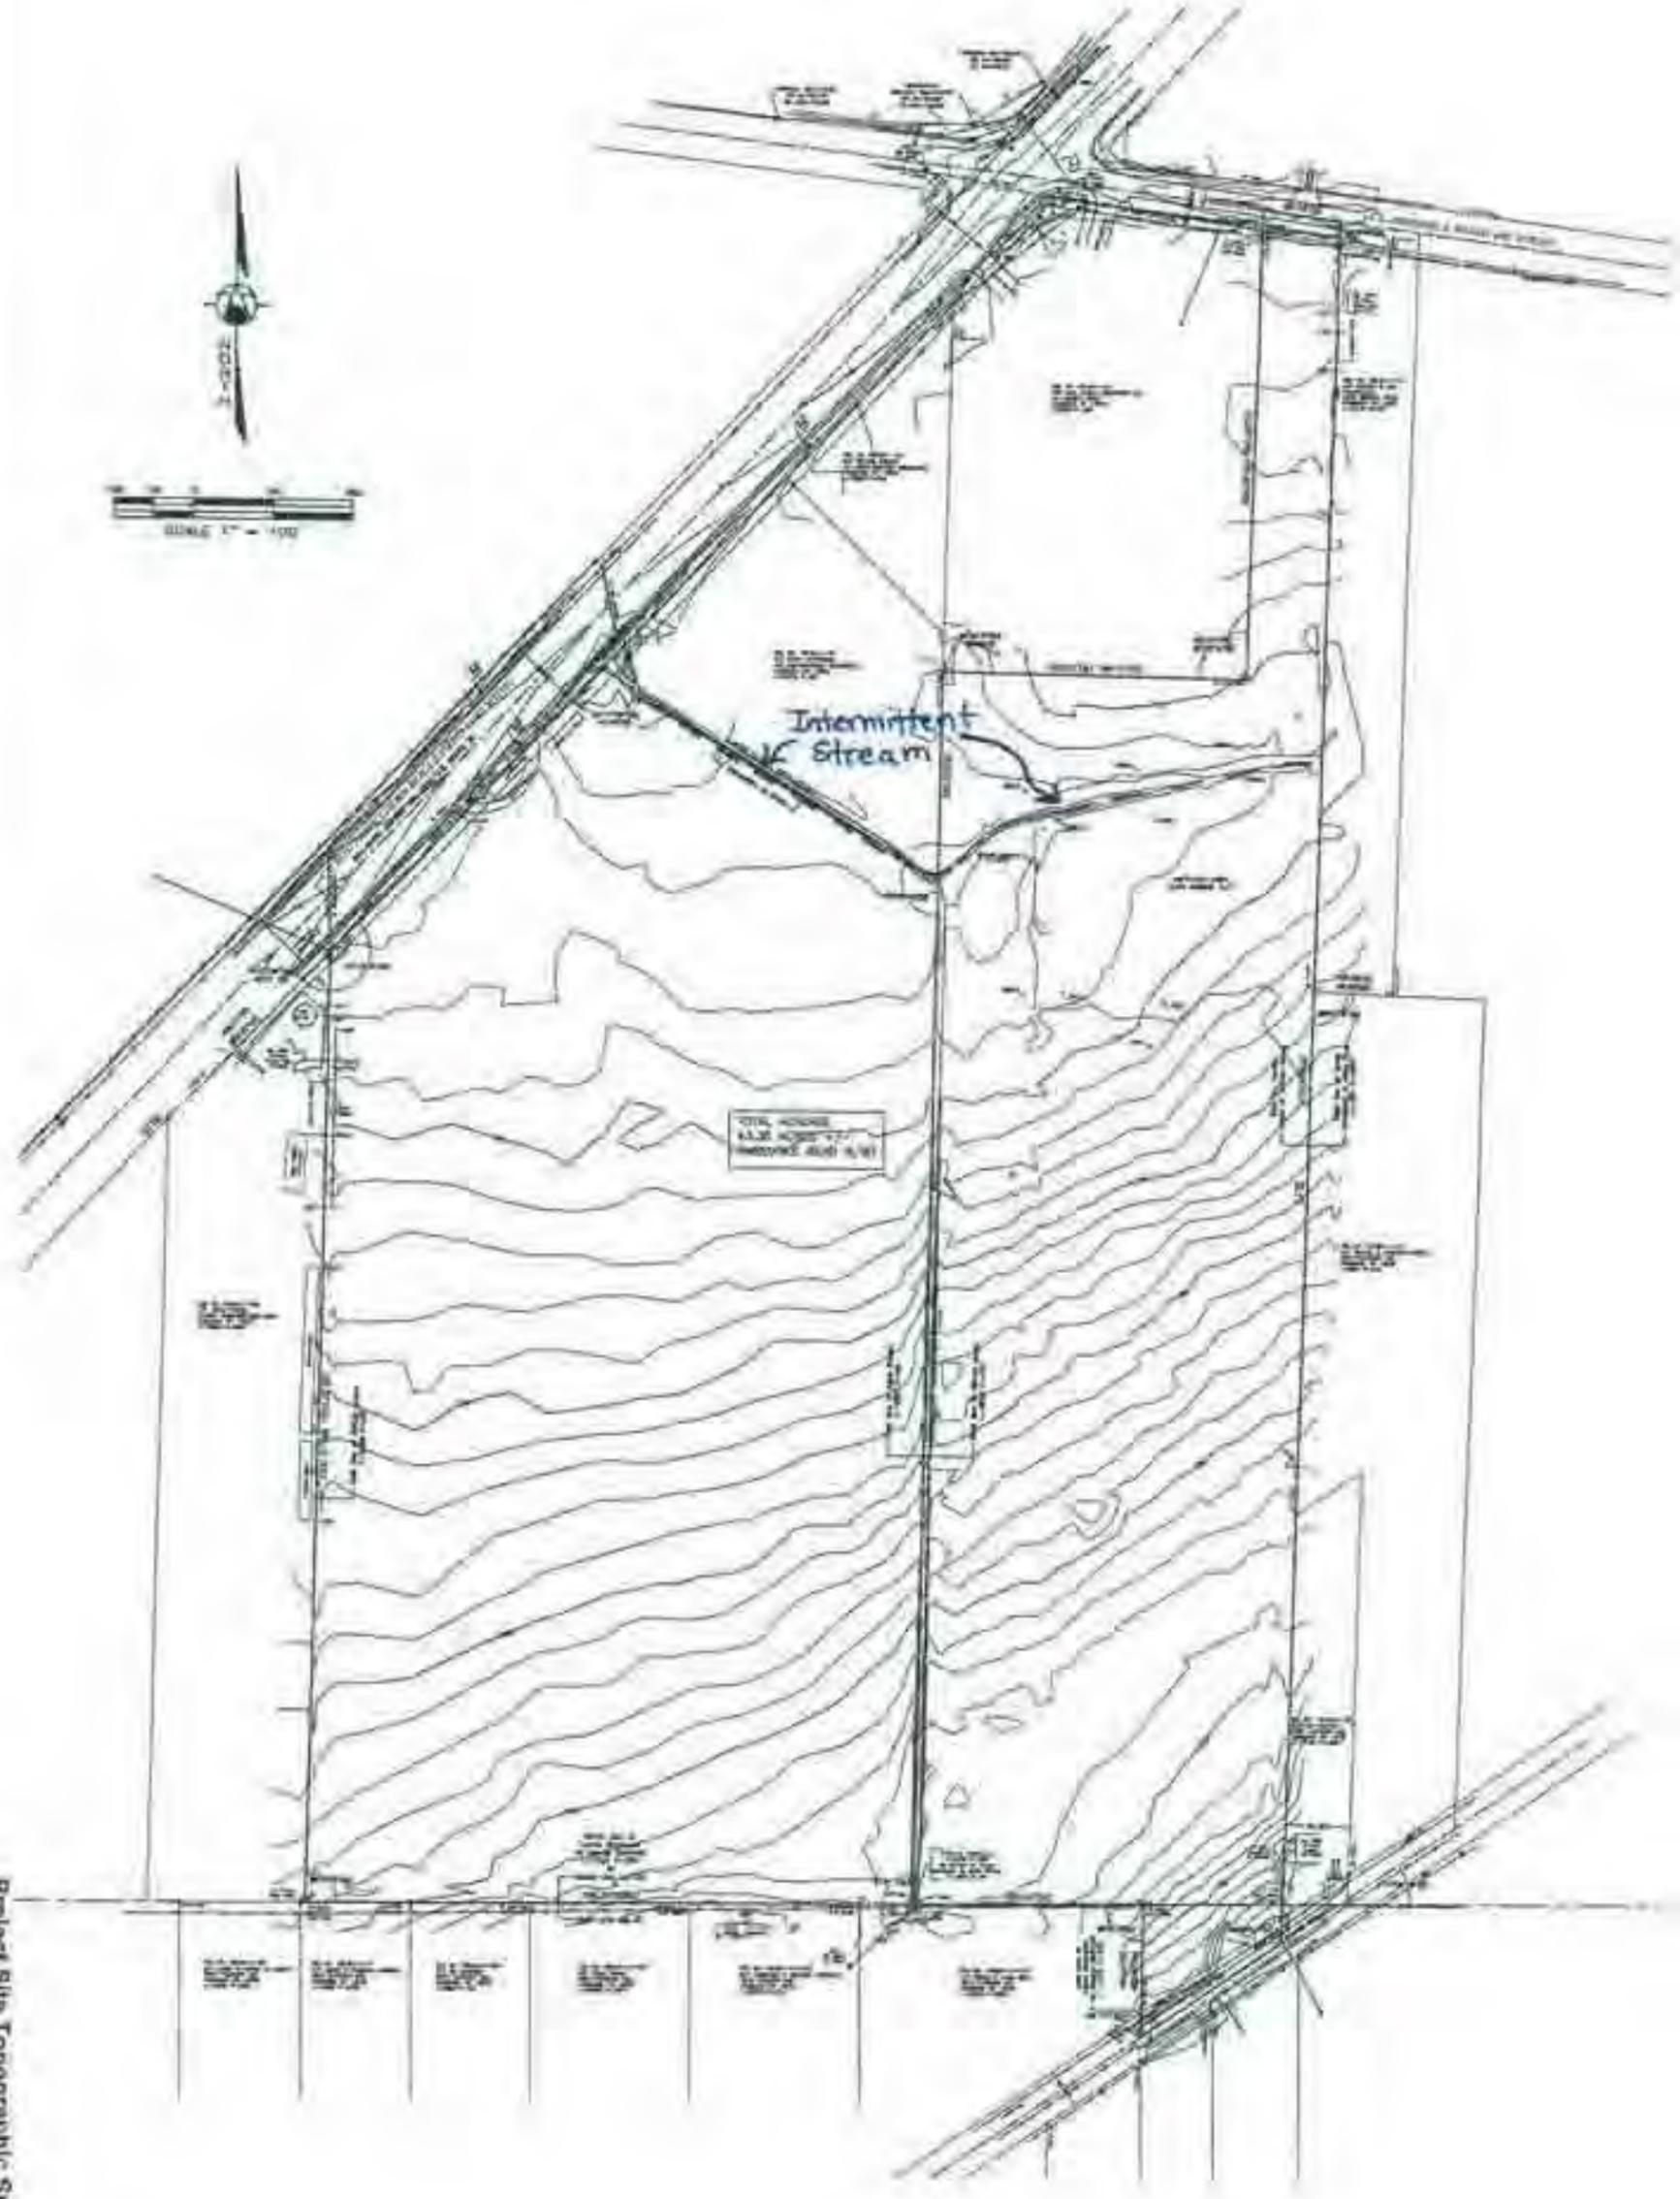
Project Site Topographic Survey Map #4

# BOUNDARY / TOPOGRAPHIC AND UTILITY SURVEY

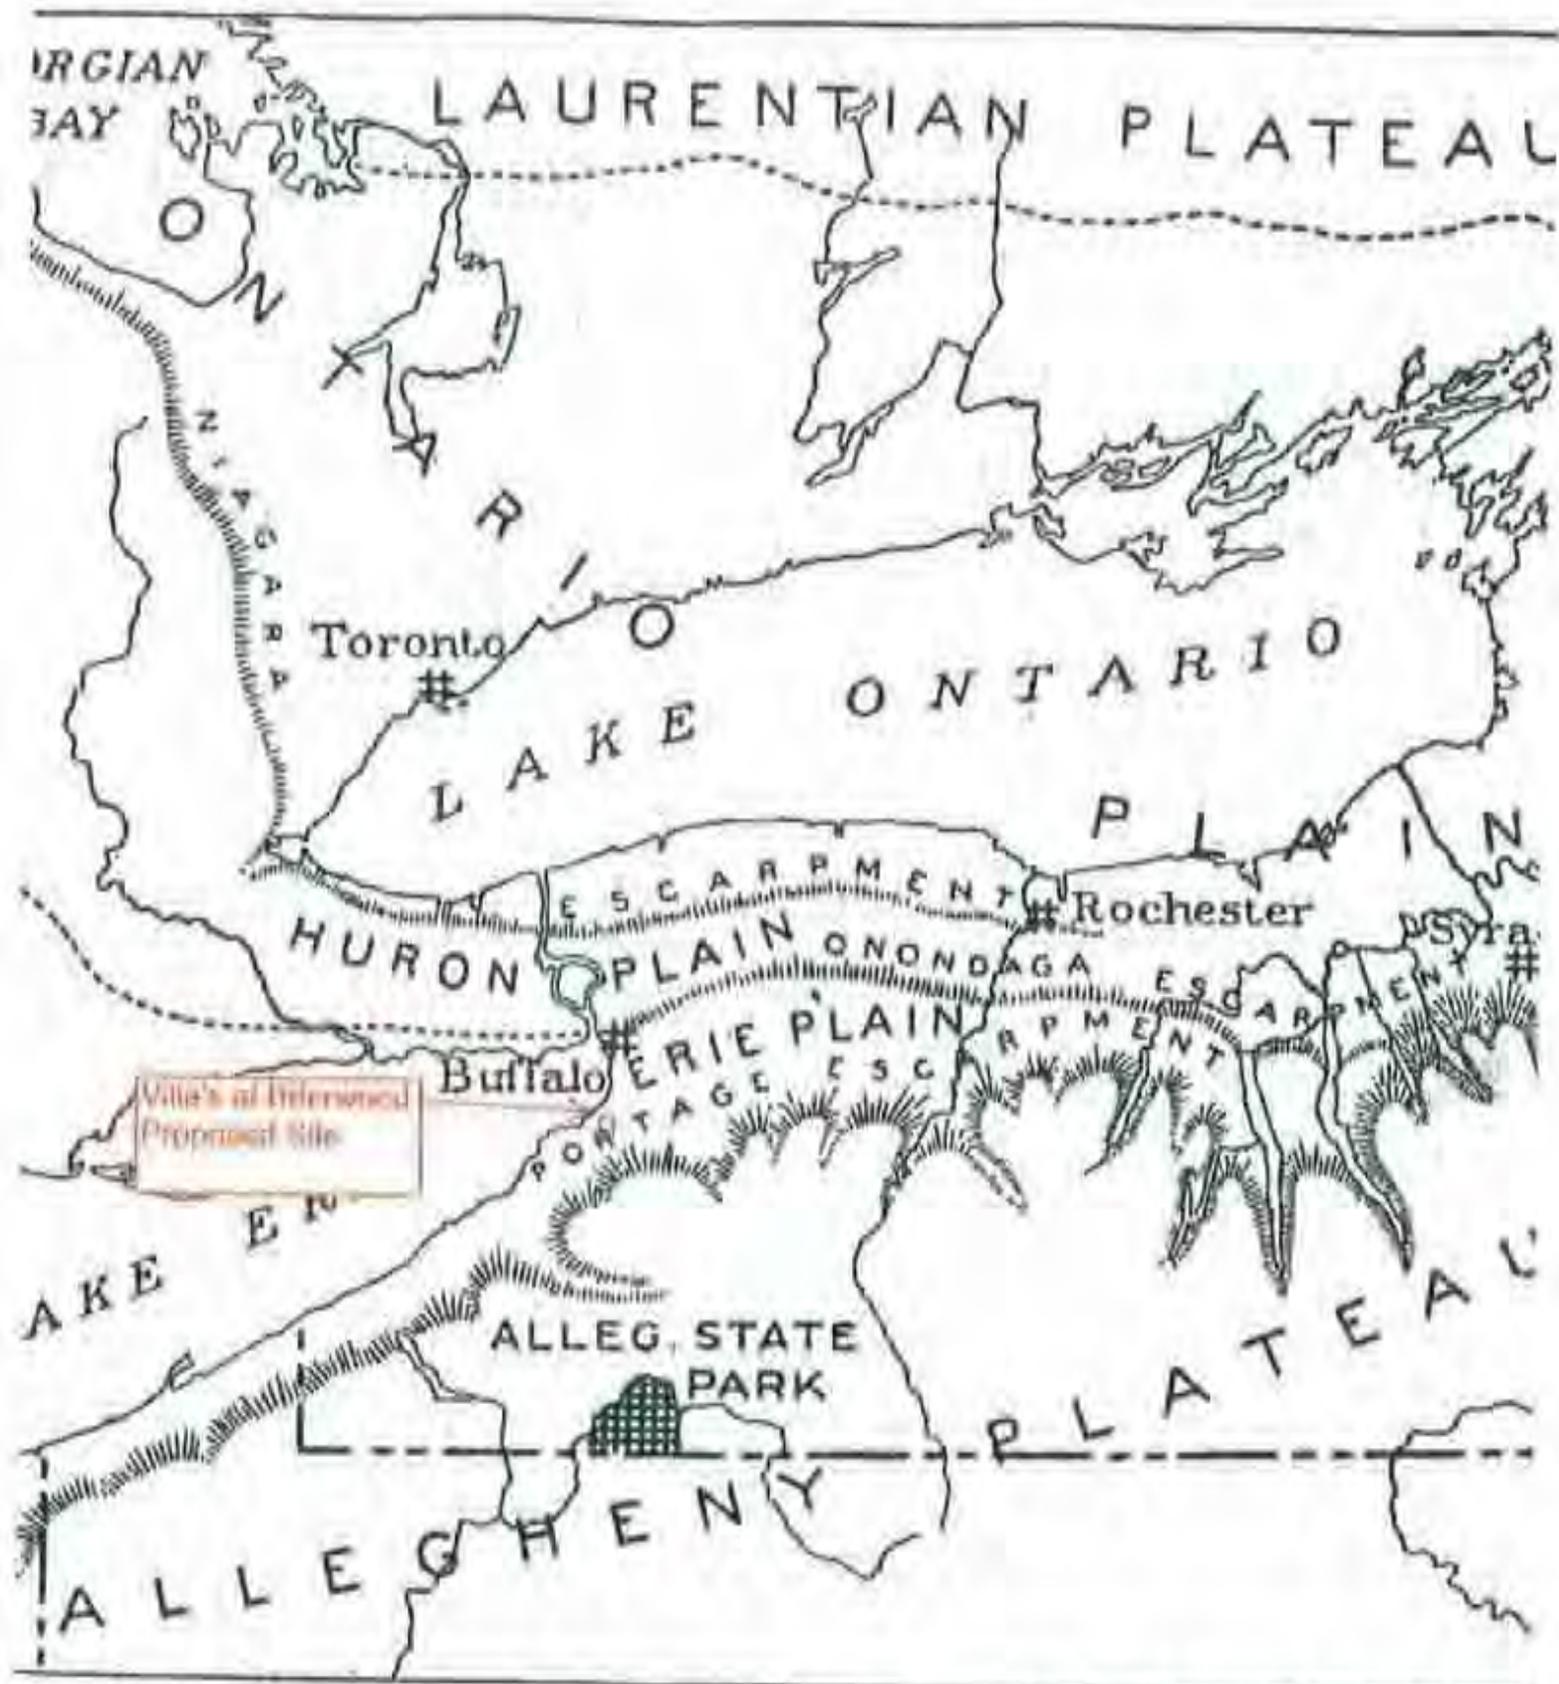
From U. S. Geol. Surv., Niagara  
 . PHYSIOGRAPHIC SKETCH MAP OF THE GENERAL REGION IN WHICH THE NIA  
 FLORAL AREA IS LOCATED

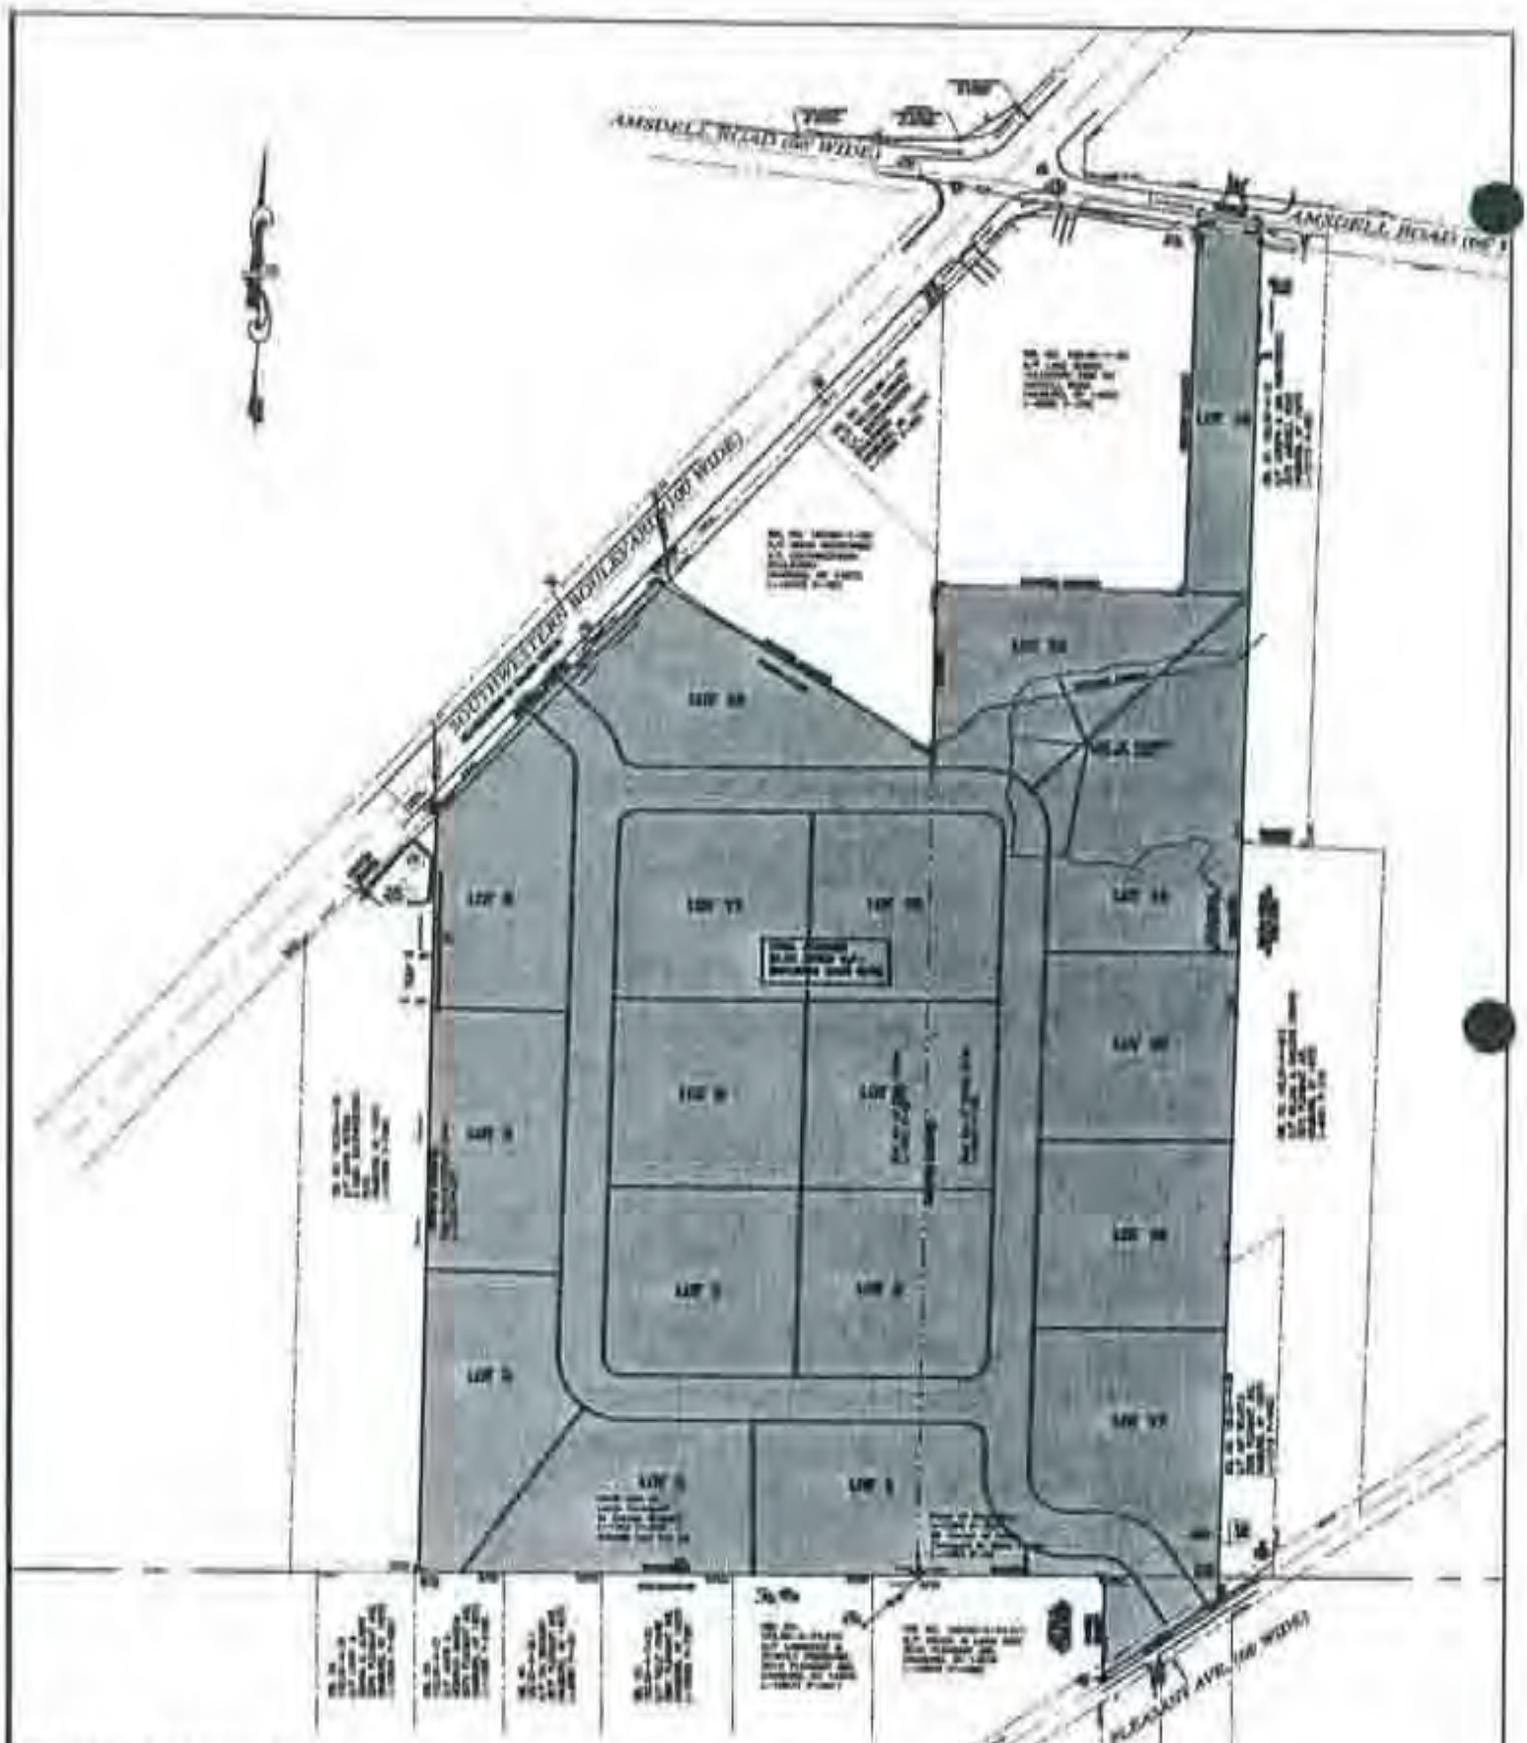
CONCEPT PLAN - A  
SINGLE-FAMILY RESIDENTIAL  
SUBDIVISION (2 AC. LOT MIN.)

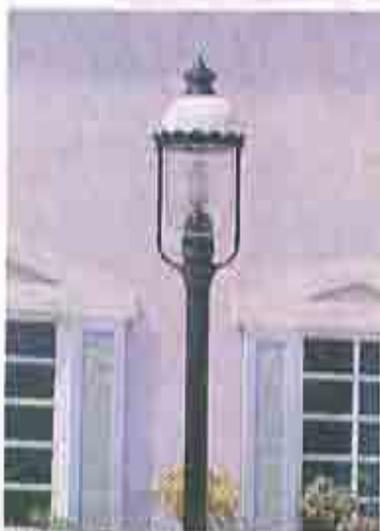
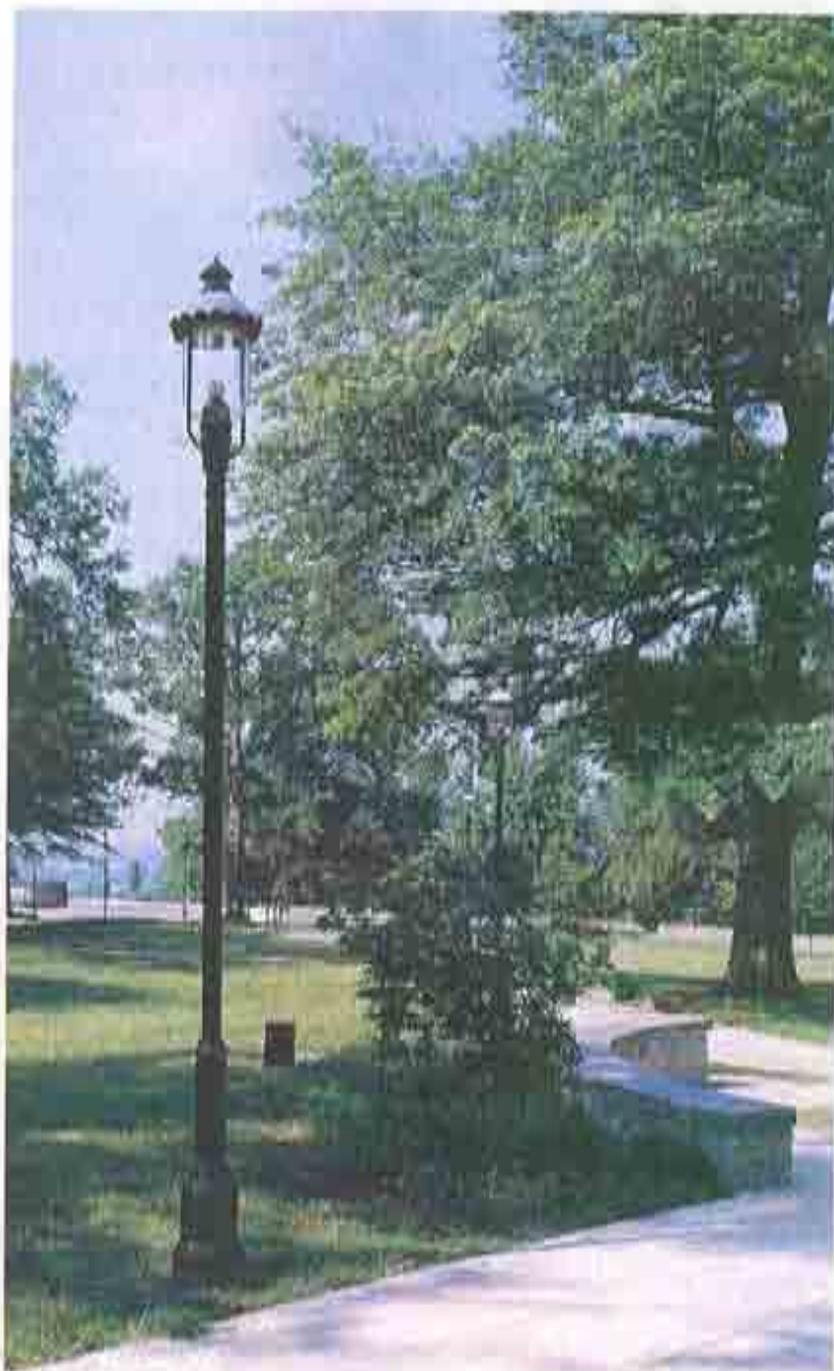
Picture of Proposed Light Standards  
#21

The Dundee luminaire is a classic design combined with state of the art reflectors for superior lighting performance. illuminate your streets without the glare of a refractor type lens. The optical system reduces glare and directs more light to the ground, rather than your eyes. The reflector system is completely gasketed to keep out insects and contaminants that can reduce the operating efficiency of the fixture.

The careful detailing of the castings and the glass chimney lend an authentic look to the fixture. A solid top or luminous dome top is available.

ALN 610 DUN 4014 WDM

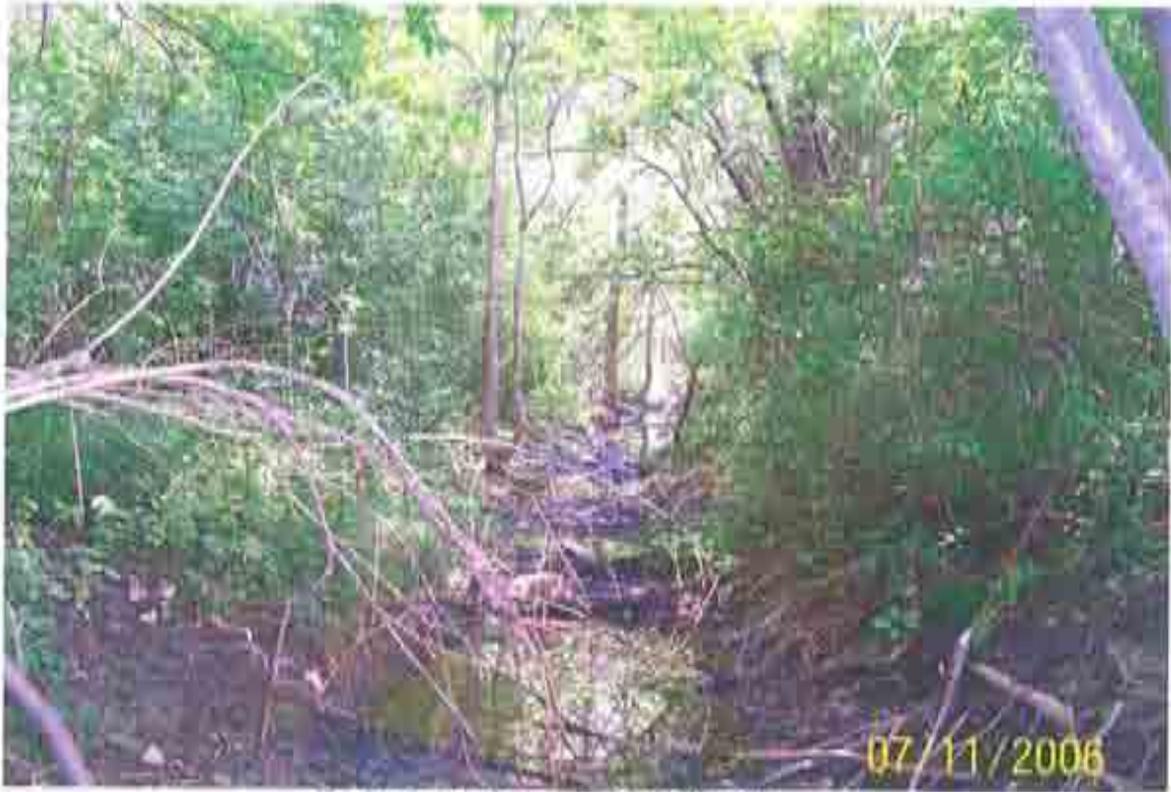
**Channelized Segment of Intermittent Stream (Wanakah Creek) between Southwestern Boulevard & North/South Ditch in summer - #22**

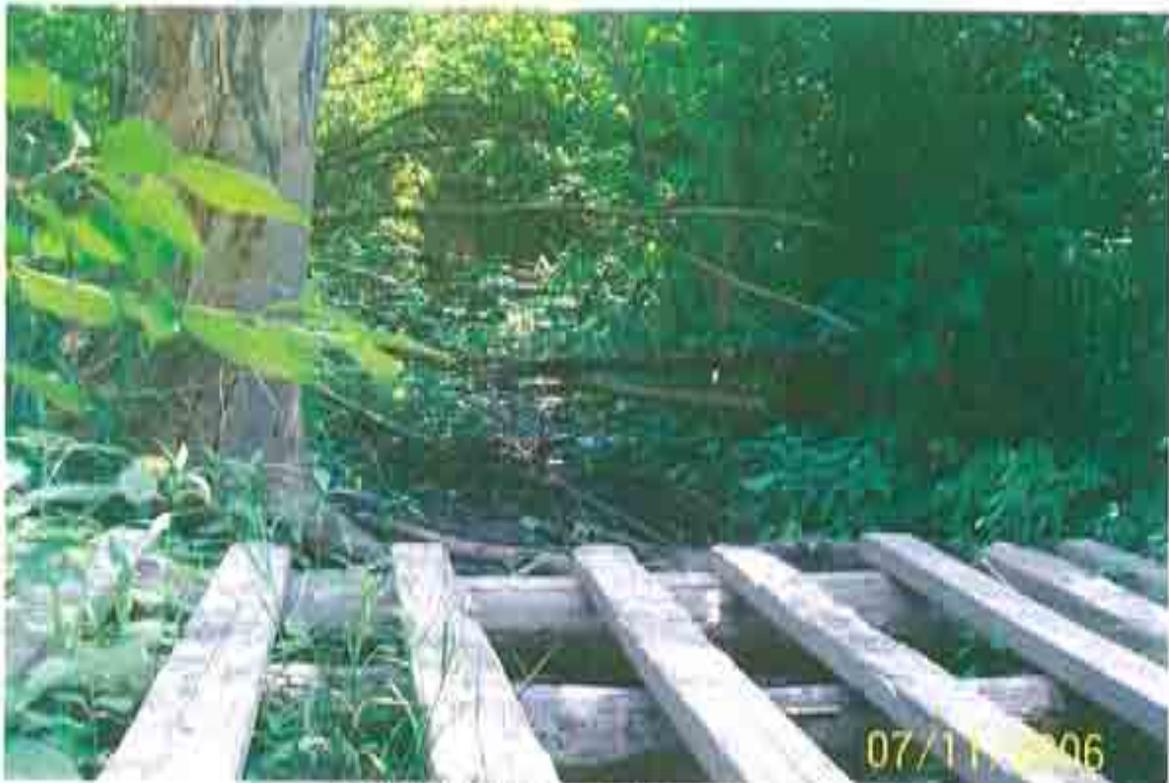
**North/South Ditch near intersection with Intermittent Stream (Wanakah Creek) after rain storm in summer #22**

**Note: Ernesto brought over 2" of rain to the site on 9/2/2006. There were several rain events the previous week that brought an additional 2" of rain to the project site.**

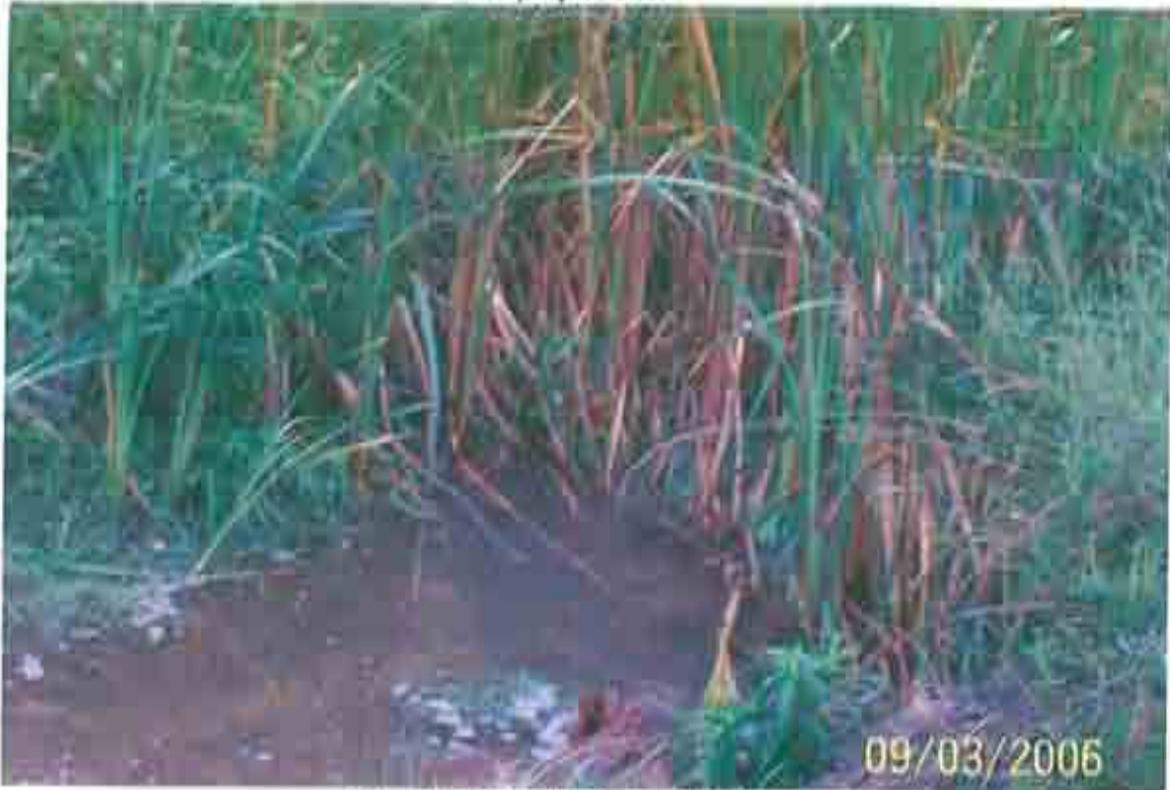
**Storm Drainage Ditch on southeast side of Southwestern Blvd. between project site and 30" culver under Southwestern Blvd. the morning after Ernesto - #23**

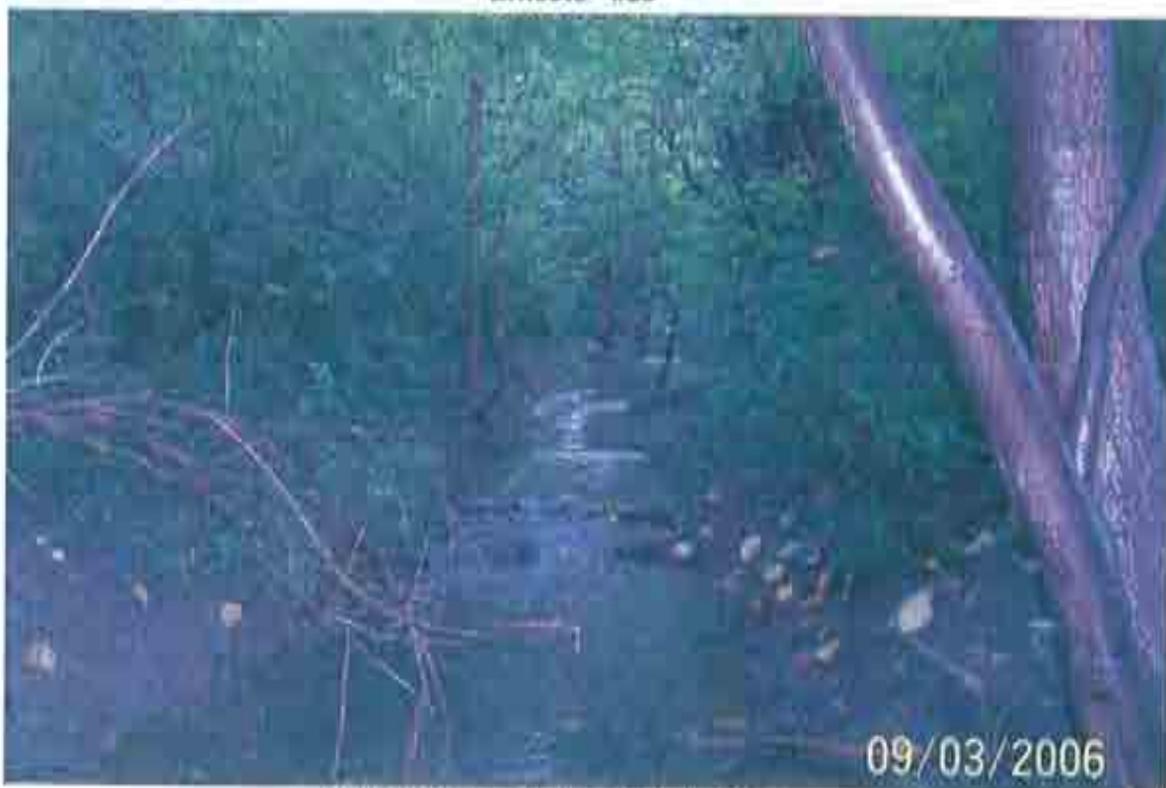
**Channelized segment of Intermittent Stream (Wanakah Creek) between Southwestern Blvd. and North/South Ditch the morning after Ernesto - #23**

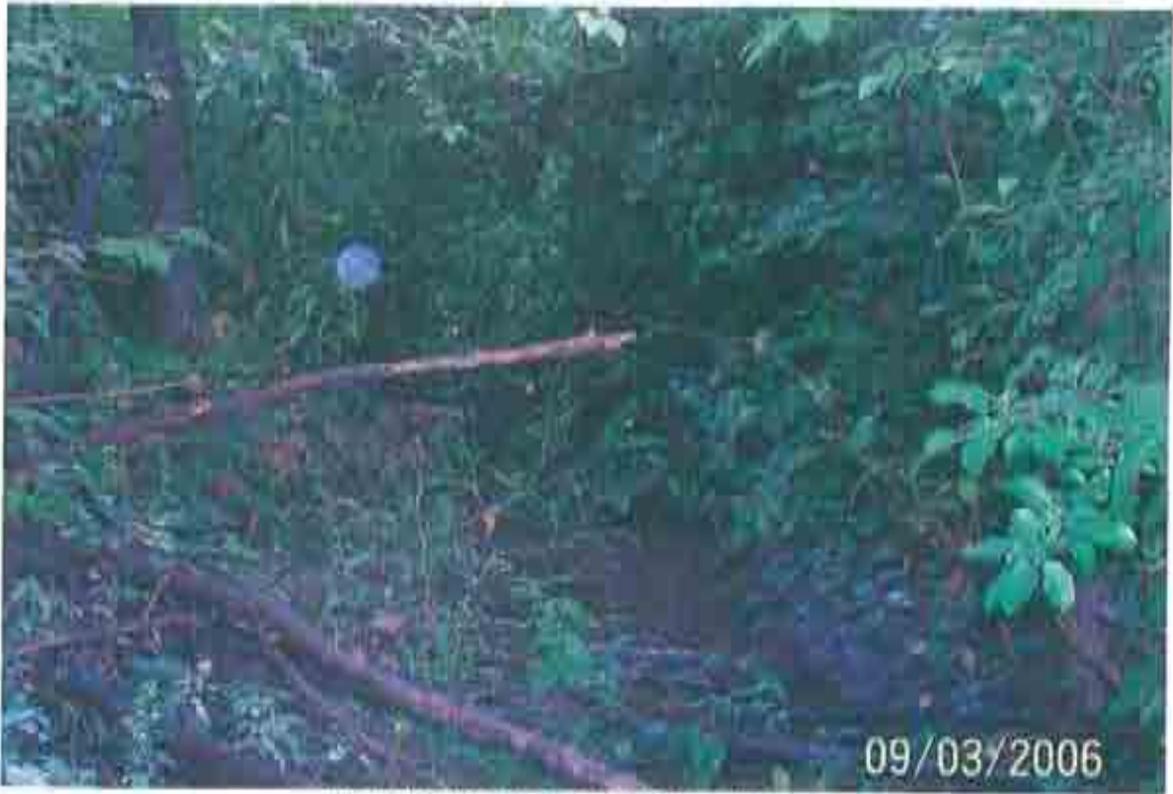
**North/South Ditch near Intersection  
with Intermittent Stream (Wanakah  
Creek) the morning after Tropical  
Storm Ernesto - #24**

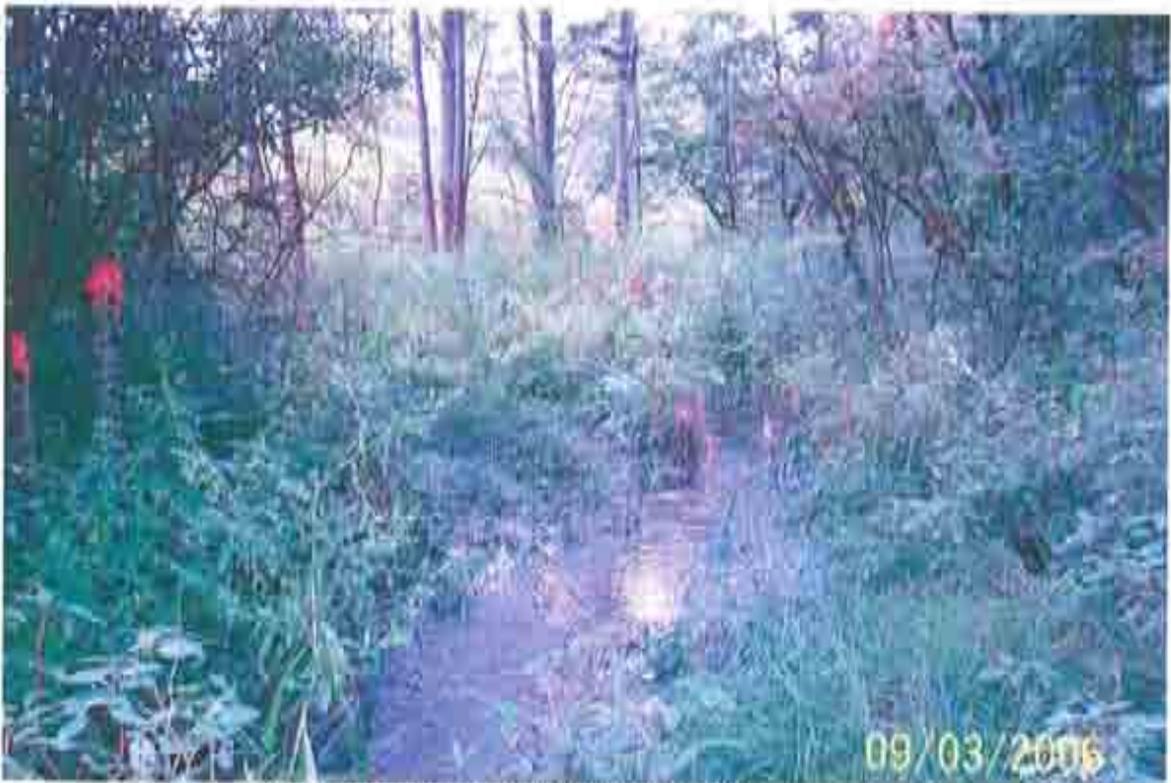
**Intermittent Stream (Wanakah Creek) in  
wetland area swollen with water the  
morning after Tropical Storm Ernesto -  
#24**

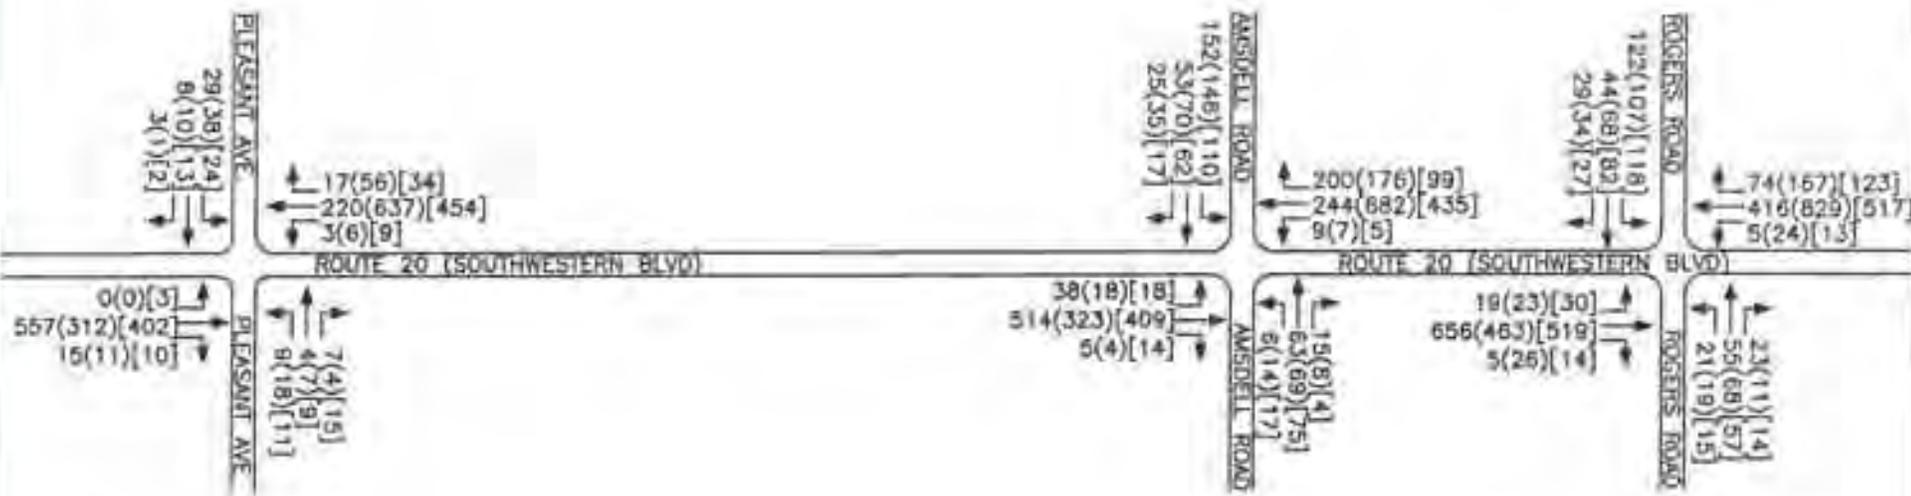
**FIGURE 3**  
 PEAK HOUR VOLUMES  
 EXISTING CONDITIONS  
 PROPOSED VILLAS AT BRIERWOOD,  
 HAMBURG, N.Y.

NOT TO SCALE  
 00(00)[00] = AM(PM)[SAT]

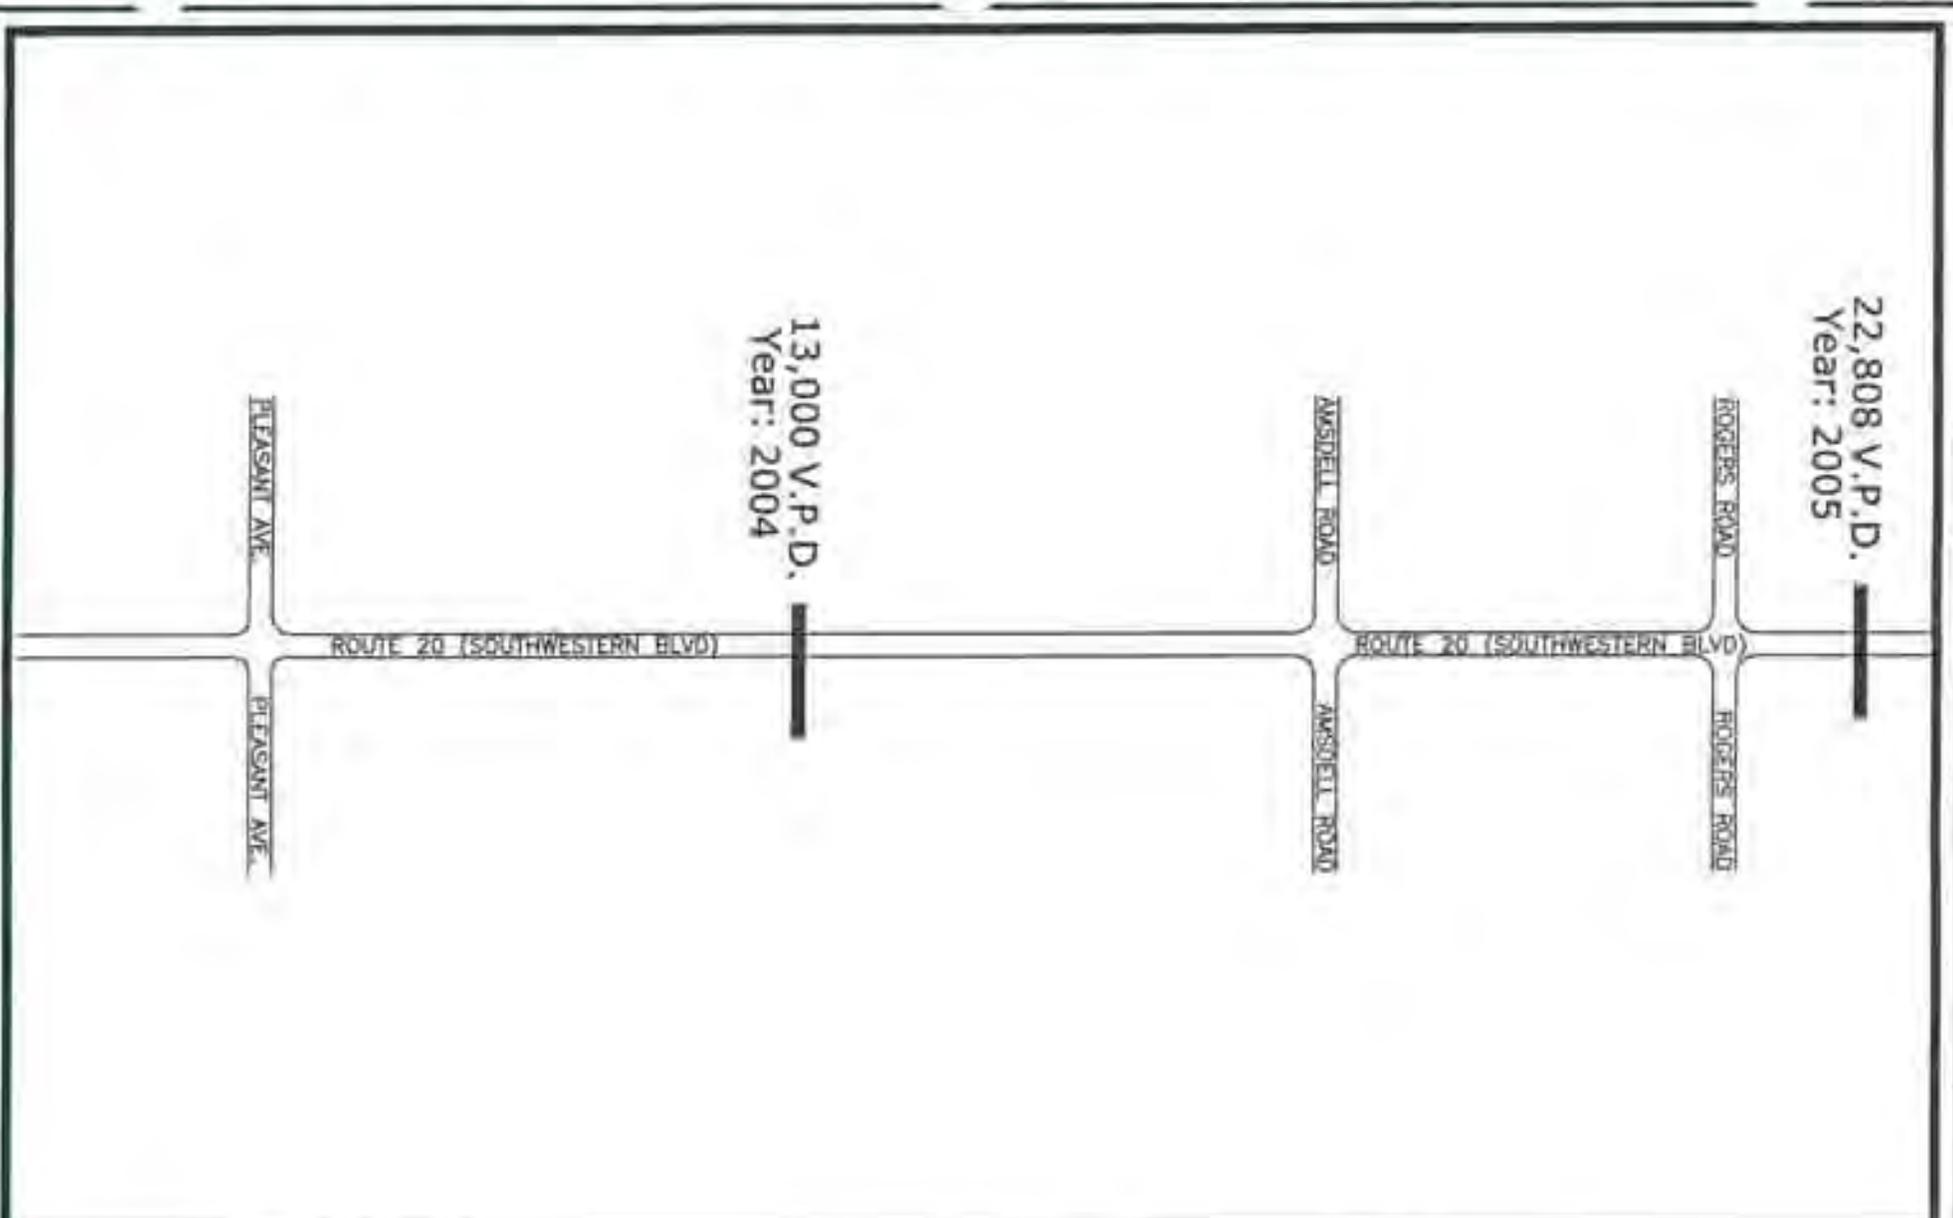
**FIGURE 4**  
 AVERAGE DAILY TRAFFIC VOLUMES  
 PROPOSED VILLAS AT BRIERWOOD,  
 HAMBURG, N.Y.

NOT TO SCALE  
 Note: All counts by NYSDOT

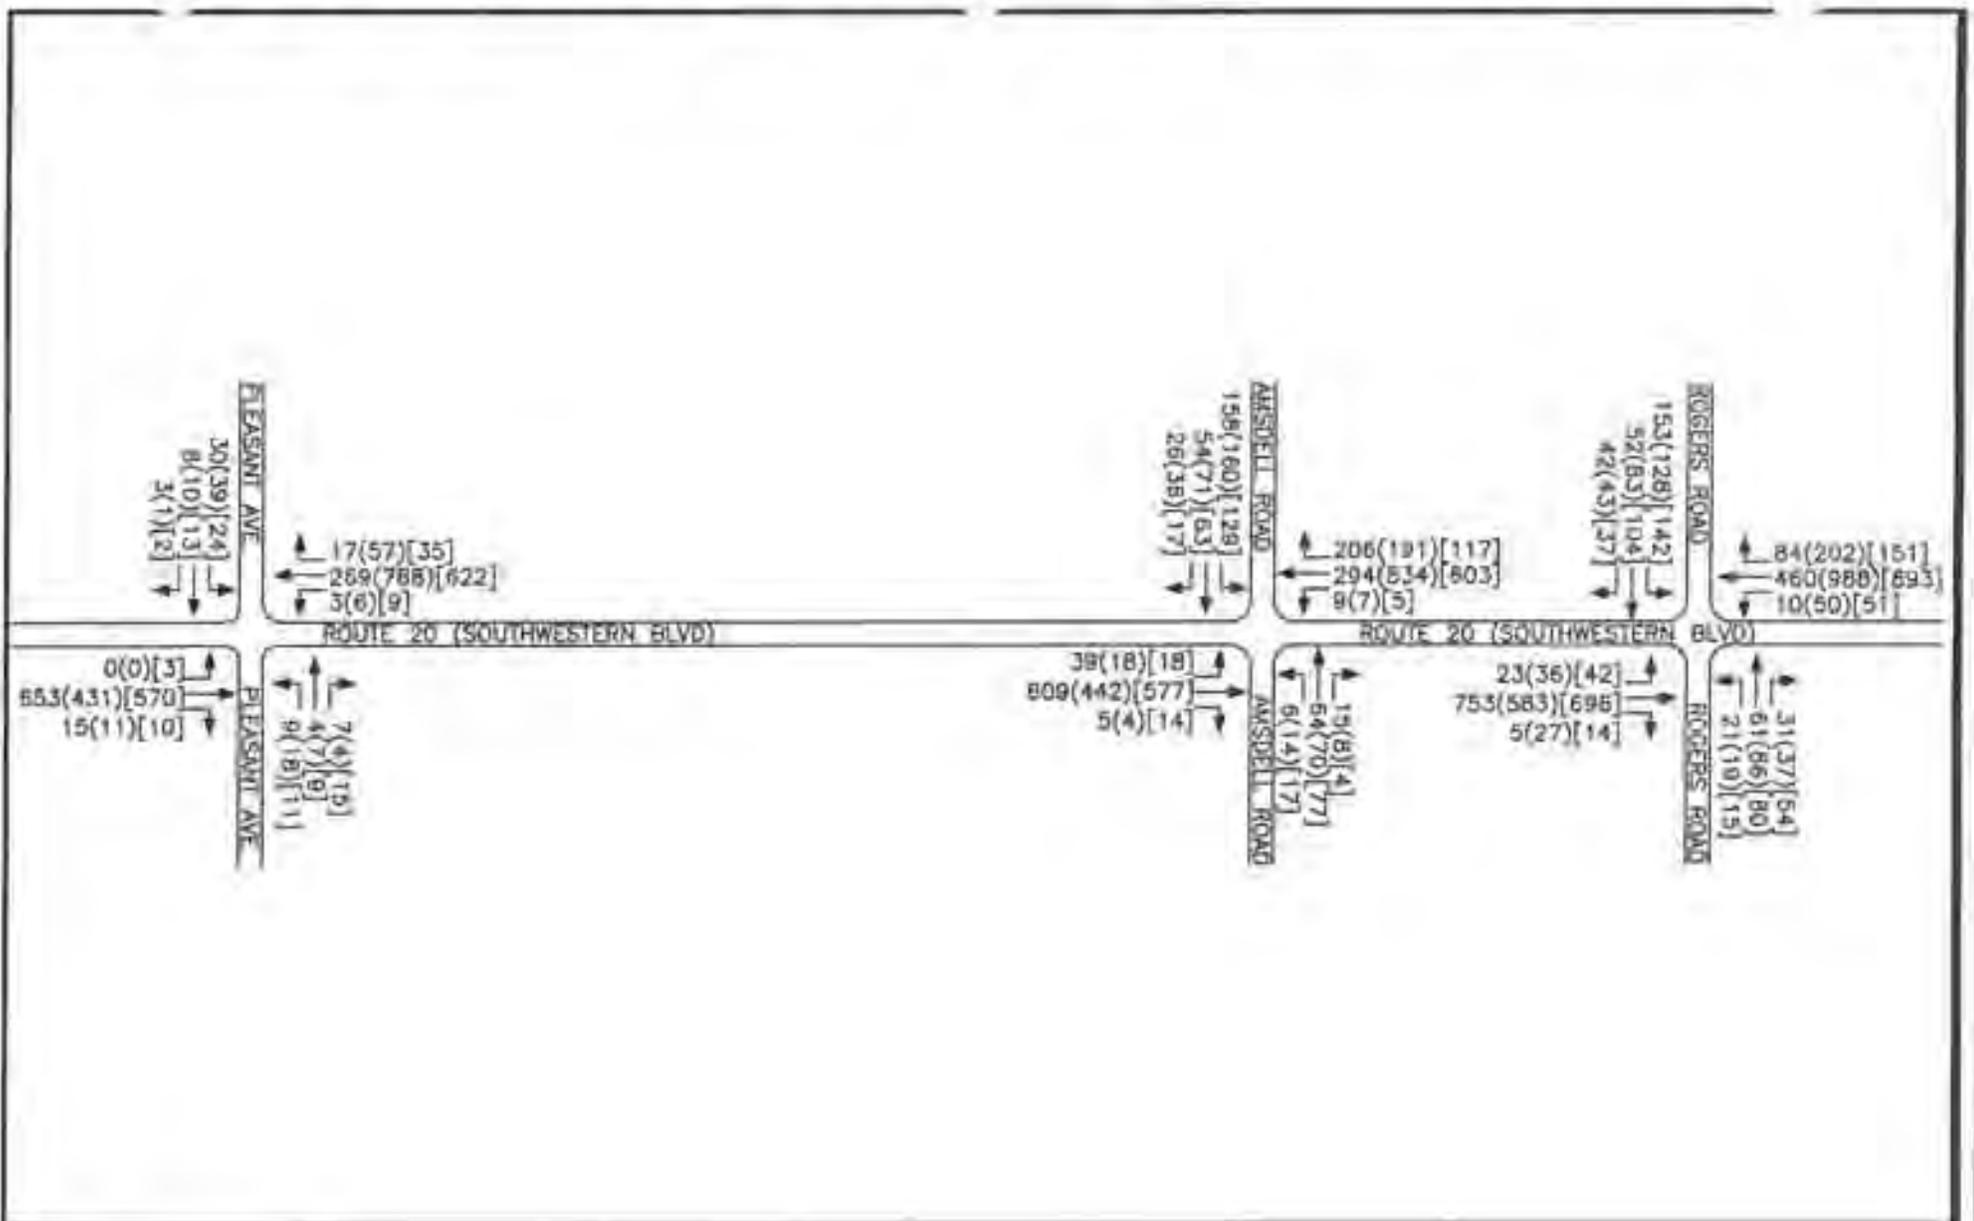
**FIGURE 5**  
 PEAK HOUR VOLUMES  
 BACKGROUND CONDITIONS  
 PROPOSED VILLAS AT BRIERWOOD,  
 HAMBURG, N.Y.

NOT TO SCALE  
 00(00)[00] = AM(PM)[SAT]

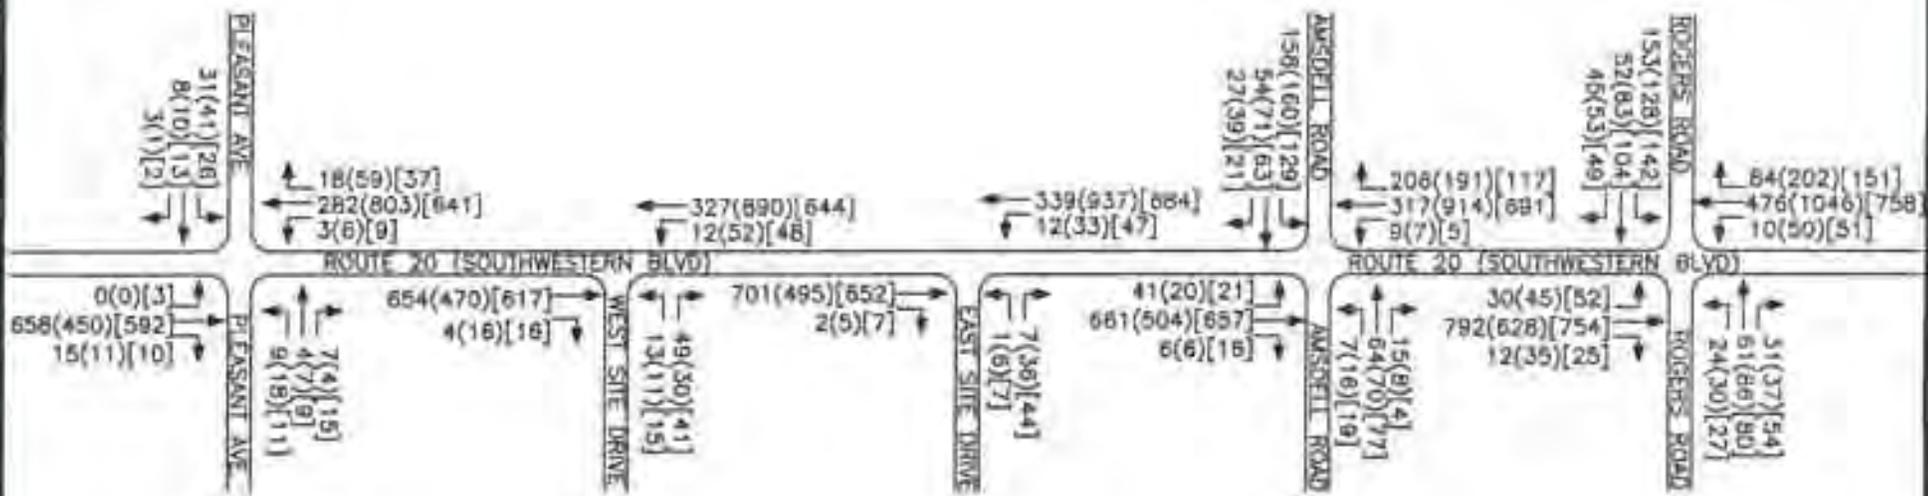
**FIGURE 8**  
 PEAK HOUR VOLUMES  
 FULL DEVELOPMENT CONDITIONS  
 PROPOSED VILLAS AT BRIERWOOD,  
 HAMBURG, N.Y.

NOT TO SCALE  
 00(00)[00] = AM(PM)[SAT]
