DRAFT ENVIRONMENTAL IMPACT STATEMENT

"VILLAS AT BRIERWOOD AND BRIERWOOD SQUARE"  
PLANNED UNIT DEVELOPMENT

"ACTIVE ADULT LIFESTYLE COMMUNITY"

TOWN OF HAMBURG, ERIE COUNTY, NEW YORK

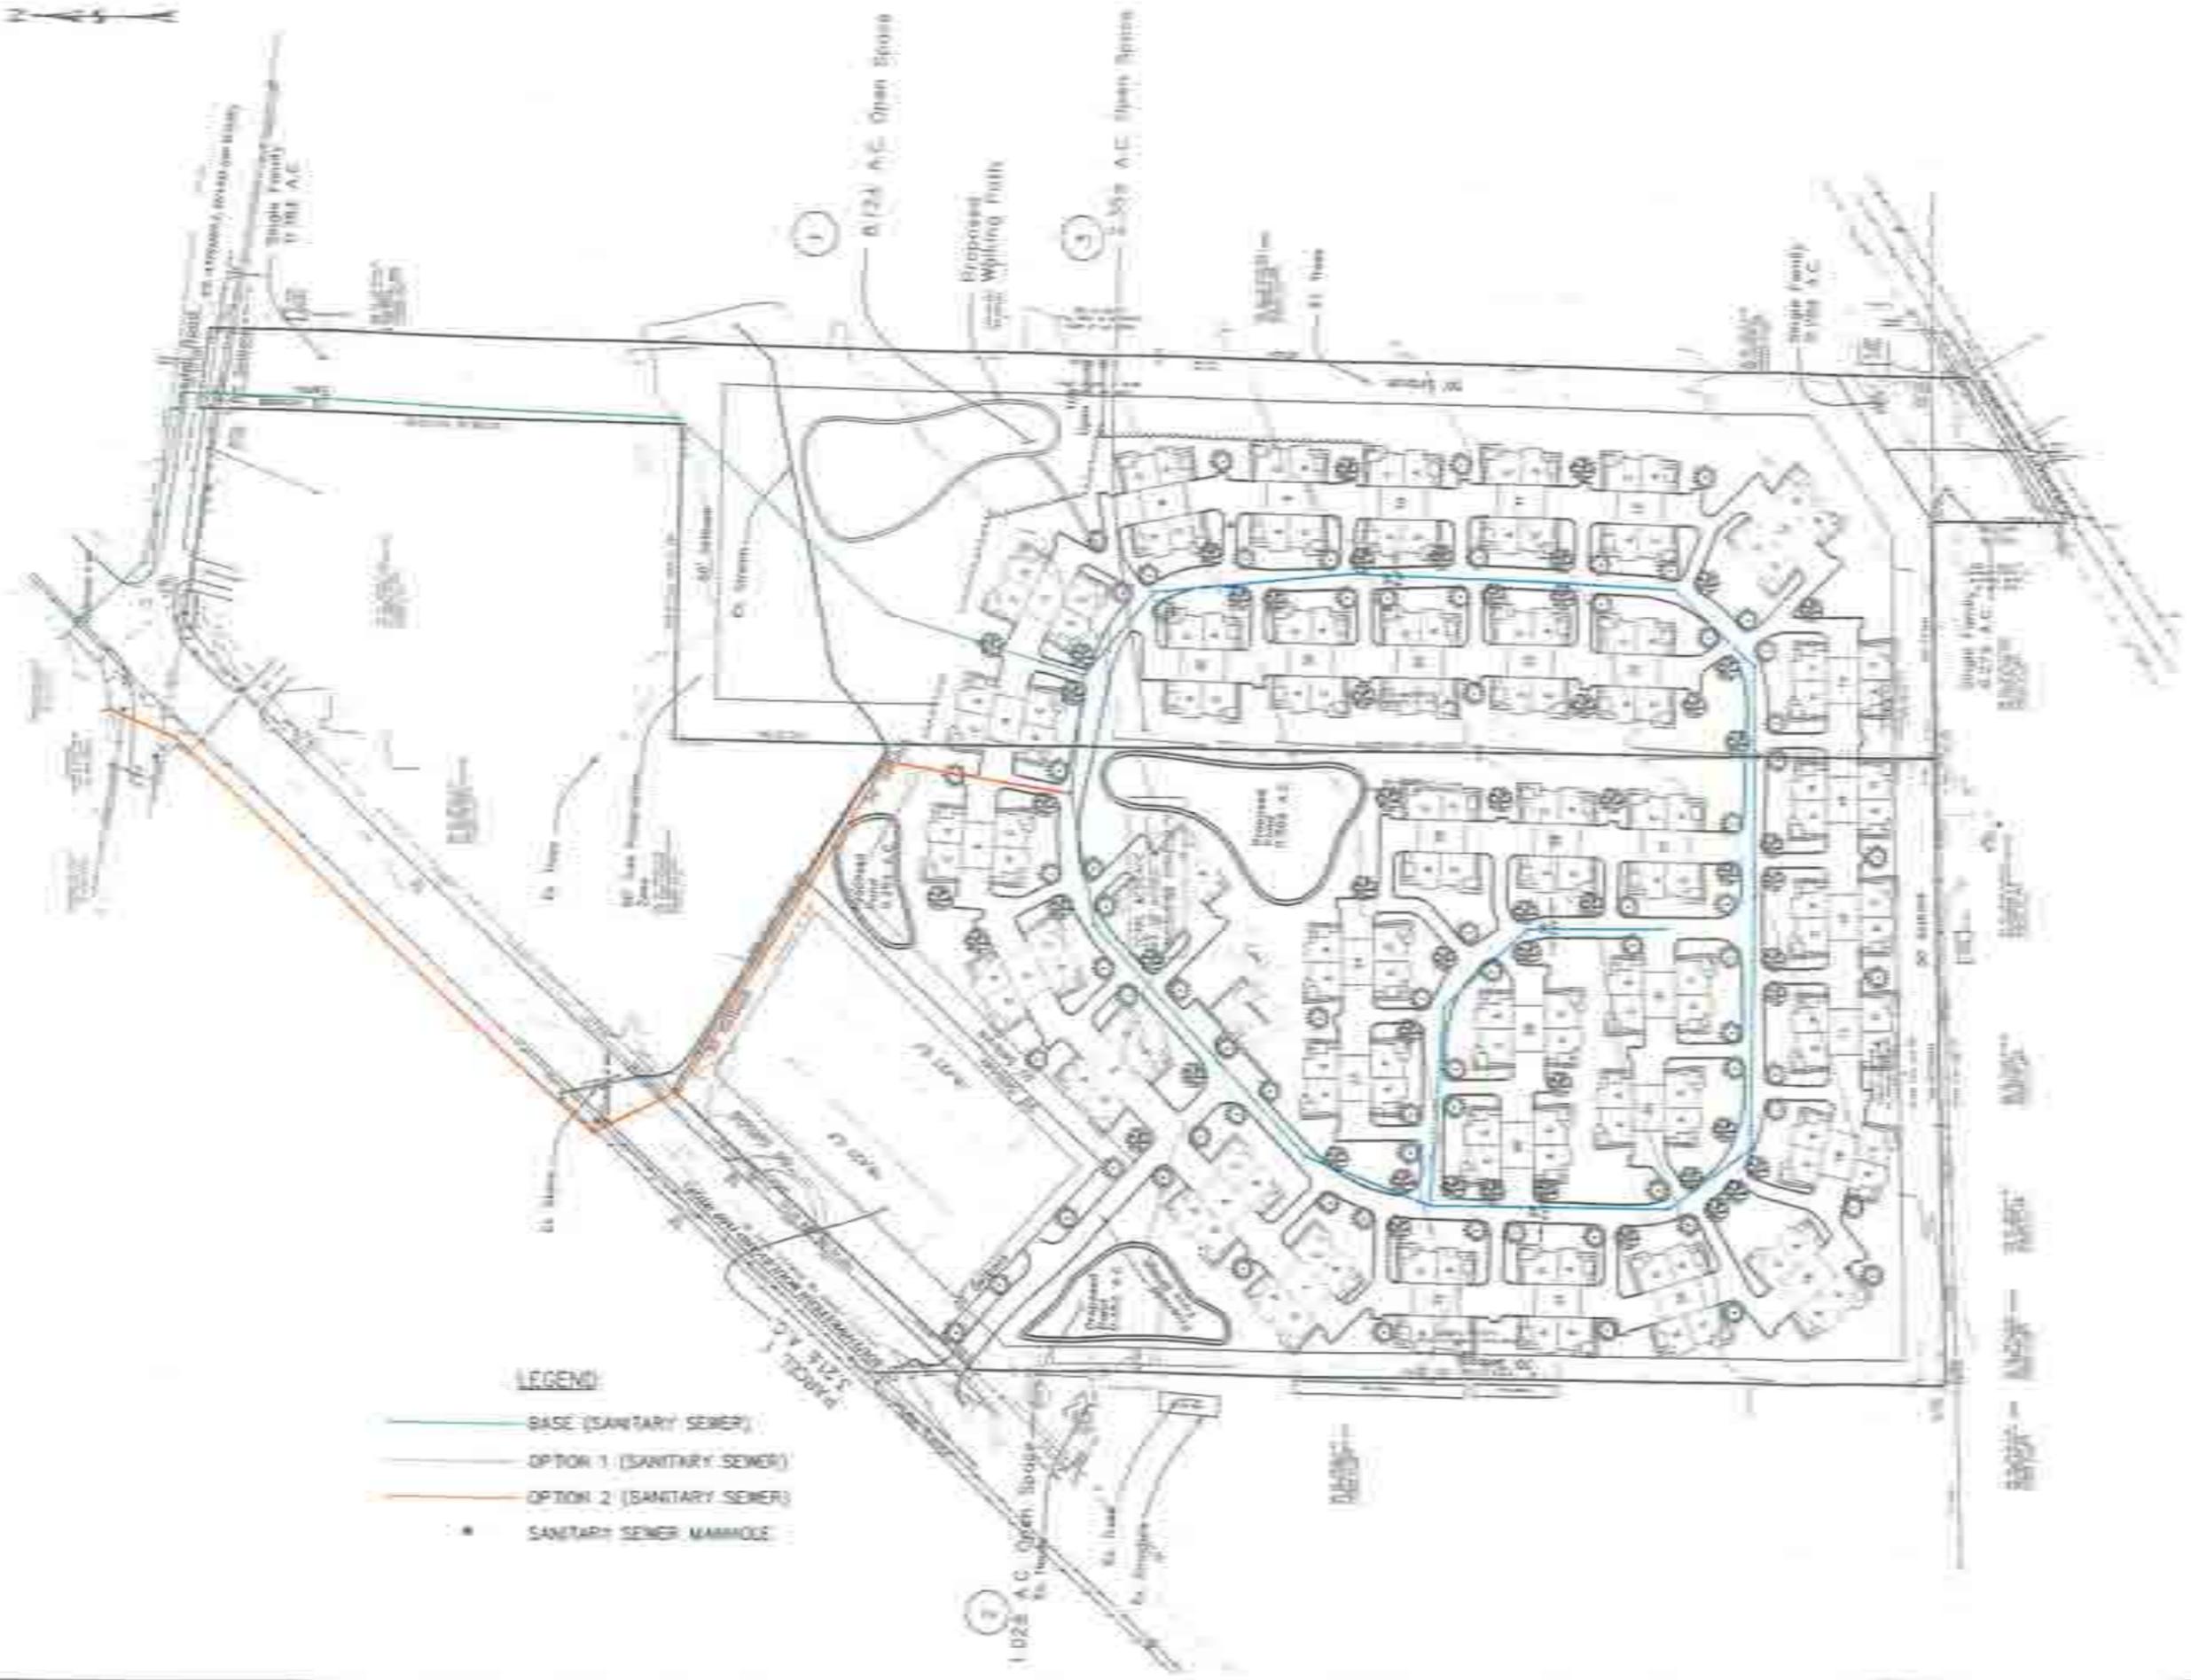
DRAFT LAYOUT

- BASE (SANITARY SEWER)
- OPTION 1 (SANITARY SEWER)
- OPTION 2 (SANITARY SEWER)
- SANITARY SEWER MANHOLE

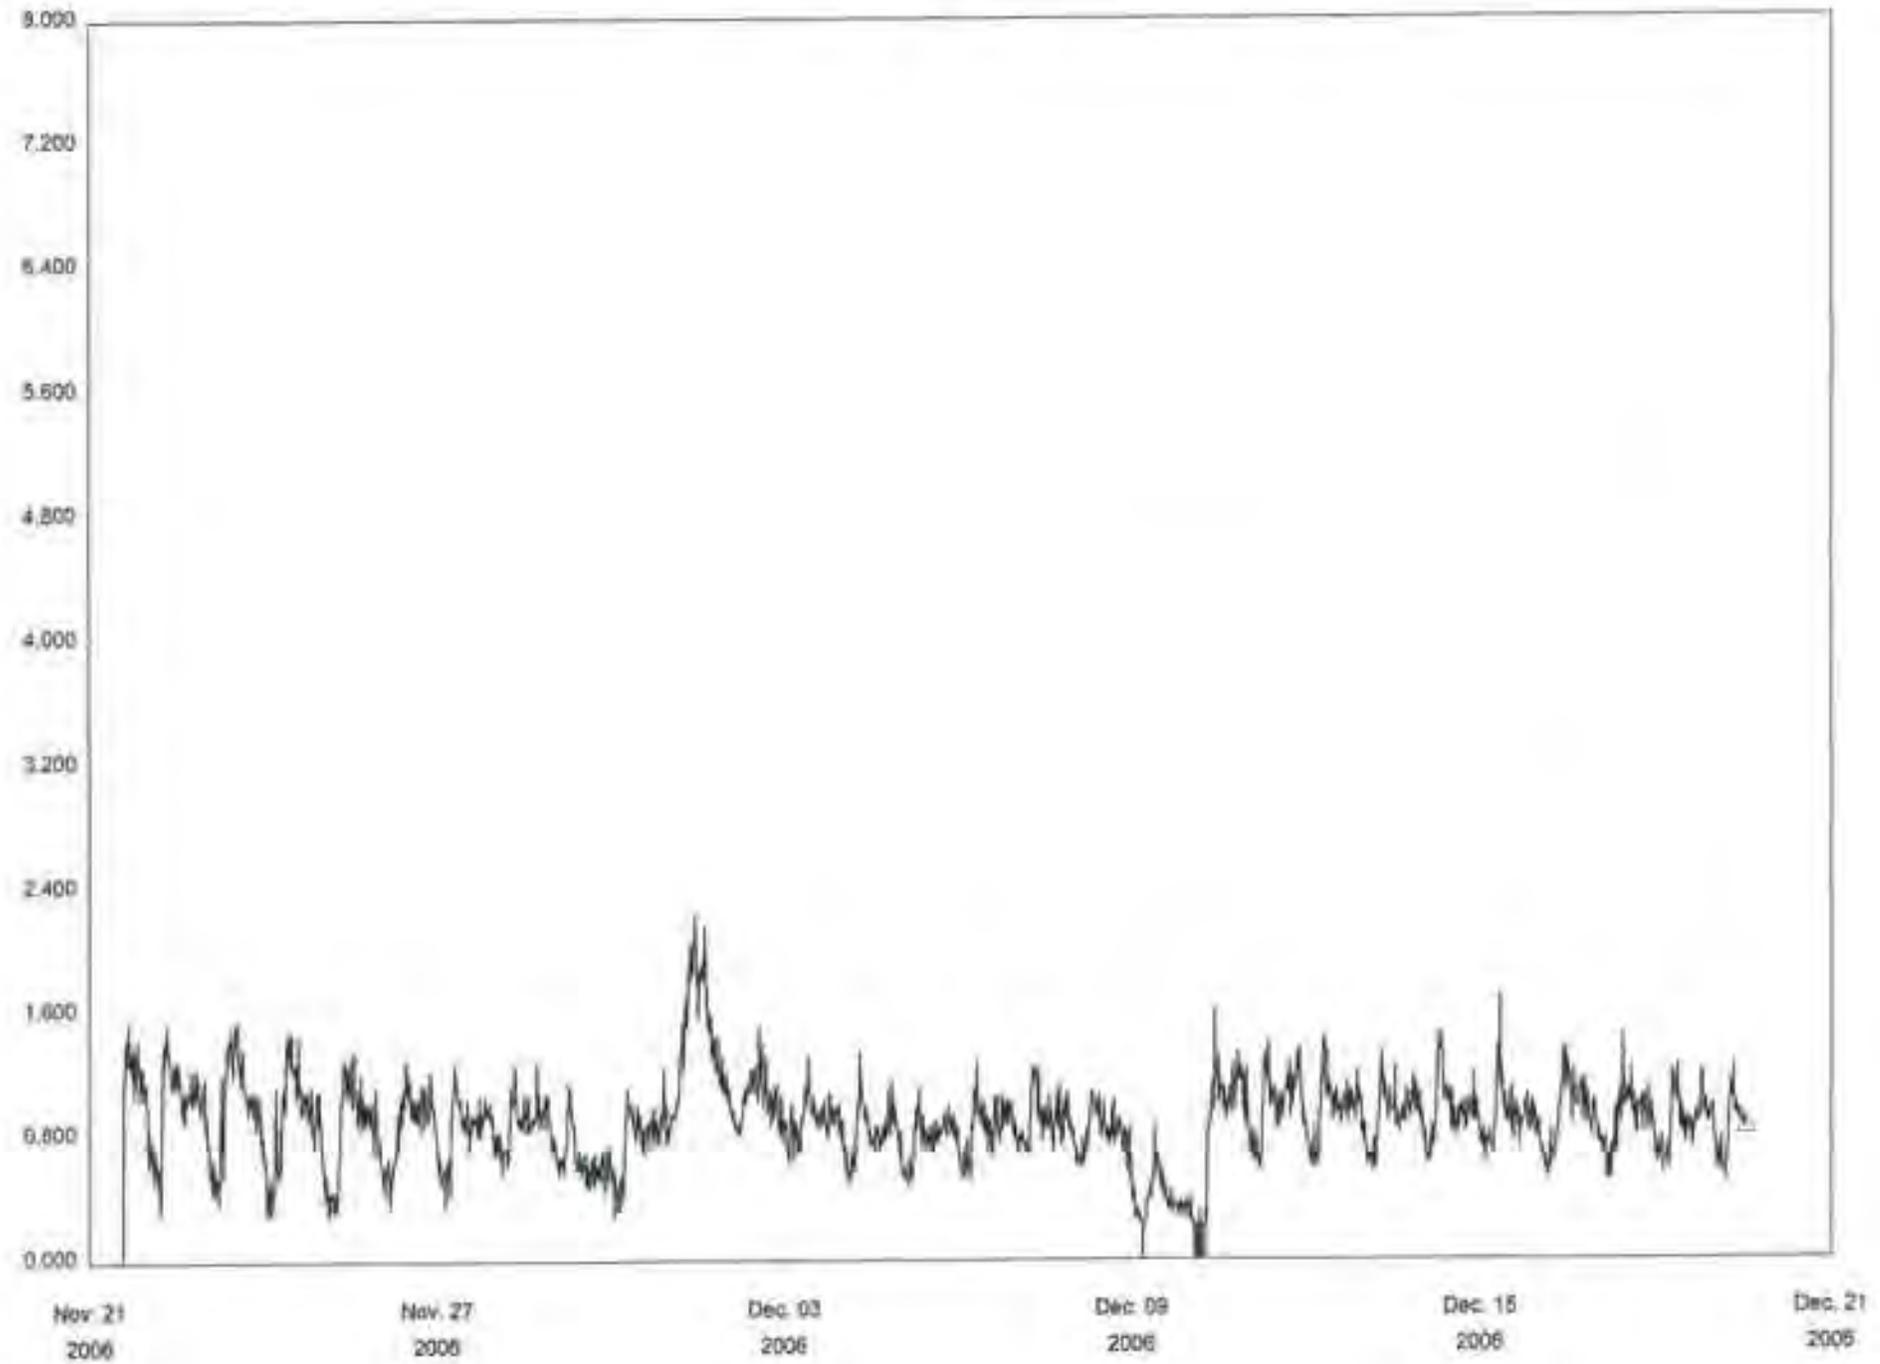
Flow 1 (mgd)

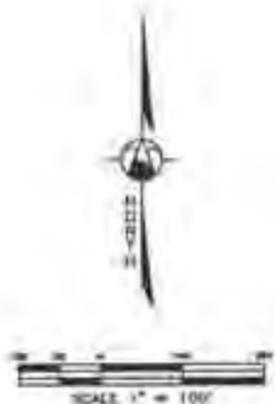
**UPLAND/WETLAND BOUNDARY;  
 PLANT COMMUNITY;  
 TEST PLOT & PHOTO DIRECTION  
 MAP #9**

↗ = Test plot + photo direction  
 x++x = Upland/Wetland Boundary  
 PC = Plant Community

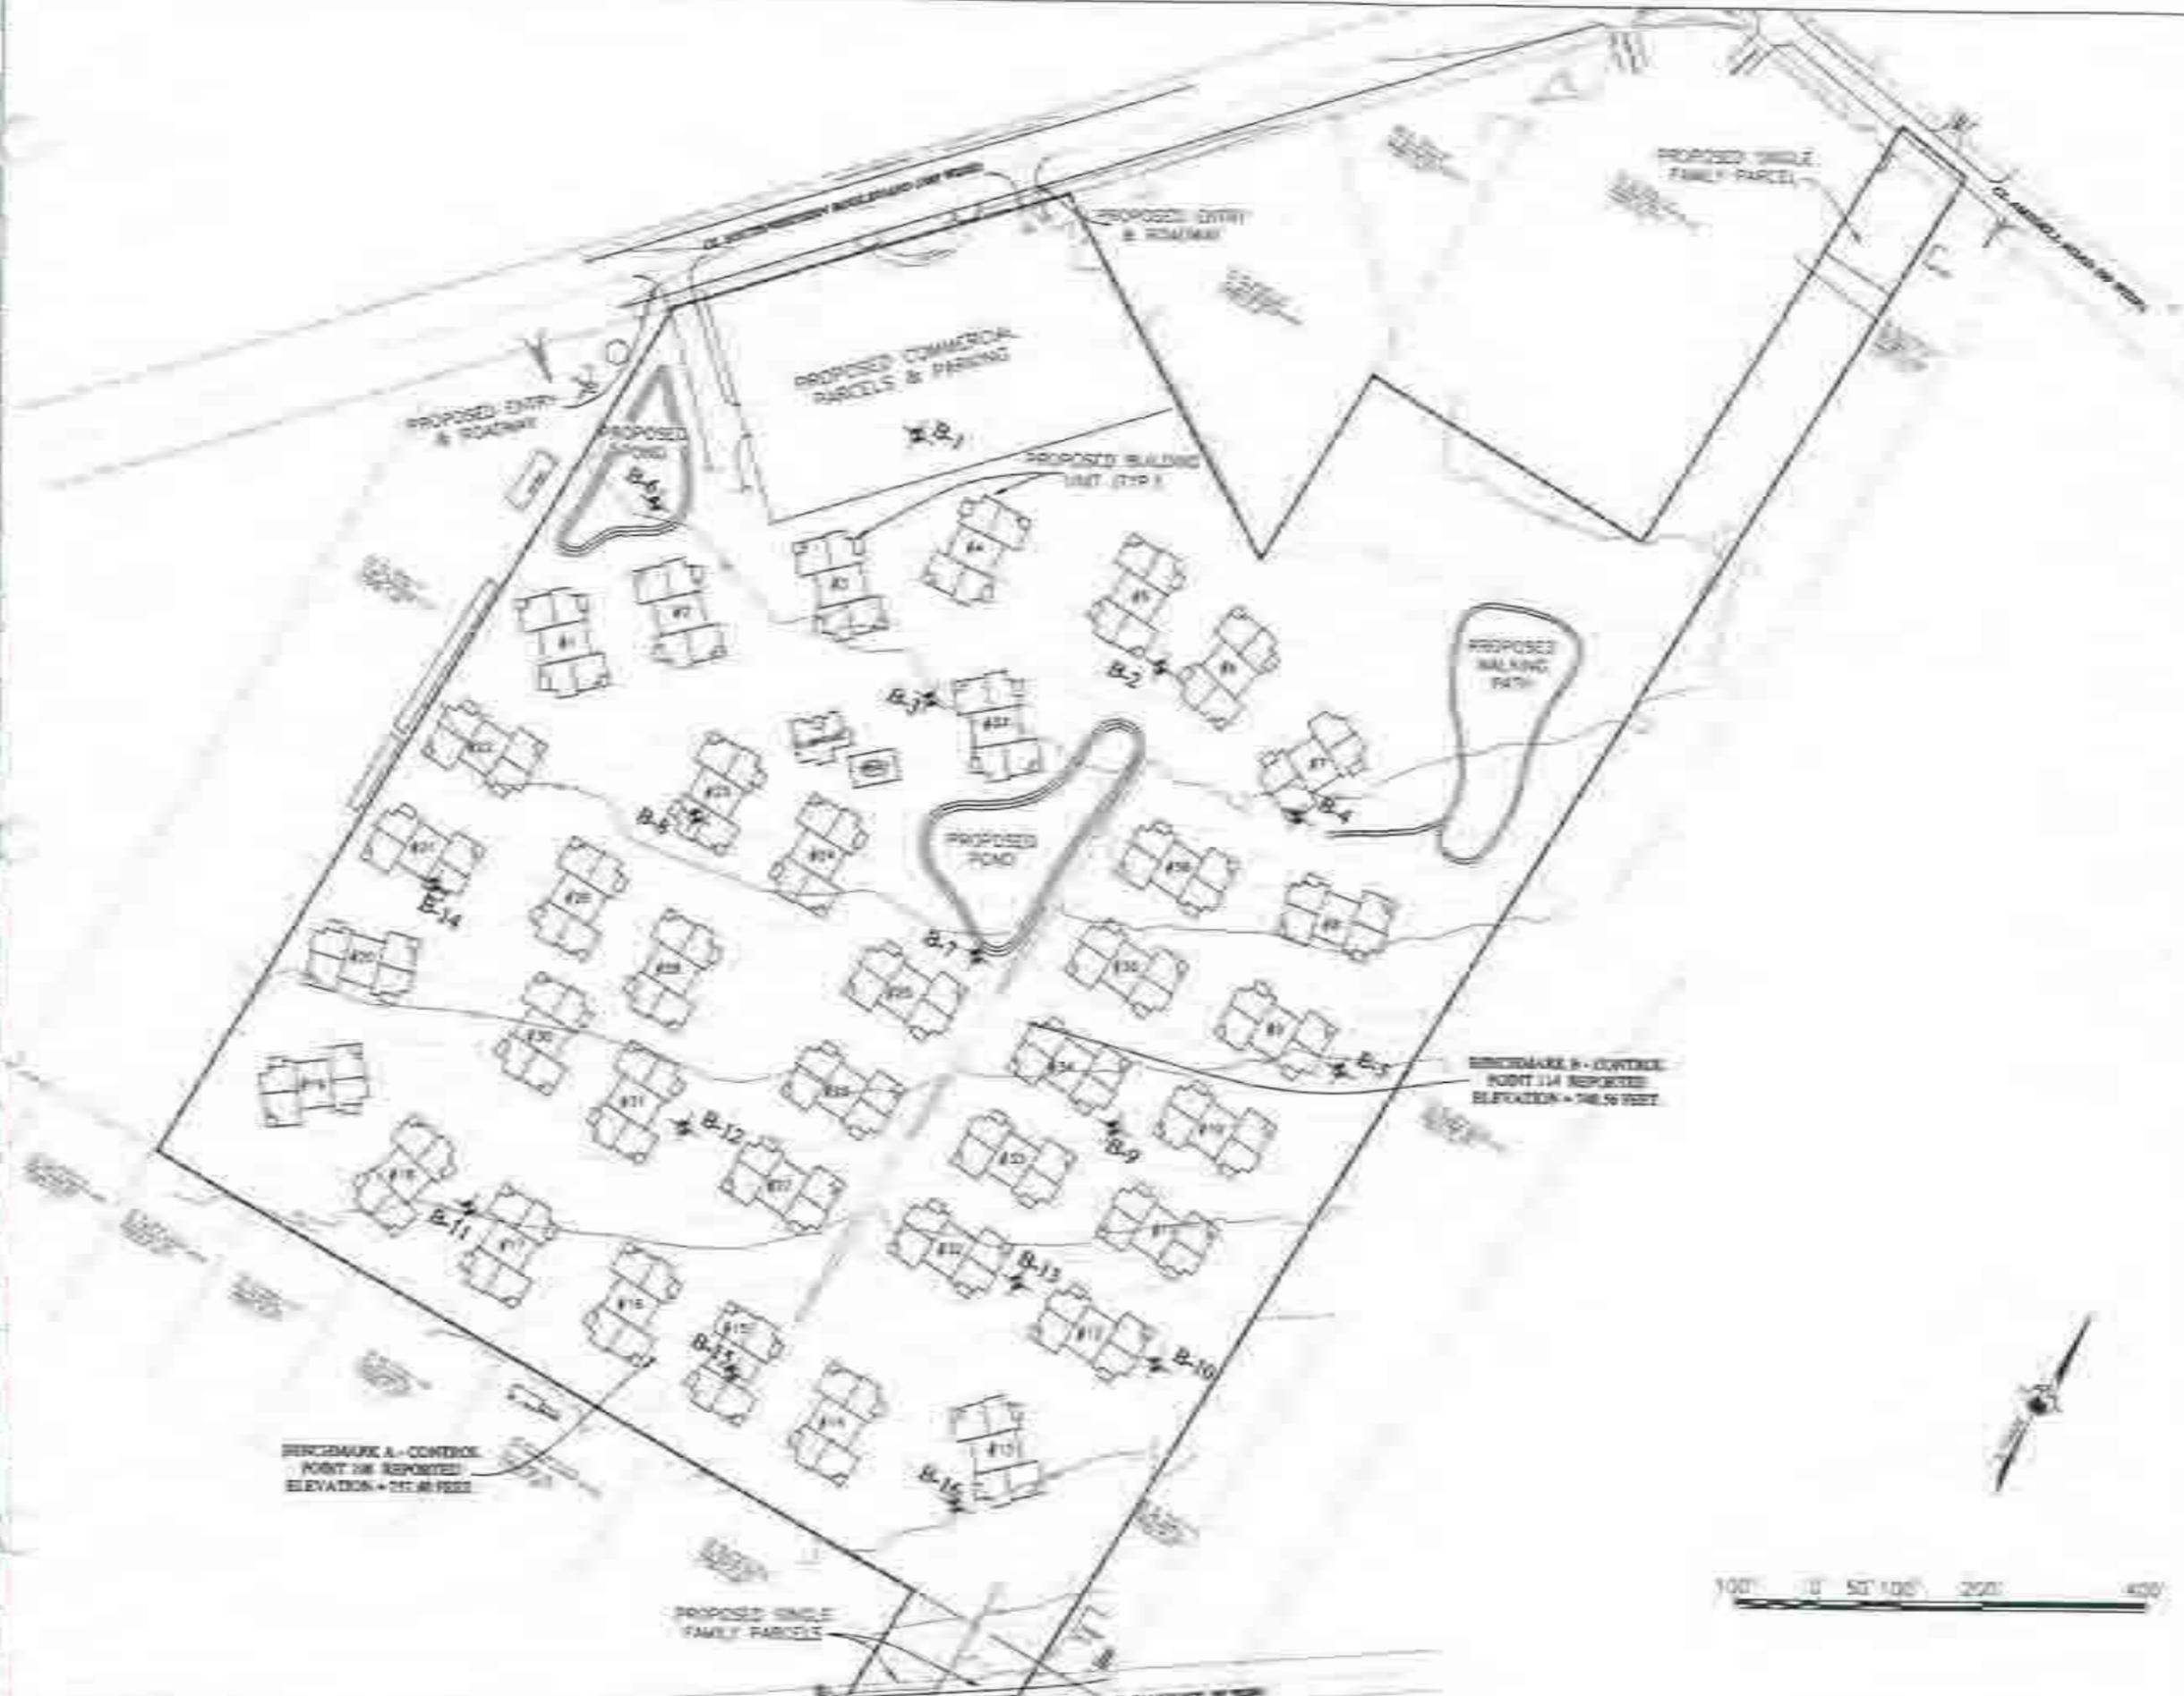
BASE MAP (TOPO) PREPARED BY  
 GENZEL LAND SURVEYING, P.C. -  
 "BOUNDARY SURVEY".

PROPOSED PROJECT LAYOUT  
 DEVELOPED FROM "CONCEPT SITE  
 PLAN" PREPARED BY EVANS,  
 MECHWART, HAMBLETON &  
 TILTON, INC.

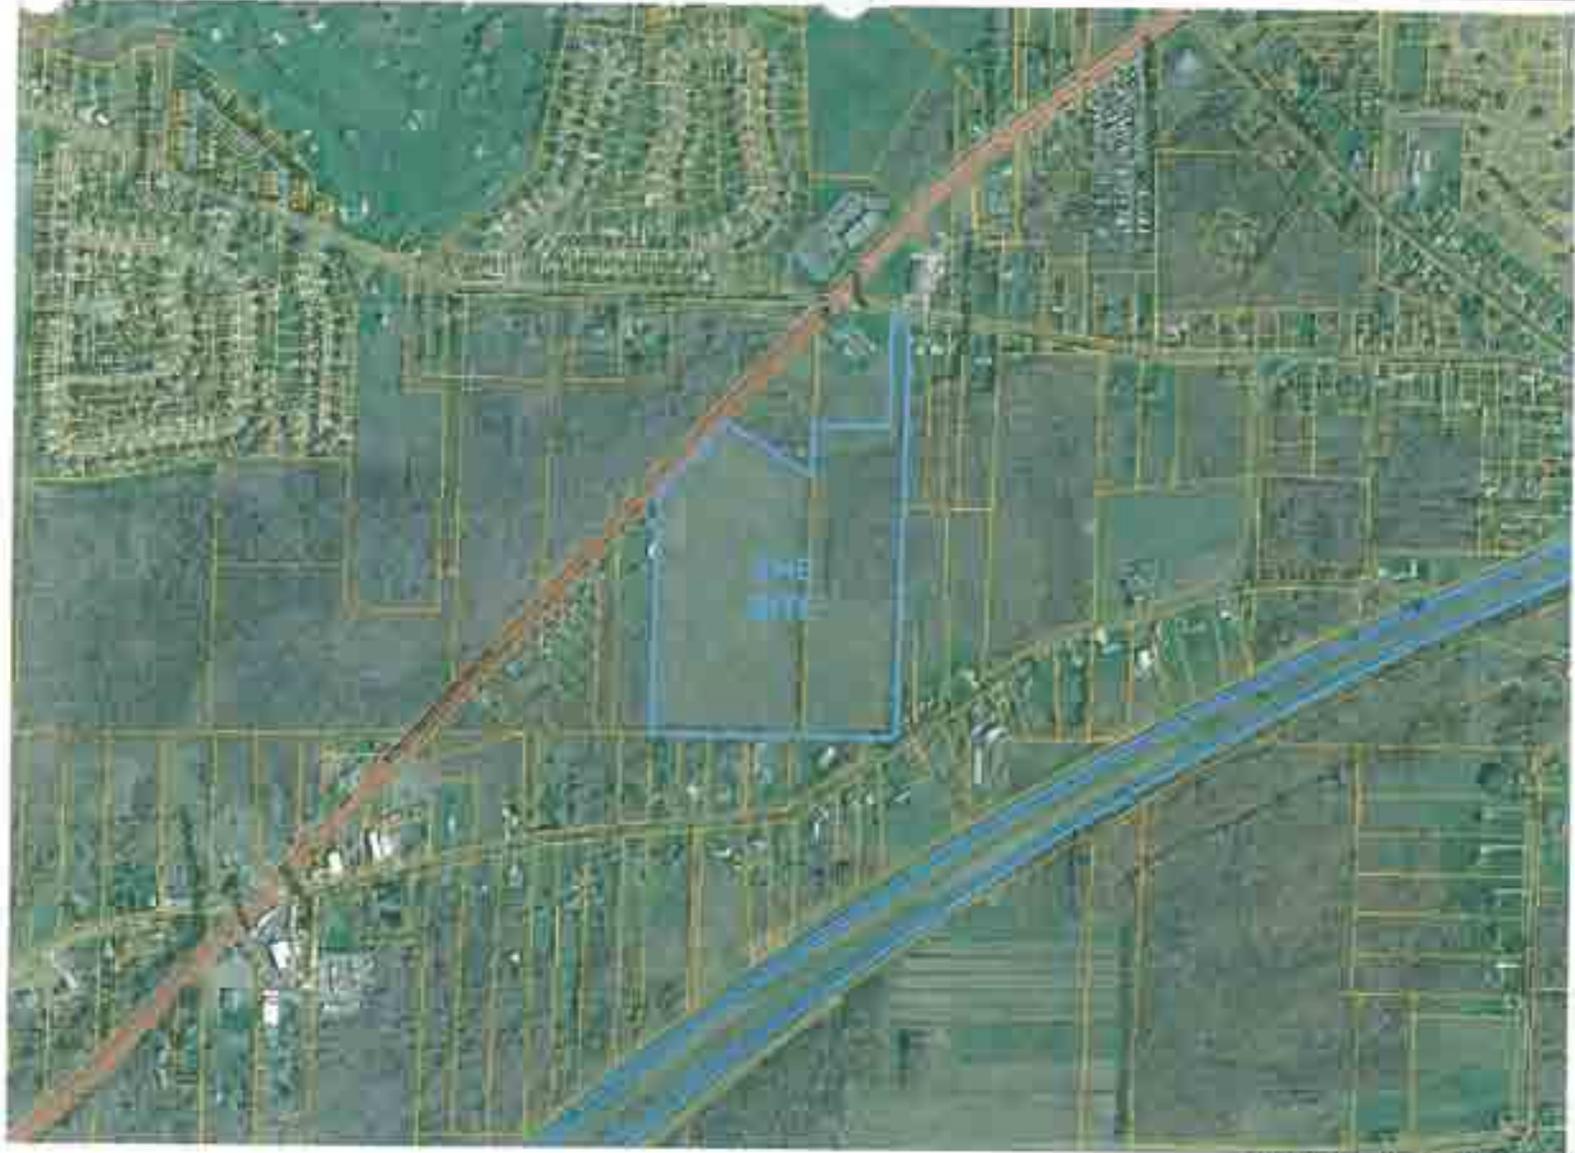
Title: **SITE PLAN**  
Southwestern Boulevard, Hamburg, New York  
(SBL #'s 182.00-4-13.1 & 182.00-4-19)

Source: Erie County Mapping System

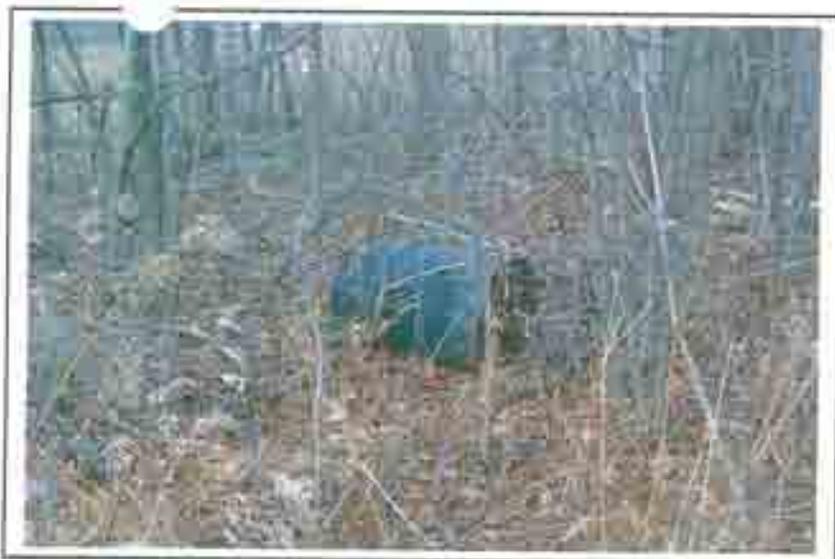
Photograph No. 1: View of abandoned drum in hedgerow.

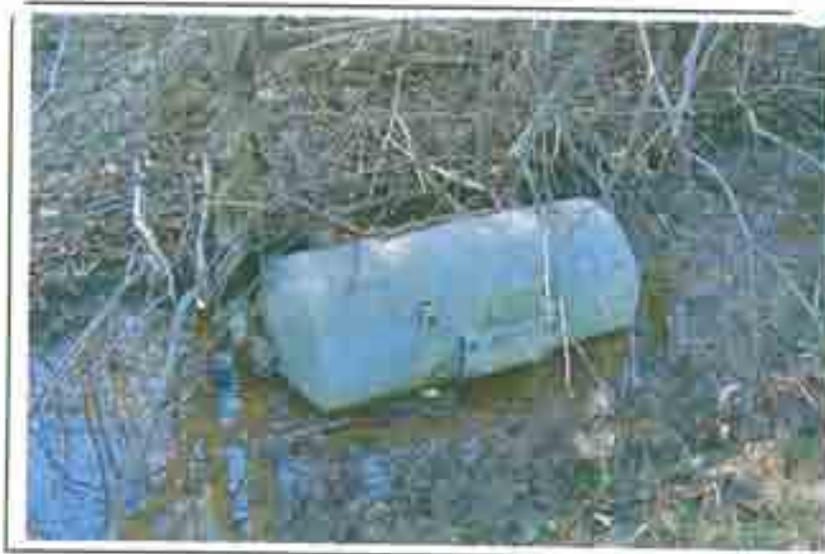
Photograph No. 2: View of abandoned water tank by the debris pile.
